## **The Collapse and Reconstruction of a Prestressed Concrete Box-Section Girder**

**Hugo Bachmann**

**Werner Horisberger,**

### **SUMMARY**

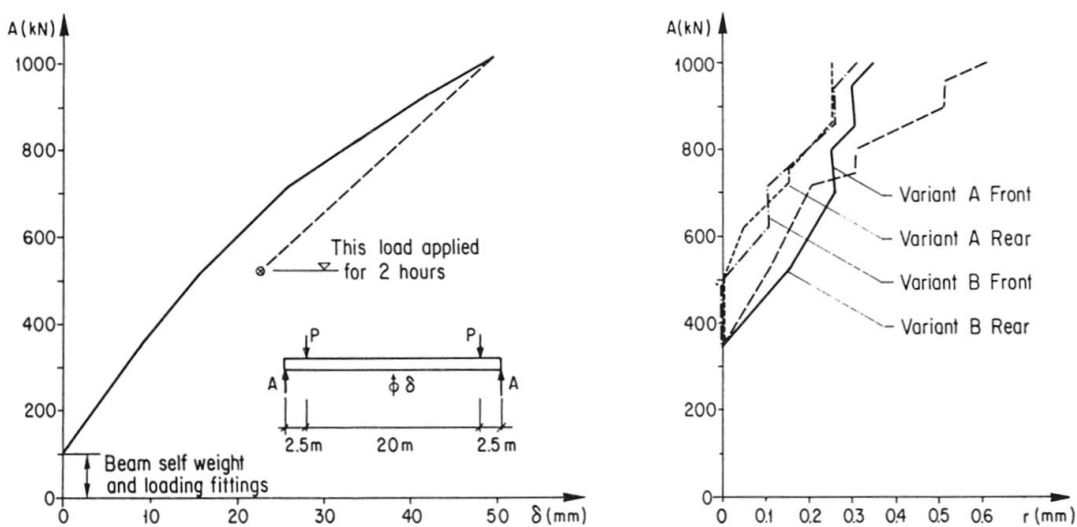
Fig. 20 Midspan deflection of the girder and also the largest crack width  $r$  in the webs as a function of the support reaction

Both remedial solutions showed themselves to be workable. The self weight of the beam and the test fittings led to a support reaction of 115 kN. With a support reaction corresponding to that of a full working load i.e. with  $Q(g+p) \approx 500$  kN there first appeared a few cracks in the web of maximum width 0.15 mm. The mid-span deflection (without self weight) was 16 mm. Following on from here a load giving a support reaction corresponding to twice the working load reaction, i.e.  $2Q(g+p) \approx 1000$  kN, could be obtained without fracture. Under this maximum loading the largest crack width in the webs was 0.60 mm and the deflection midspan = 50 mm. Fig.20 shows the midspan deflection and also the crack widths as functions of the support reaction. Fig. 21 shows the crack pattern at the girder end A.
