Zeitschrift: IABSE reports = Rapports AIPC = IVBH Berichte
Band: 57/1/57/2 (1989)

Rubrik: Workshop 3: Durability of suspended structures

Inspection Evaluation, and Rehabilitation of Suspension Bridge Cables

Inspection Program for the Lisbon Suspension Bridge
Programme d'inspection pour le pont suspendu de Lisbonne
Untersuchungsprogramm für die Hängebrücke in Lissabon

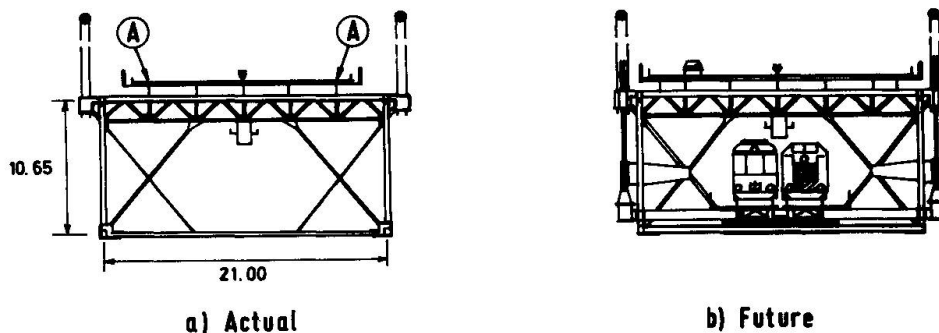
The truss beam is, 10,6m high and 21m wide, suspended from the hangers (23m apart) about 70m above water level. Fig. 2 shows the actual cross section and the future situation with the train. The actual widening design considers the space between the border of the upper deck and the hangers.

Fig. 2 - DECK CROSS SECTION.

At the first stage of the program, the corrosion inspection was implemented. At the columns only superficial corrosion was found, mostly at the interior of the base section. The concrete caissons were also observed and filmed under water to check for concrete degradation, but no relevant findings were obtained. At the cables hangers and cable bands, and with an external observation, only small spots of superficial corrosion were found. Due to the good external condition, an internal observation with electromagnetic techniques was not considered necessary at this stage. All the bars of the deck truss were also inspected and plots of the superficial corrosion along the bridge were drawn for each element (Fig. 3). Structural damage by corrosion was found only in a few nuts of the bolted connections which presented section reductions of more than 20%. It is estimated that about 2% of the deck bolts will need to be replaced shortly. During deck inspection some transversal bars located over the longitudinal girders (shown in Fig. 2 by A). It is estimated that 13% of the total number present this problems.

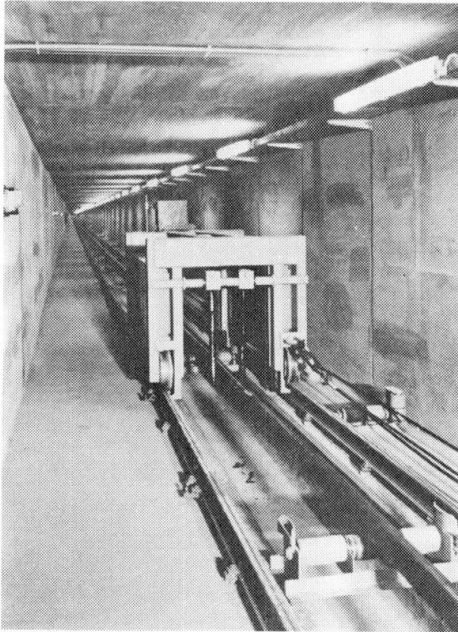
Nach dem Einsetzen der Seilköpfe in den Kuppelwagen (Fig.4) und in den Klemmenwagen (Fig.5) wurde eine Last von 1430 kN, das sind 30 % der rechnerischen Seilbruchlast, aufgebracht. Mittels Einrichtung zur Konstanthaltung konnte die Belastung des Seiles während der Sanierung der beiden Drahtbrüche auf gleichem Niveau gehalten werden.

Fig. 4 Seilreckanlage, 400 m lang, mit Einziehwagen, Kuppelwagen im rückwärtigen Teil des Tunnels

Die Seilreckanlage wurde 1970 im Werk Wien als Tunnelreckanlage, vier Meter unter Hüttenflur, errichtet. (Fig.4) Als Besonderheit der Anlage ist hervorzuheben, daß der Reckvorgang zu jeder Zeit bei konstanter Temperatur und unabhängig von den Außenbedingungen erfolgen kann.
