**Zeitschrift:** IABSE reports = Rapports AIPC = IVBH Berichte  
**Band:** 73/1/73/2 (1995)

**Artikel:** Renovation of Seattle's historic Paramount Theatre  
**Autor:** Lundeen, Terry R. / Harriott, James D.  
**DOI:** <https://doi.org/10.5169/seals-55172>

## Renovation of Seattle's Historic Paramount Theatre

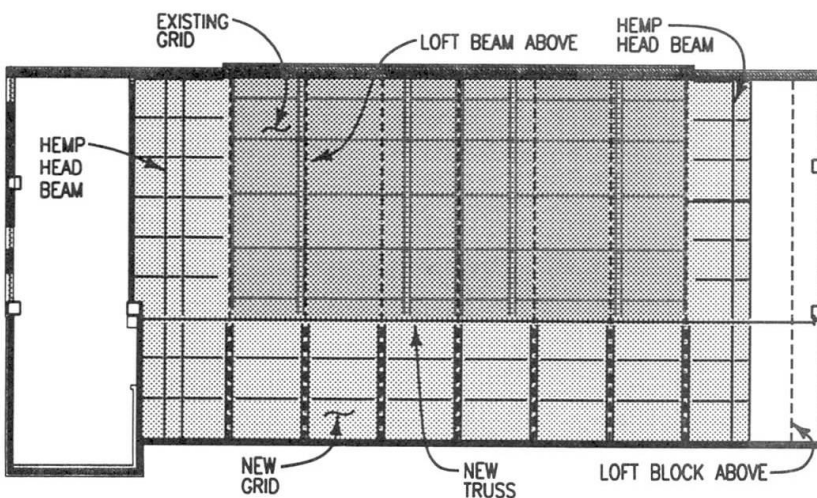
Fig. 3: Major Stage Rigging Elements

Another important improvement during this renovation was the modification of the rigging arrangement. Originally, the stage rigging system was mounted to the gridiron 21 m above the stage and 3 m below the roof. This arrangement created a congested web of loft lines at the gridiron, making access to spot lines very difficult. In modern theatres, rigging consists of loft lines pulled vertically through sheaves which are attached to roof beams and hemp lines which thread through pulleys mounted on the gridiron. The loft lines support scenery and are spaced at 20 cm on center upstage and downstage and spaced at 3 m on center side to side. The loft lines are collected on the head block at stage right and then drop down to a counterbalance pit below stage level. The hemp lines support spot loads on the stage and pass through hemp head beams on each side of the gridiron. A plan view

In general, the original roof and gridiron structure had adequate overall capacity for modern production loads, however, it was not configured for the new arrangement. Complete removal of the stage roof and gridiron structures was considered as an option, but cost and

constructability issues dictated that the preferred approach was to modify the existing structure. This modification required careful consideration of sequence and load transfer during construction. A 9 step sequence was developed and was included on the structural drawings. The new elements to be installed included loft beams, head block, new gridiron hanger supports, gridiron grating and beams, hemp head beam, and two counterweight loading areas. The erection sequence allowed for installation of all the new elements without shoring the existing structure.

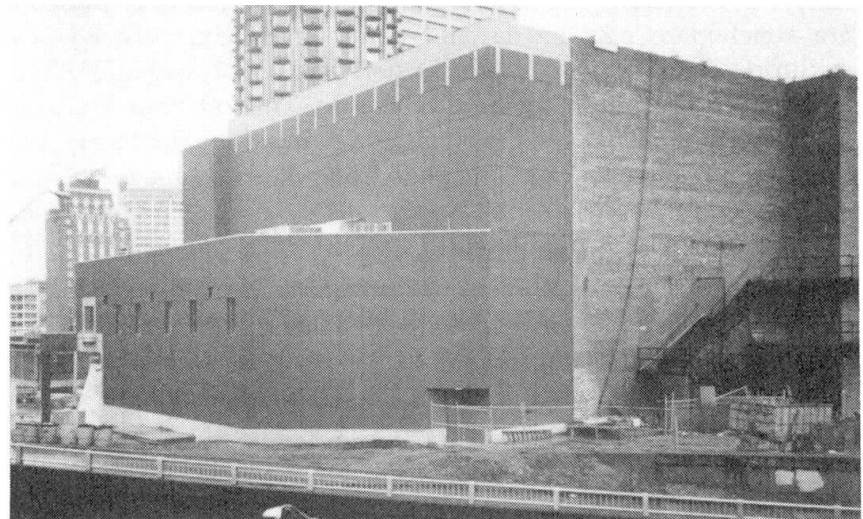
Fig. 4: Backstage Addition

The next major component of the renovation was the expansion of the building in the area adjacent to the new stage. This expansion, approximately 9 m by 33 m in plan, included a new transformer vault and electrical room in the basement, a two-truck loading dock at street level, a large 6 m by 9 m freight elevator down to the stage level, a dressing room level, a passenger elevator and exit stair to allow access to 8 existing stage left levels, and a rooftop mechanical area.

The foundation of the new structure consisted of concrete augercast piles in combination with the steel soldier piles, which were attached to the concrete walls for transfer of permanent gravity loads. The loading dock is a cast-in-place concrete structure designed for highway truck loads. The dressing rooms and roof are conventional steel frame floor systems supported on steel tube columns at the exterior and concrete masonry unit (CMU) walls at the backstage wall. This tall slender 19 cm CMU wall also supports a portion of the expanded stage roof. A photograph of the building showing the backstage addition is given in Figure 4.
