### **The Development of Asphalt Surfacing for Steel Bridge Decking**

J. J. TROTT

D. S. WILSON

Road Research Laboratory, Department of Scientific and Industrial Research,  
United Kingdom

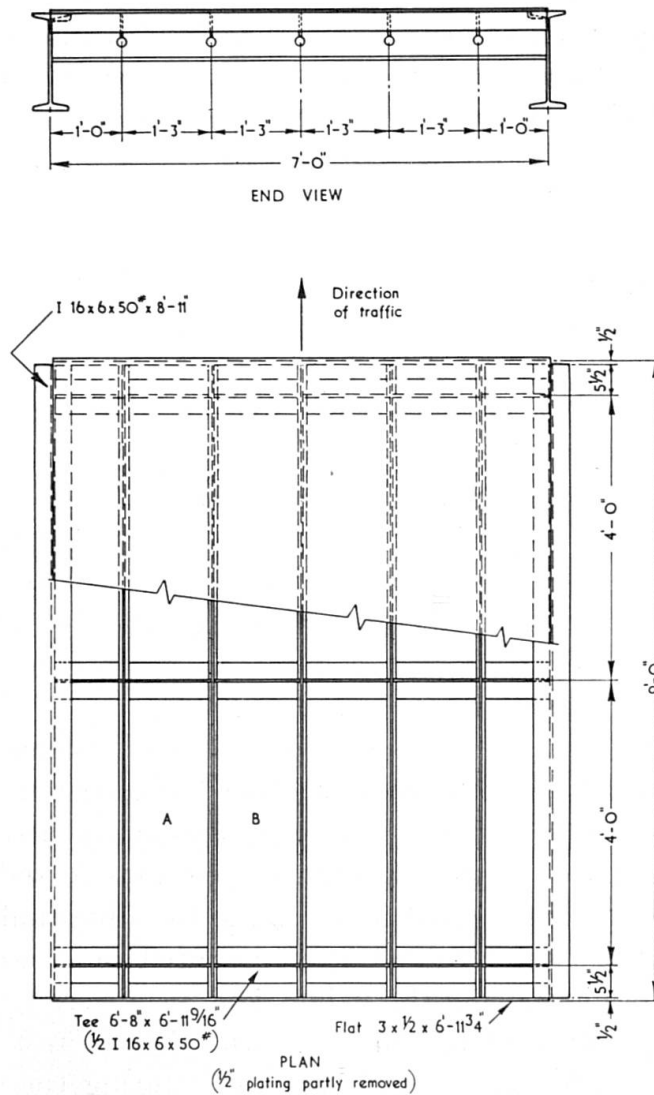
Fig. 1. Deck Panels for First Surfacing Test.

Loading tests were made on these panels on two occasions — 2nd February and 1st March, 1950 — to determine whether the surfacings would crack due to the deflection of the decking under the maximum design wheel load of 12½ tons. The load was applied in turn at positions A and B (see fig. 1) on each panel. The load was applied to the plate by a hydraulic jack through a section of 14-in. wide solid rubber tyre mounted on a wooden block, and released rapidly by unscrewing the valve. The tests were repeated twice each day and the temperature of the mastic at the time of test varied between 1 and 4½°C. The mastic surface did not crack during these tests. Since the stiffness of the decking on the proposed bridge is greater than that of the

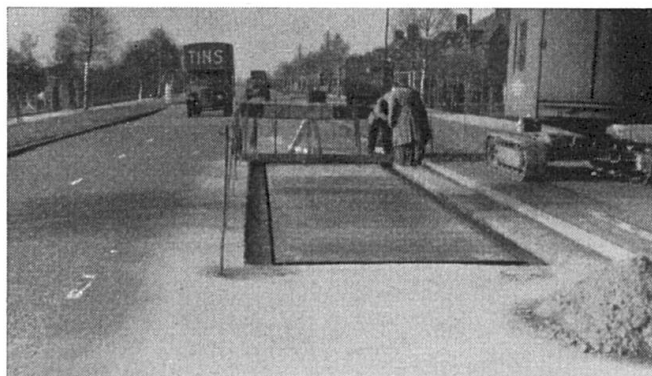
Fig. 2. Panels in Position Prior to Surfacing.

For the full-scale tests, four panels, each 9 ft. long by 7 ft. wide, were laid in the road (see fig. 2). Three of the panels had smooth deck plates while the fourth had a chequered plate which was included because it was feared that the surfacing might "push" on a smooth plate. The four plates were sand-blasted and painted as described, and then placed in the carriageway with their ends supported on concrete beams. The levels of the panels were stepped to permit thicknesses of surfacing of 1 in., 1½ in. and 2 in. to be laid on the three smooth plates and a 1½-in. surfacing on the chequered plate. Fig. 2 shows the panels in position before surfacing. Steel plates 12 in. wide covered the gaps between the sides of the panels and the road. The panels were sited on the braking side of a bus-stop and thus received maximum traffic forces. A proprietary brand of mastic asphalt was selected as suitable; this was supplied and laid by the Limmer and Trinidad Lake Asphalt Company Limited. The material complied in general with B.S. 1447, Table 1, Col. 3, but the penetration of the 50/50 mixture of Trinidad Lake asphalt and asphaltic bitumen was in the neighbourhood of 10. The penetration of the soluble portion of this binder was about 20. 40 per cent of granite chippings were added, as indicated in B.S. 1447. ½ inch coated granite chippings were rolled into the surface of the mastic to provide a non-skid surface.

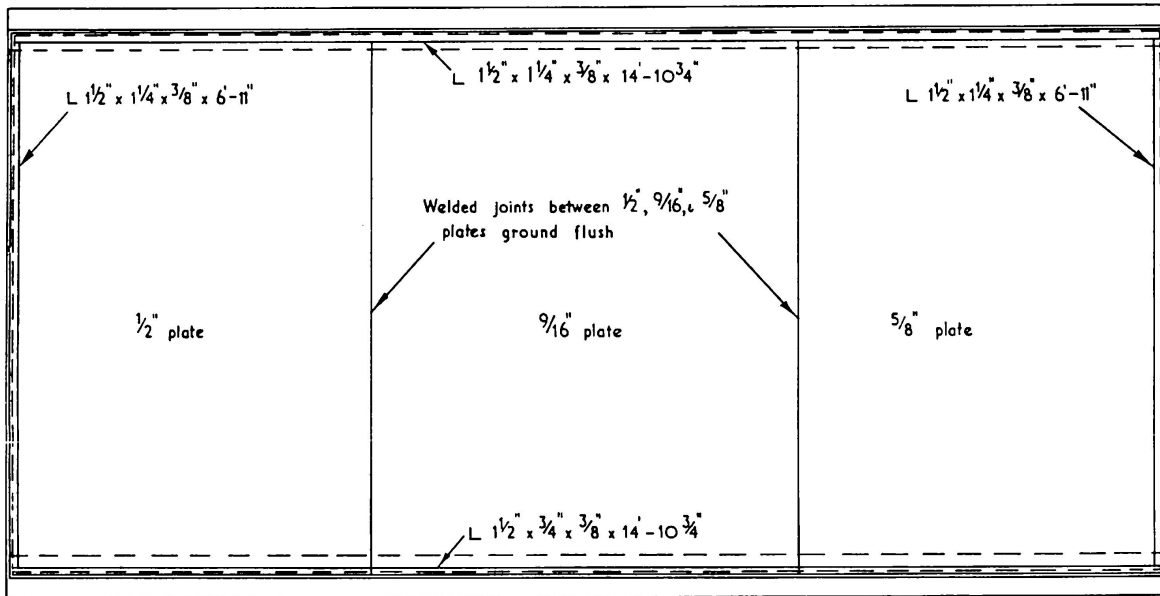
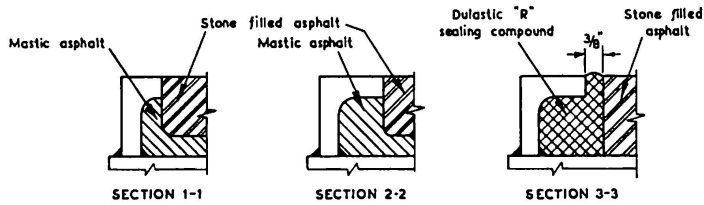
Fig. 7. Panel Used for Second Experiment.

The large panel was similar in construction to those described earlier. Angle-iron was welded along its edges as shown in fig. 7 in order to contain the asphalt. Two of the existing panels, namely that with the chequered steel plate and that carrying the 2-in. mastic asphalt surfacing, were taken out of service and replaced by the 15 ft. by 7 ft. plate in November 1950. Two methods of laying the surfacing were employed and the methods used to seal the edges are shown in fig. 7. The panel was subjected to traffic and weathering for  $5\frac{1}{2}$  years and was removed for inspection in July, 1956. The surfacing was removed near to the corners to inspect the sealing and the results were as follows:

*Corner A.* The edge here was formed by  $1\frac{1}{2}$  in. by  $1\frac{1}{4}$  in. angle and was filled with a proprietary rubber/bitumen sealing compound. The joint was found to be perfect.

*Corner B.* The edge here was formed from either  $1\frac{1}{2}$  in. by  $1\frac{1}{4}$  in. or  $1\frac{1}{2}$  in. by  $\frac{3}{4}$  in. angles and filled with damp-proof mastic. There was an obvious construction joint between the two courses of mastic and this was filled with dust and dirt. Little adhesion occurred between the damp-proof mastic and the angle-iron: the latter showed signs of rusting.

to the angle-iron was poor and water had entered, causing some corrosion of the angle. The steel deck plate was undamaged.

*Corner D.* The construction was as for *A*. The joint appeared perfect but droplets of water were found in three small pockets (1 to 2 sq.in.) under the mastic. They caused some discoloration but the zinc film was intact and the deck plate undamaged. There was no evidence to indicate how the water had reached the small pockets.

No rusting of the deck plate occurred at any of these points.

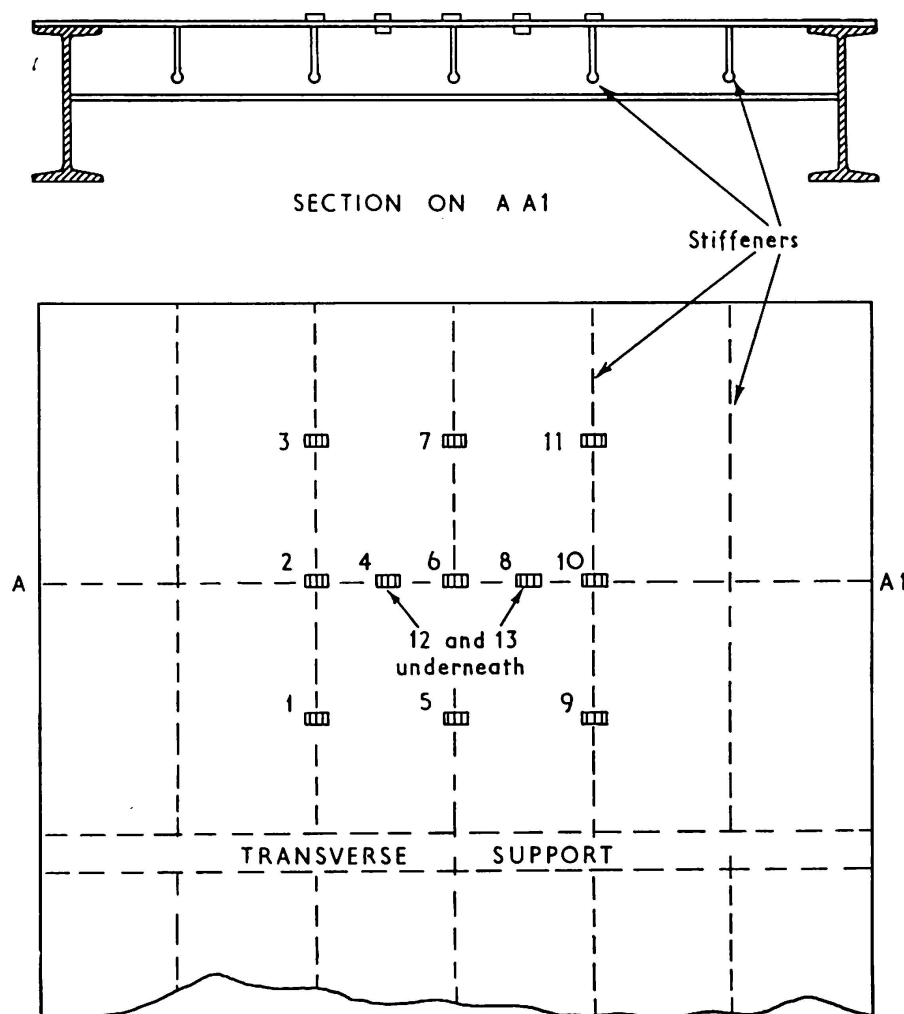
Fig. 11. Portion of Deck Plate Showing the Positions of Strain Gauges.

Gauges 1 to 11 were used on the upper surface of the steel and gauges 12 and 13 were attached to its under side. The strain gauges were of the foil type and were cemented to the steel by an epoxide resin. A thermocouple was also attached to each steel plate to measure the temperature of the asphalt surfacing.

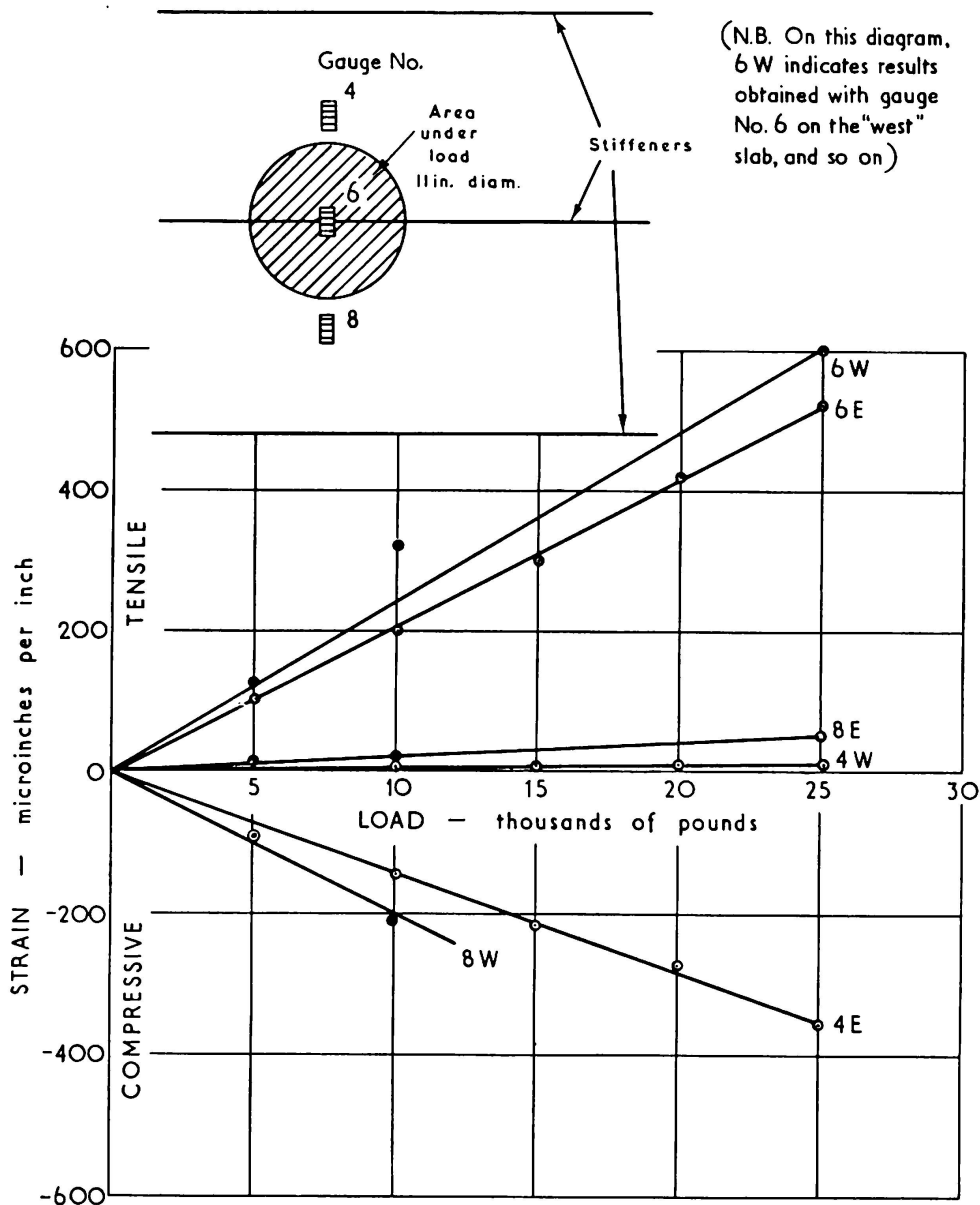
Fig. 12. Results of Static Tests on the Bare Steel Plate With Centre of Load Over Gauge No. 6.

were made are shown in figs. 12 and 13, one test being made directly over the central stiffener and the other midway between two stiffeners. Figs. 12 and 13 show the measured strains plotted against applied load. Linear relationships occurred between strain and load in all cases, hence these diagrams could be used to determine the strain in the steel at a load equal to that applied by each wheel when tests were made later with a moving vehicle. The largest tensile strains in the transverse direction occurred at gauge No. 6 on both panels, this gauge being that placed across the stiffener. As figs. 12 and 13 show, the rigidity of the panels (marked "East" and "West") was approximately equal, particularly having regard to the variations that might occur in producing the complicated welded structures.
