Zeitschrift: **IABSE publications = Mémoires AIPC = IVBH Abhandlungen**

Band (Jahr): **25 (1965)**

# **Ship Collisions Against Bridge Piers**

CHR. OSTENFELD

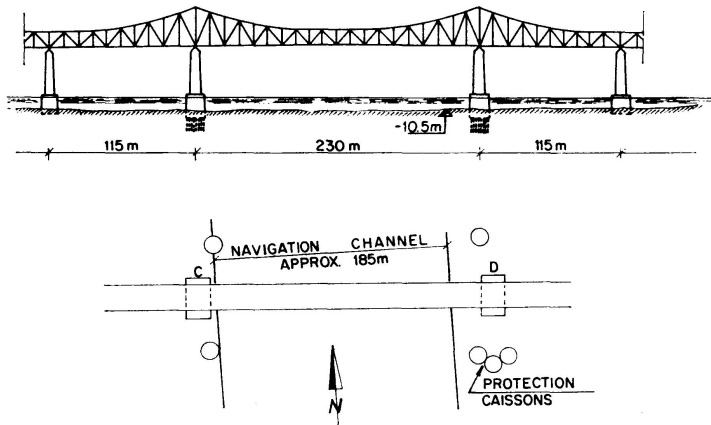
Ship colliding with pier whereby superficial damage to the pier resulted.

The pier was only slightly damaged. Small lumps of concrete were broken off.

Fig. 4. Outerbridge Crossing, New York. The plan shows the location of the protection caissons in relation to navigation channel and piers.

### 6. Protective Measures Planned (Refer Figs. 4 and 5)

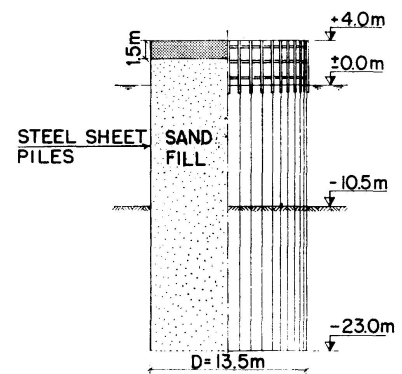
Fig. 5. Outerbridge Crossing, New York. Protection caisson.

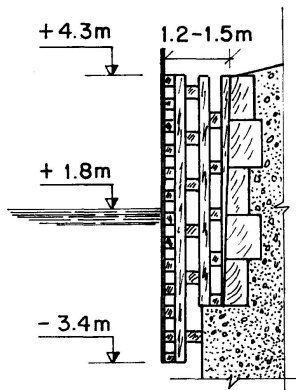
Fig. 8. Chester-Bridgeport Bridge, Philadelphia. Elevation of pier and detail of fender.

The fender, as now planned (refer fig. 8), consists of five layers of timber reaching about 2.5 m above and about 5 m below water level. The fender covers the entire circumference of the pier. The total depth of the five layers of the timber structure is 1.2—1.5 m, so that the fender structure will be in a position to absorb a rather considerable kinetic energy.

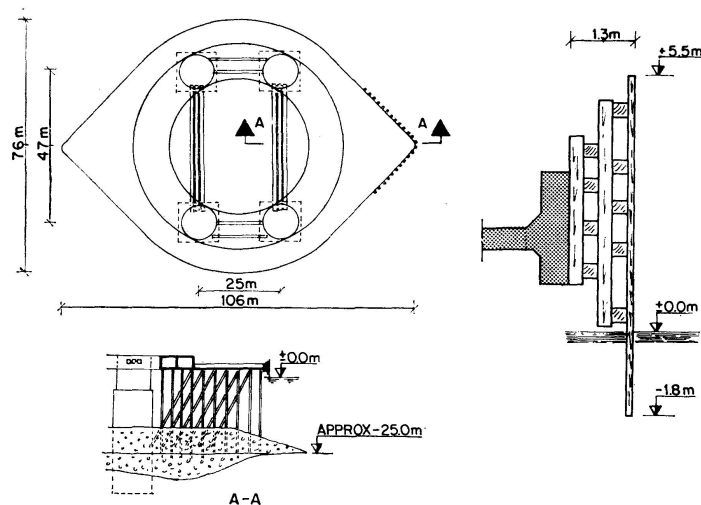
Fig. 12. Carquinez Strait Bridge, California. Pier protection, plan and section, and detail of fender.

This permanent protection, refer fig. 12, consists of a heavily reinforced horizontal concrete slab, supported on vertical piles and rakers, brought down

into a thick layer of rock debris. The concrete slab is interconnected with the four reinforced concrete caissons, so that the construction in its entirety functions as one unit with a view to absorption of impact. The outer edge of the concrete slab is relatively thin, it is assumed that this part of the slab will be crushed and, partly, be forced into the ship; in this way adequate provision is found to have been made for absorption of the greater part of the kinetic energy. Moreover, the concrete slab is provided with a fender, consisting of vertical and horizontal timber with a total depth of about 1.3 m. When the new bridge was built, in 1958, the steel tower of the central pier was founded

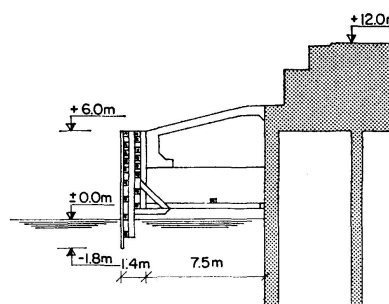
Fig. 14. San Francisco-Oakland Bay Bridge, California.  
Detail of pier protection.

The protecting structure (refer fig. 14) is a ribbed concrete slab cantilevered 7.5 m from the ends of the pier and 3.6 m from the sides. To the concrete slab is attached, moreover, a timber fender structure, consisting of several layers of vertical and horizontal timber with a total depth of about 1.4 m, reaching from about 6 m above to about 2 m below water level. Hence, the total distance the ship has to pass before reaching the pier proper will be about 9 and 5 m respectively, whereby a considerable amount of kinetic energy can be absorbed.

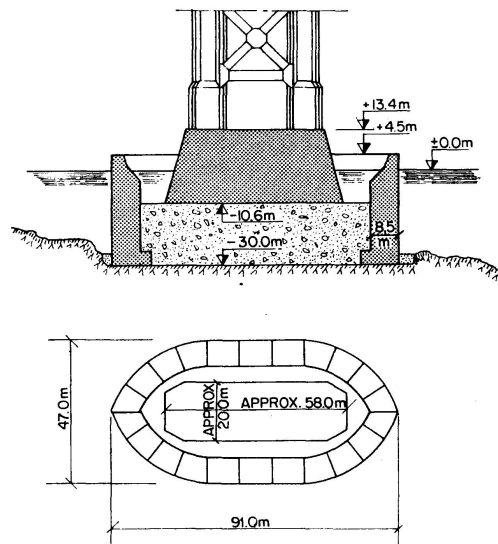
Fig. 18. Golden Gate Bridge, California. Plan of South Tower with concrete wall which was acting as cofferdam during the construction period and which is now acting as permanent protection.

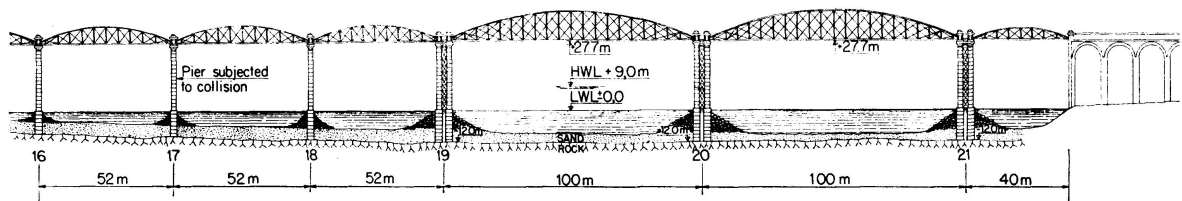
Fig. 19. Severn Railway Bridge, England.

The bridge is a little more than 1 km long, having a series of spans of about 40—50 m, and two large navigation spans — far away from the place of collision.

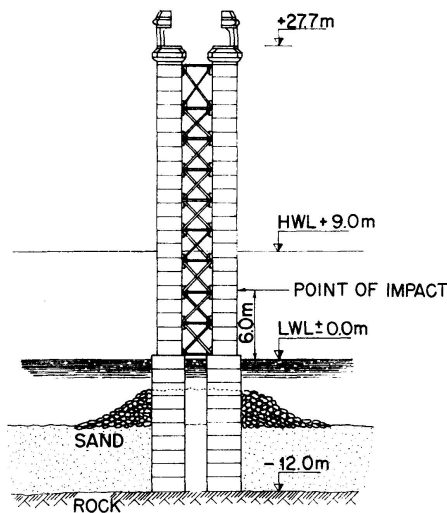
Fig. 20. Severn Railway Bridge, England. Pier 17.

The bridge was built in 1875—1879. The superstructure is of old-fashioned design: Parabolic steel trusses. Clear height under the bridge about 20 m, above high water level (tidal changes amount to about 10 m). Most of the piers, including the pier involved in the collision, consist of two cast iron cylinders, of diameter 2.1 m, filled with “Roman Cement” (see fig. 20). These cylinders stand on two similar cylinders of 2.7 m diameter, carried down to
