| Zeitschrift: | IABSE structures = Constructions AIPC = IVBH Bauwerke |
|---|--|
| Heft: | C-46: Repair and rehabilitation of bridges: case studies I |
| Artikel: | The bridge in the Radnika Street in Belgrade (Yugoslavia) |

9. The Bridge in the Radnička Street in Belgrade (Yugoslavia)

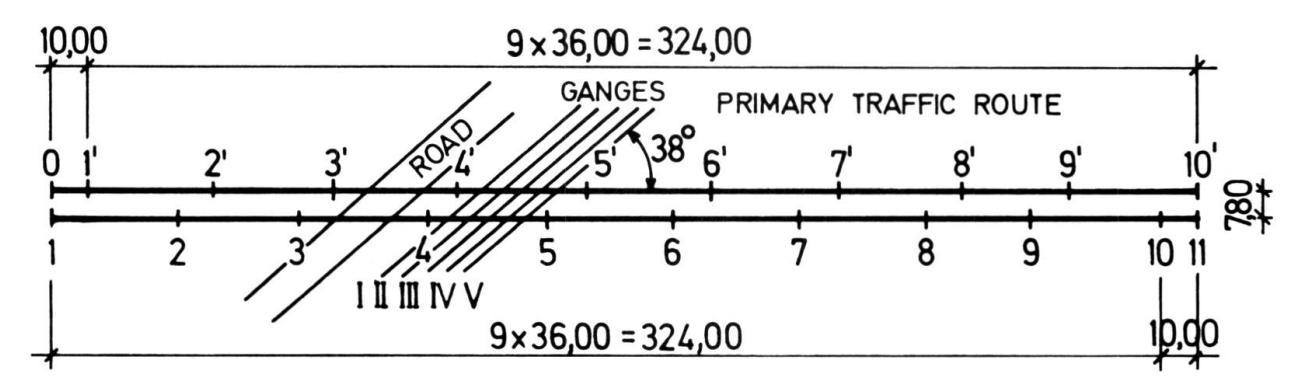
Fig. 1 Location plan of the bridge

The bridge is skewed, in vertical curvature with the biggest slope of 6%, the length being $9 \times 36 + 10 = 334$ m and the useful width 6 m, (Fig. 1). The main box girder, lateral compound I beams, horizontal bracing and box columns are made of steel. The connection between the main and lateral steel girders is presented in Fig. 2.
