The Clifton Suspension Bridge – Preservation for Utilisation

M. Stuart CULLIMORE

Deputy Chairman
Clifton Suspension Bridge Trust
Bristol, UK

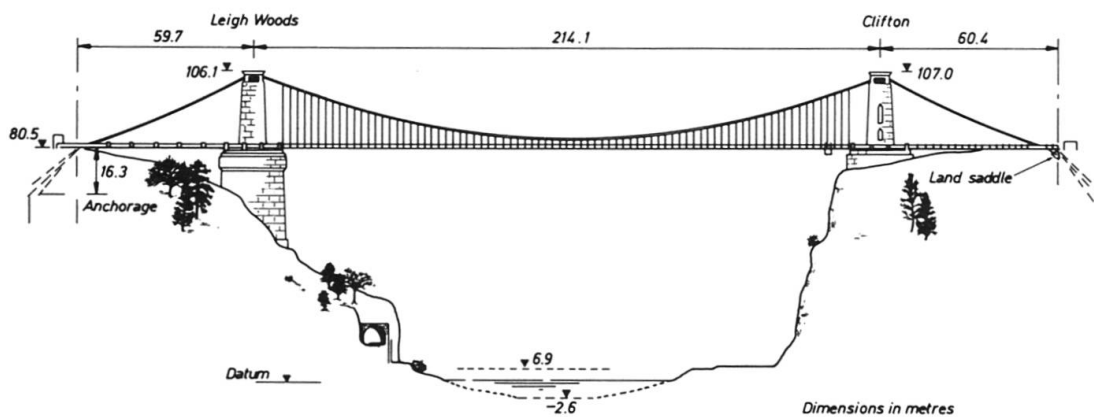
Fig. 1 South elevation of bridge

The promontory from which the bridge springs on the Clifton side is a stable formation of massive blocks of rock. The Leigh Woods masonry abutment is approximately 23m square, rising some 40m from the side of the cliff (Fig. 1). There has been no evidence of any movement at either abutment although there had recently been 'slips' in other parts of the Avon Gorge. Large solution cavities are known to exist in the limestone in this region together with clay layers within the limestone sequence. In view of this and the presence of water seepage in the vicinity, a site investigation of the Leigh Woods abutment was ordered in 1969.

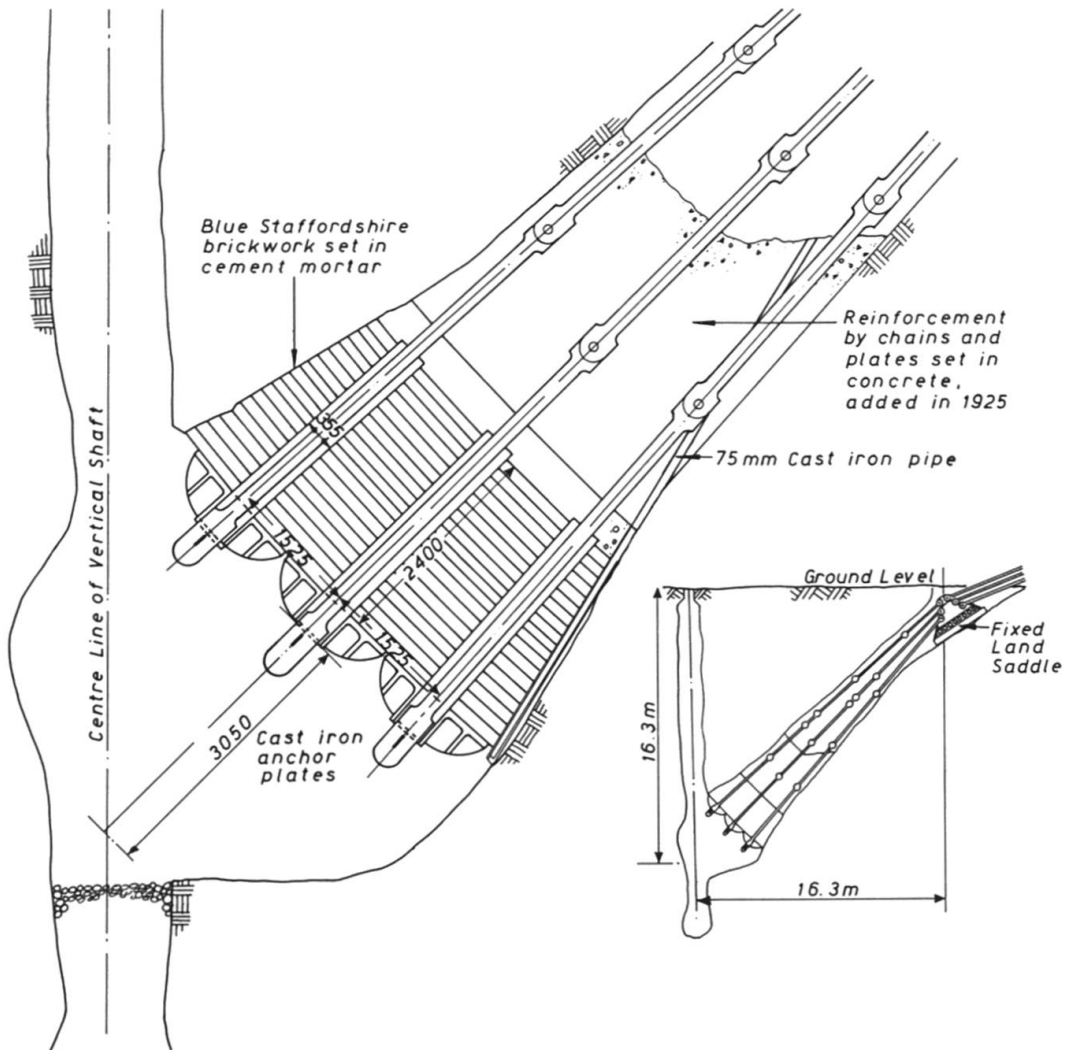
Fig 4 Anchorage

The mass masonry abutments are faced with red sandstone ashlar. The towers, faced in local Pennant stone, have a freestone capping with a cast iron parapet. They carry the saddles and roller beds which also came from the Hungerford bridge and were increased in height to accommodate the third chain. The land chains are attached to the tower saddles and span freely to fixed land saddles just below ground level. From there they dip down at about 45° for 18m separating to pass through separate cast iron anchor plates which are supported by brick arches abutting on the solid rock (Fig. 4).
