Flash Floods on Bridge Piers

Alfonso KRUMDIECK

Civil Engineer
Electrowatt Eng. Services Ltd.
Zurich, Switzerland

3. THE FLASH FLOOD OF FEBRUARY 13, 1982

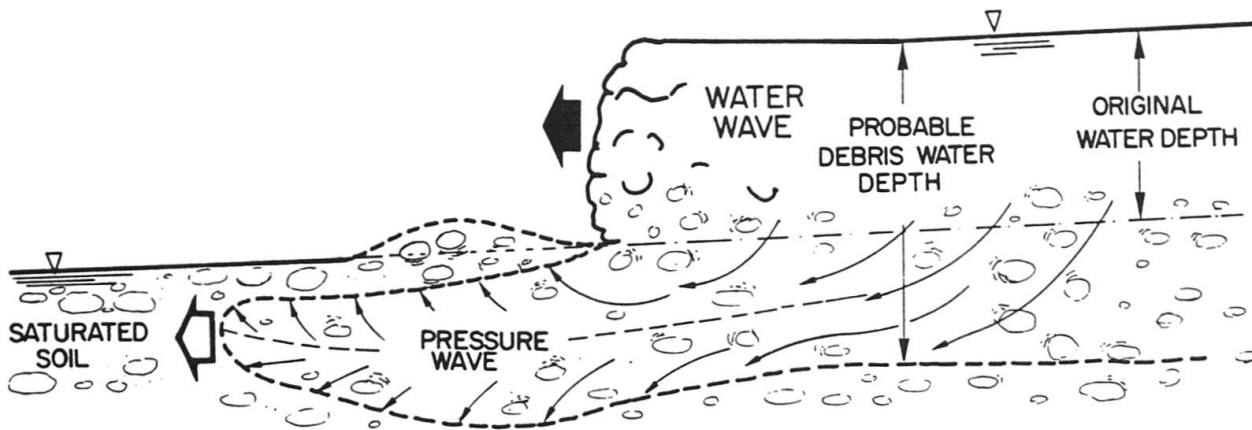
FIG. 3 SCHEMATIC VIEW OF A FLASH FLOOD WAVE.

Wave-induced pore pressures and soil liquefaction in front of a water wave produced in saturated soils have been reported in recent years by several authors (e.g. Sleath [7]; Madsen [8]; Nataradja and Singh [9]; Zeevaert [10], etc.) Similarly in this case, it is postulated that the incoming water wave in the wadi bed generated a pressure wave in the saturated soil. This pressure wave has the ability or property to travel through the saturated granular soil at a velocity which is greater than the velocity of the water wave on the surface of the river bed (see Richart et al., [11]). Therefore, the pressure wave will have to travel in a pulsating or intermittent form in front of the water wave (see Fig. 3).

The pressure wave will increase the magnitude of its pressure when the water wave increases in size. If the size of the water wave continues to grow, there is a moment in which the pressure wave will reach a value equal to or greater than the effective confining pressure and the shear strength of the soil will become zero, i.e. it fluidizes. Fluidization, as opposed to liquefaction, is a mechanism by which a cohesionless material achieves a viscous liquid-like condition by forcing a fluid from an external source upward through the sediment, until the immersed weight of the grains is balanced by the total fluid drag, (Othmer [12]; Leva [13]; Kunii and Levenspiel [14]).

It is postulated that this temporary fluidization of the soil in front of the water wave caused those piers to collapse or to sink before erosion had time to act. This temporary fluidization of the soil is also the reason which allows the incoming water wave to enrich and to reinforce itself with not only the water retention pirated from the saturated soil, but also with the fluidized soil debris as well. This explains why the measured discharge runoff can be, in certain cases, far greater than the calculated discharges from the rainfall records alone.
