# Session III: Construction, performance, renewal

Zeitschrift: **IABSE reports of the working commissions = Rapports des commissions de travail AIPC = IVBH Berichte der Arbeitskommissionen**

Band (Jahr): **032 (1979)**

**Construction, Performance, Renewal**

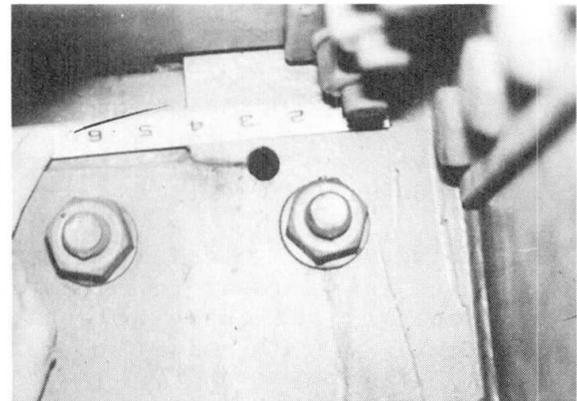
Fig. 7 Zero Radius

Another detail that has given trouble is the connection of brace frame angles to stiffeners (Figure 6) with the gussets groove welded to the stiffener. Referring to Figure 7, the critical detail has a zero radius. The stress causing crack growth is the lateral force from trains. Since maximum lateral impacts often occur due to hunting (side to side snaking) of empty cars, it took less than five years for these cracks to develop.

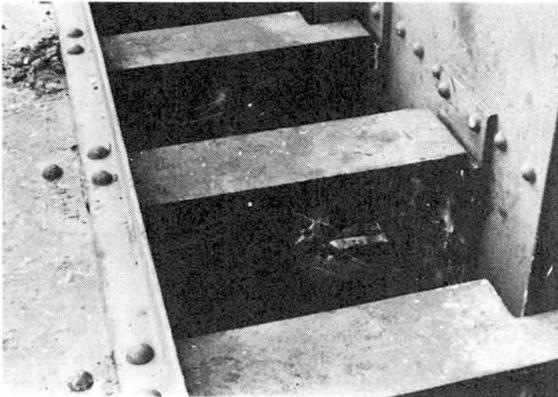
Fig. 17 Torsional loading

This (Figure 17) structure cracked due to torsional loading caused by constant train breaking. Although the floor beams are not welded there is no component redundancy as the beams are rolled. Nevertheless, the redundancy of the deck system has permitted regular train operations for over a year with 4 adjacent floor beams failed.

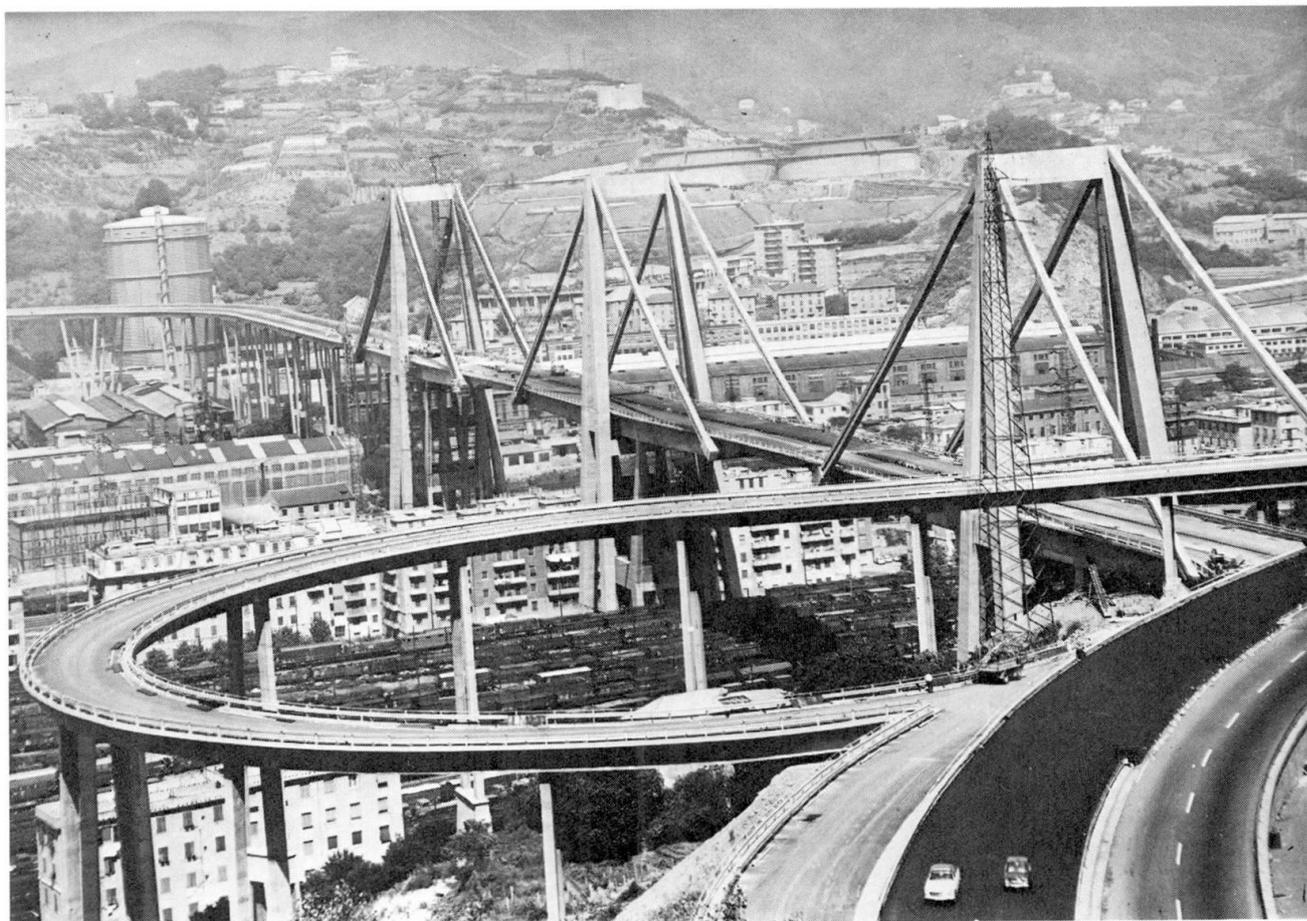
Figure 3 - General view of the structure.

Essentially, it has been ascertained that the structure stands the very heavy traffic to which it is continuously submitted without signs of deterioration or static inadequacy.

The balanced systems are behaving in a regular way and obviously, as far as they are concerned, we must not worry about cracks because we deal with structures the parts of which are practically all in compression under the effect of external loads or prestressing.

Some slight cracks of a very small size (much below 0.2 mm) have been noticed in the secondary connecting cross elements - which obviously had not been prestressed - and which were surely due to the vibration caused by the traffic.

On the other hand, no cracks are noticed on the horizontal elements of the secondary unprestressed "V" piers.

This, evidently, is due to a sufficient distribution of the reinforcement within the concrete and to a non-exceptional shrinkage of the concrete.

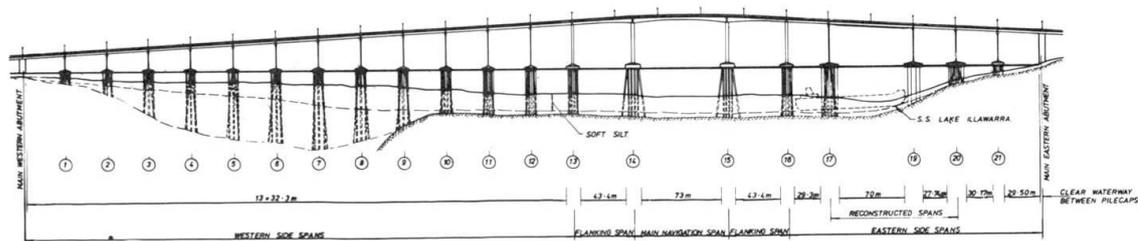
Fig. 2 Elevation of restored bridge

At the bridge site the river is wide and deep, water depths generally being in excess of 30 m. The bridge itself consists of three separate structures (Fig. 2), the navigation spans in mid river, 13 x 42.7 m spans in the western main viaduct and 6 x 42.7 m spans in the eastern main viaduct. The original design recognised the possibility of a ship collision although the

The method adopted is shown in Fig. 4 and has been reported on previously by LESLIE [7] and [8]. As the broken 1.4 m diameter piles at Pier 18 (40 m to bed level being the deepest part of the river), rose 15 m above the mud level this pier was omitted and the method involved the replacement of the three fallen spans by two spans; an 85 m steel span 17-19 and 43 m concrete span 19-20. Cross-sections are shown in Figs. 6 and 7. The scheme involved 14 new 2 m diameter vertical piles rock anchored at the base, some of which were to be used both as falsework piles and permanent piles. Foundation conditions were predetermined using one borehole per pile and were good, consisting of almost fresh dolerite at Piers 19 and 20 and partly weathered basalt at Pier 17. At Piers 17 and 20 the existing columns and pile caps had to be demolished and replaced. At Pier 17 additional piles, working in conjunction with the eight existing 1.4 m diameter raking piles, a bigger cap, and heavier columns were required to resist the greater loads from the double span. At Pier 20 there are no additional loads, but it was considered necessary to replace the badly damaged pile cap and columns, and the falsework piles required to achieve this were incorporated into the permanent structure, although not strictly required from a strength viewpoint. As there was a considerable time saving involved, the replacement of the substructure at these two piers was to be undertaken without demolishing the flanking spans (total mass 1,250 tonnes each) supported by them.

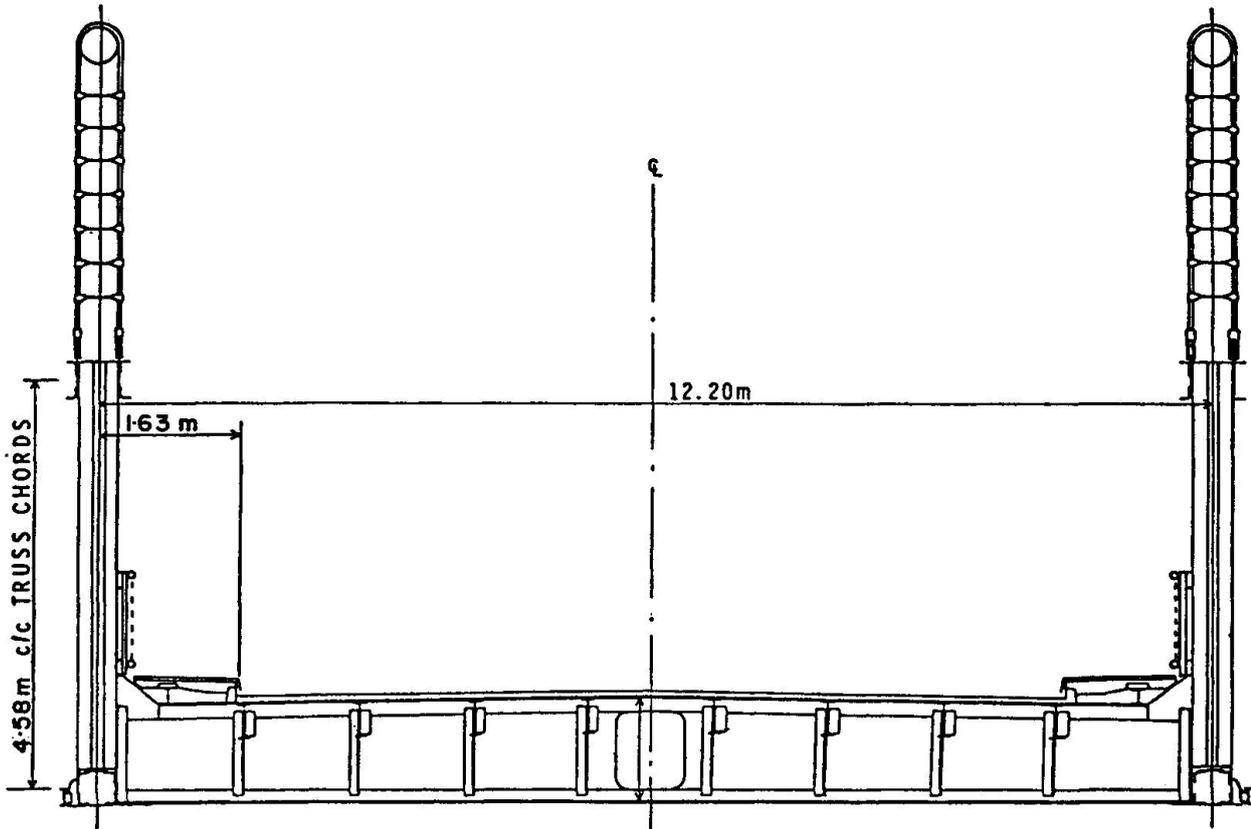
Fig. 3 Cross Section of Suspension Bridge.

The stiffening truss, being of a U shape in cross section (see Figure 3), has a low torsional rigidity. The towers are made of rivetted boxes and the girders and bents of the North Viaduct are rivetted steel plate girders. The South Main Tower is founded on rock, but all other foundations are spread footings on gravel.

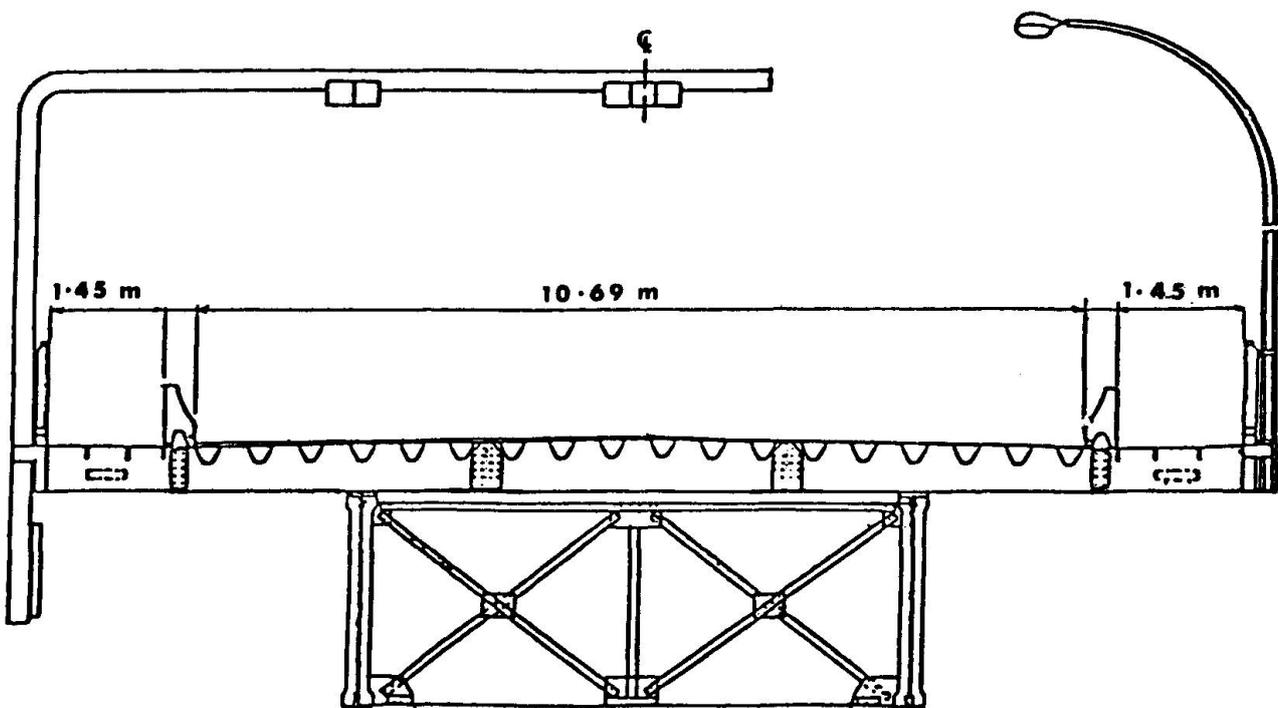
Fig. 4 Cross Section of Renovated North Viaduct

Consideration of the constraints on a structural solution for the North Viaduct led to two conclusions. Firstly, the new deck must have a much lower dead weight than the original in order to afford margins for wearing surface, increased width, traffic barriers etc. and secondly, the new deck and girder system must have increased live load bending capacity to handle a higher live load with a girder capacity reduced by corrosion.

A suitable solution was found in the form of an orthotropic steel deck connected by diaphragms to the existing longitudinal girders in order to ensure composite behaviour under live load. This effectively reduced dead load well below previous values and also reduced girder live load bending stresses.
