The long-term behaviour of viaducts subjected to heavy traffic and situated in an aggressive environment: the viaduct on the Polcevera in Genoa

R. MORANDI

THE VIADUCT ON THE POLCEVERA, FOR THE GENOA-SAVONA SPEEDWAY.

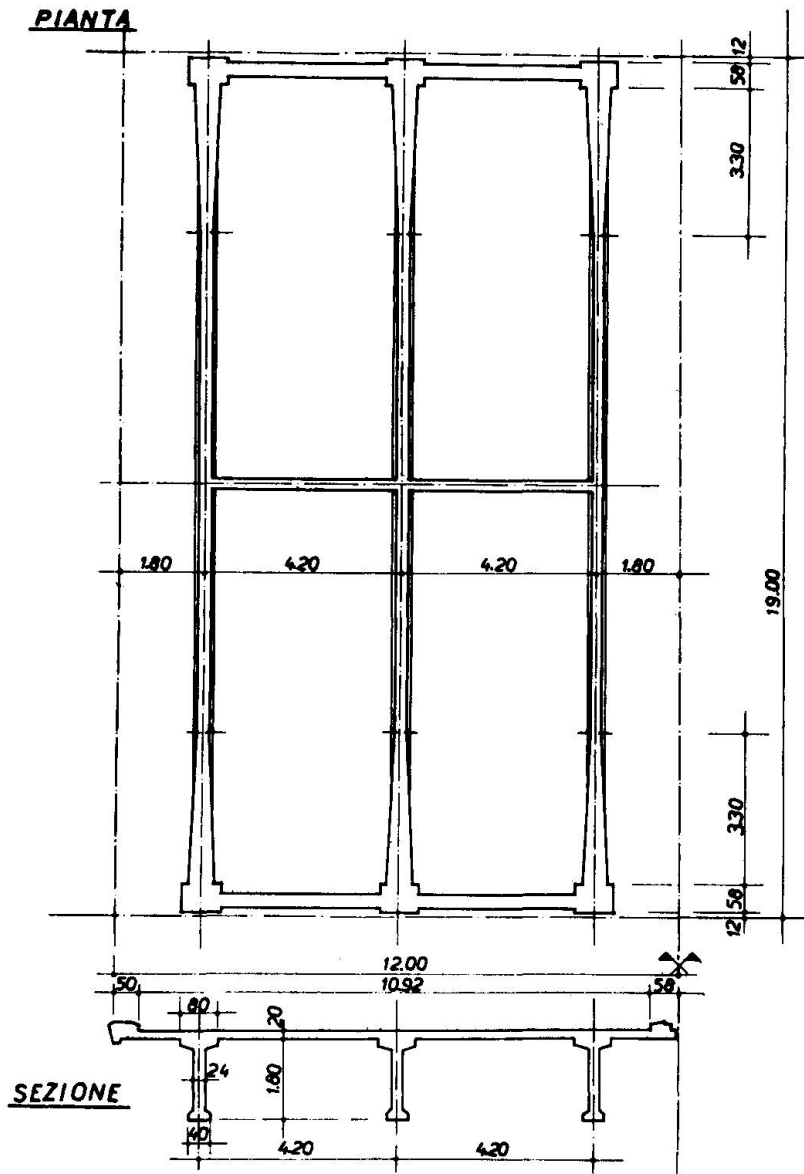
Fig. 1 - Geometry of the standard bay.

During my visit I found some superficial distress in the paving joints, some excessive crushing of the bearings (although nothing really serious) but, most important of all, that all the parallel beams of the deck showed a diffused pattern of cracks of very similar length, frequency and width on all the bays.
