# Application of photon tomography to weld inspection

Autor(en): **Frank, Karl H. / Kohutek, Terry L.**

Zeitschrift: **IABSE reports = Rapports AIPC = IVBH Berichte**

Band (Jahr): **37 (1982)**

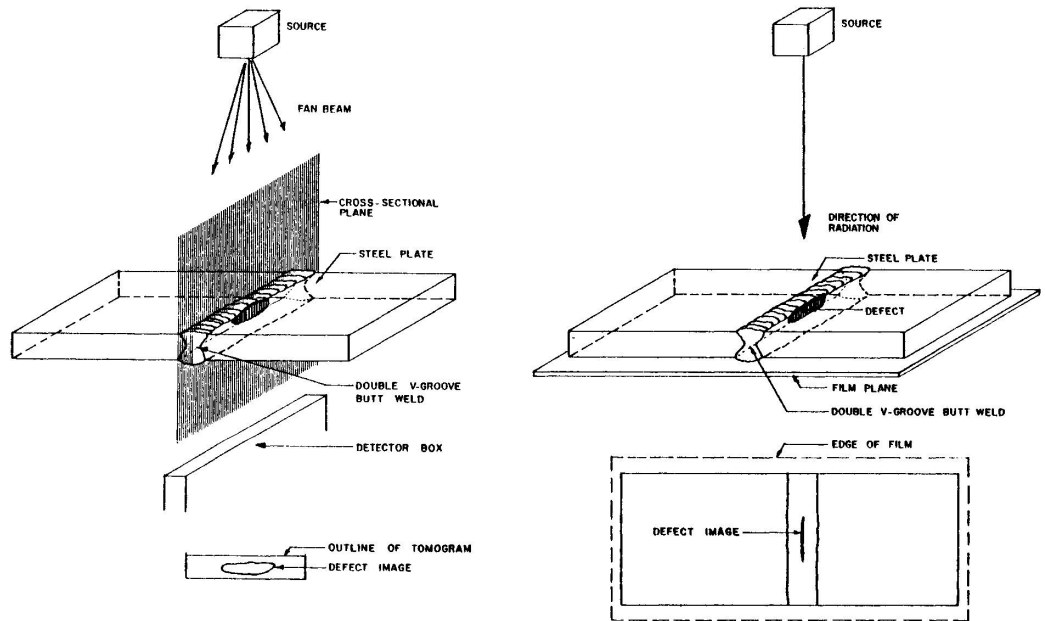
Fig. 1 Defect Imaging with CT and RT

A comparison of the information obtained from computerized tomography (CT) and RT inspection of a butt weld is shown in Fig. 1. The defect geometry in the slice plane is obtained in the tomogram while the radiograph yields only the length of the defect. The image of the defect in the tomogram allows the significance of the defect to be rationally assessed.
