# Design and retrofit for fatigue damage in web gap

Zeitschrift: **IABSE reports = Rapports AIPC = IVBH Berichte**

Band (Jahr): **37 (1982)**

## **Design and Retrofit for Fatigue Damage in Web Gap**

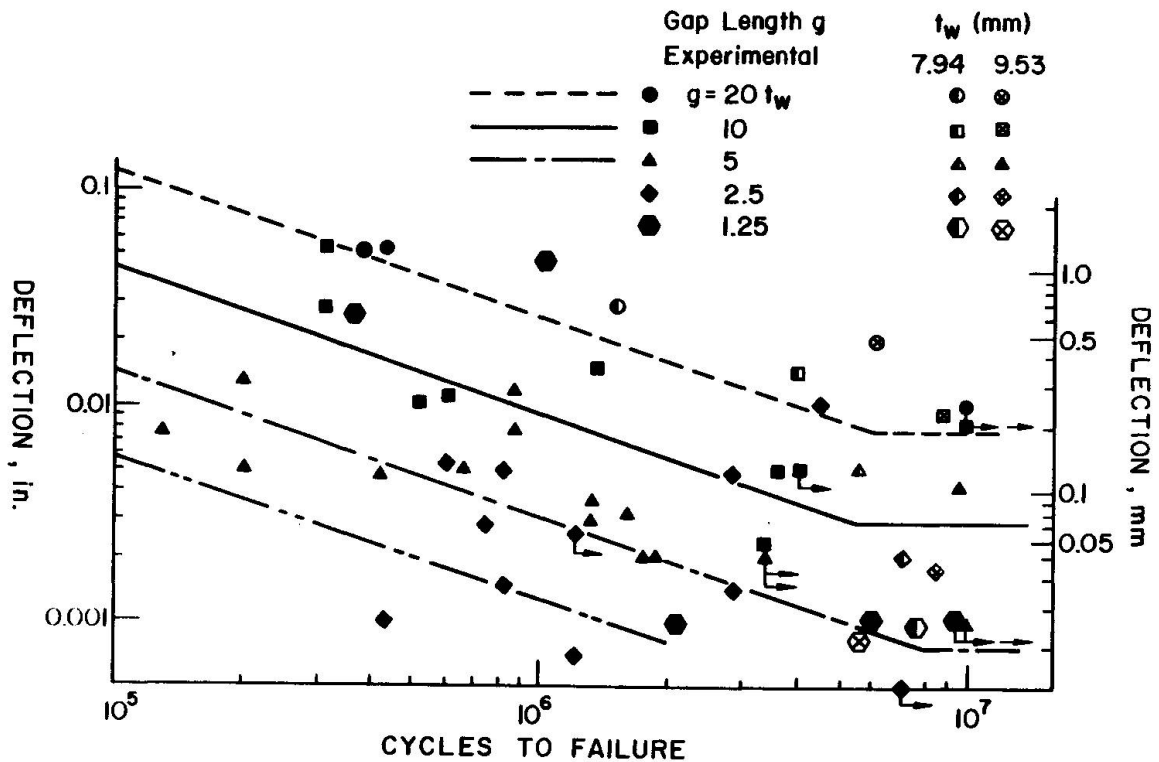
with an initial crack size of 0.762 mm. A final through thickness crack size of 28.6 mm was also selected, but this value had very little effect on the fatigue life estimates. This final crack size was selected, because it represented the length of a typical crack for the experimental data (Fig. 4) [7]. The deflections used in plotting the theoretical values were the relative displacement between the end of the cut short stiffener and the tension flange. This comparison between experimental and theoretical data is shown in Fig. 4. Figure 4 shows that

Fig. 4 Experimental and Theoretical Results of Out-of-Plane Displacement

Parametric studies were conducted to determine the variation of the maximum web gap stress with varying gap length, web thickness and type of connection of cross-bracing to the transverse connection plate. The results of several studies can be seen in Fig. 4. They correspond to 7.94 mm web with moment connection and a 9.53 mm web with moment connection. The parametric studies permit the following observations and recommendations. The out-of-plane web stresses can be minimized by providing a gap of six to ten times the thickness of the web. They can be effectively eliminated if the transverse connection plate is welded to the tension flange. Welding the transverse connection plate to the tension flange should satisfy the fatigue restrictions of [2], Category "C", with only minor adjustments to the original girder design, because the end of the cut short stiffener is very close to the tension flange and is also classified as a Category "C" detail. If a gap of six to ten times the web thickness is selected, then web buckling under tension field action should be checked.
