Case Stories of Dolphin Accidents and Remedies

Yoshiaki NAOI
Supervising Engineer
Chuo Fukken Consultants
Osaka, Japan

Toshiyuki ISHIKAWA
Chief Engineer
Chuo Fukken Consultants
Osaka, Japan

The report outlines recent ship collision accidents with dolphins in Iwakuni, Japan and their remedies.

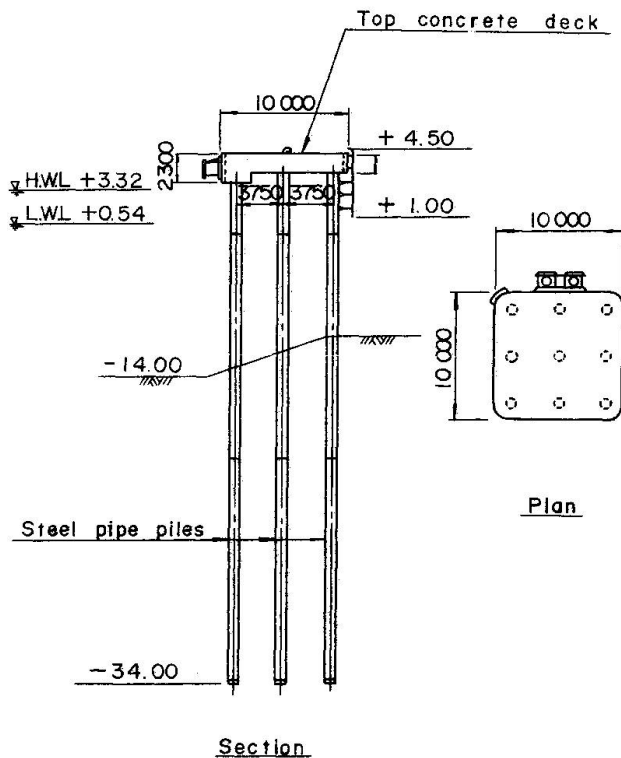
Fig.2 Structure of Dolphin B-3

As shown in Fig.2 the Dolphin B-3 consists of 9 steel pipe piles (914.4 mm in diameter, 16.0 mm in thickness, and 41.5 m in length) and the top concrete deck. The structure has the flexibility to absorb the kinetic energy of ship berthing for an approaching velocity of 15 cm/sec. That is, the resisting capacity against impact is maintained by the mutual effect between the rigidity of the steel pipe piles and the viscoelasticity of the foundation strata.

Upon inspecting the piles in the water, the buckling on the piles were found near the welded joints of No.3,6,8 & 9 piles 2 m deep in the water and the shells thereon had been torn off.

Further, the maximum deformation was found on the middle piles (12.7 mm in thickness) while the upper piles above D.L. -0.50 m were still vertical with little deformation. The reason for this is that the materials of the upper piles were thicker (16.0 mm in thickness) and they were stuffed with filling concrete.

After the diving inspection, voids of 40 cm in width and 100 cm in depth were observed in the sea bed on the offshore side of the piles. It indicated that plastic deformation in the ground occurred by the energy exerted by the collision.

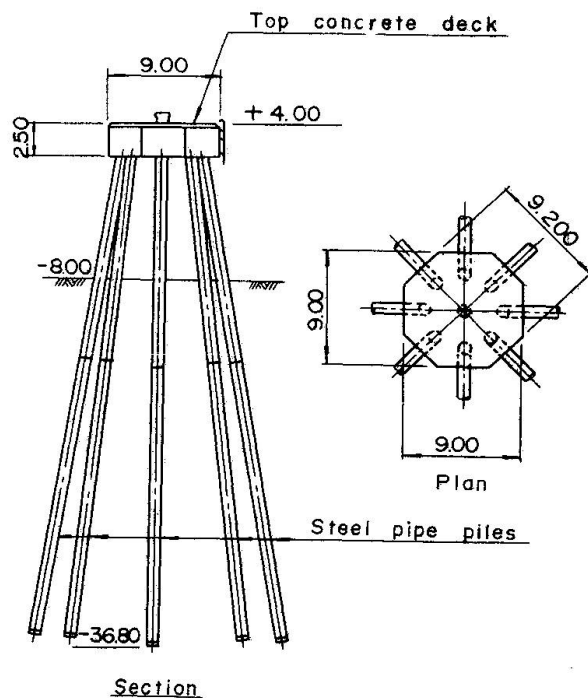
Fig.3 Structure of Dolphin M-1

In the structure of the Dolphin M-1, 9 steel pipe piles (609.6 mm in diameter, 12.7 mm in thickness, and 40.5 m in length) composed of 8 radial battered piles and 1 vertical pile are rigidly connected with the top concrete deck. This mooring dolphin has a rigid structure in contrast with the breasting dolphin, that is, the static load worked through mooring ropes is borne by the structure so that a ship can keep a certain distance with the berth.

An opening made by the collision was found at the junction of the top concrete deck with the steel pipe piles. This opening was 20 cm at its maximum in a direction of north-west. At the same time a wedge from the shearing force (1.6 m in width, 0.2 m in height, and 0.4 m in depth) appeared in the concrete deck.

Upon measuring the deformation of the central vertical pile in three directions, the maximum displacement of 25 cm was observed in the direction of south-east. (See Fig.6)
