Vulnerability of Norwegian Bridges across Channels

Per TAMBS-LYCHE
Director Bridge Division
Public Roads Administration
Oslo, Norway

SUMMARY

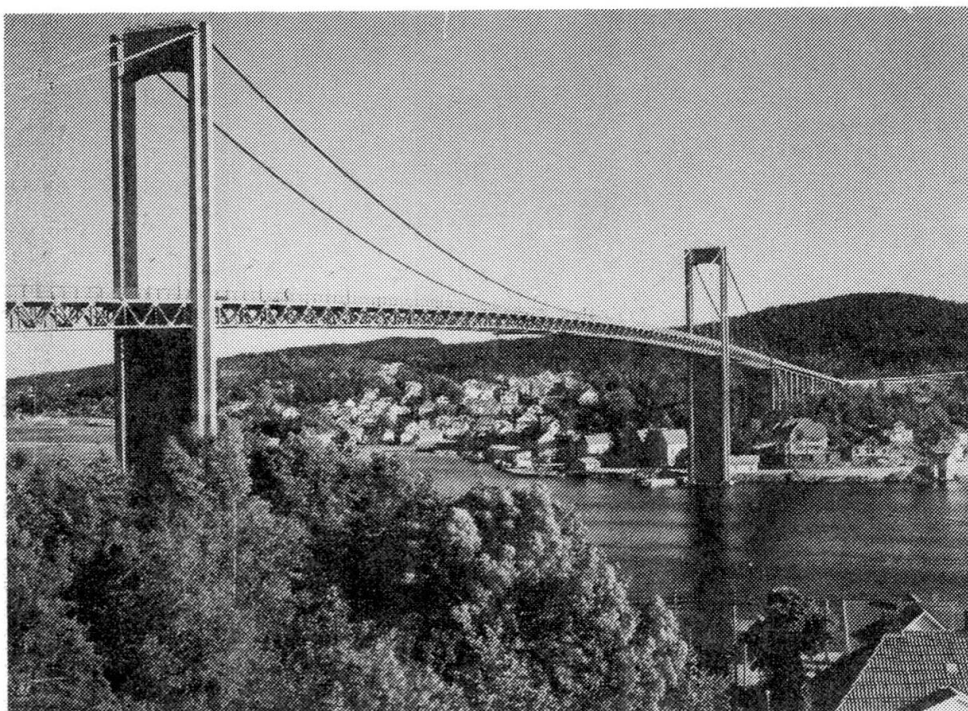
Fig. 6 Brevik Bridge

The 677m long structure consists of suspended main- and sidespans of 272m and 85m respectively in addition to 16 viaducts. Fig. 6.

It was opened to traffic in 1962 and spans the inlet to the Frierfjord where the harbour of Porsgrunn and the largest chemical industrial centre of the country are situated.
