Theme A: Case stories of recent ship collision accidents

Case Stories of Recent Ship Collision Accidents

Ship Collisions with Danish Lighthouses

Newport Brückenzusammenstoß

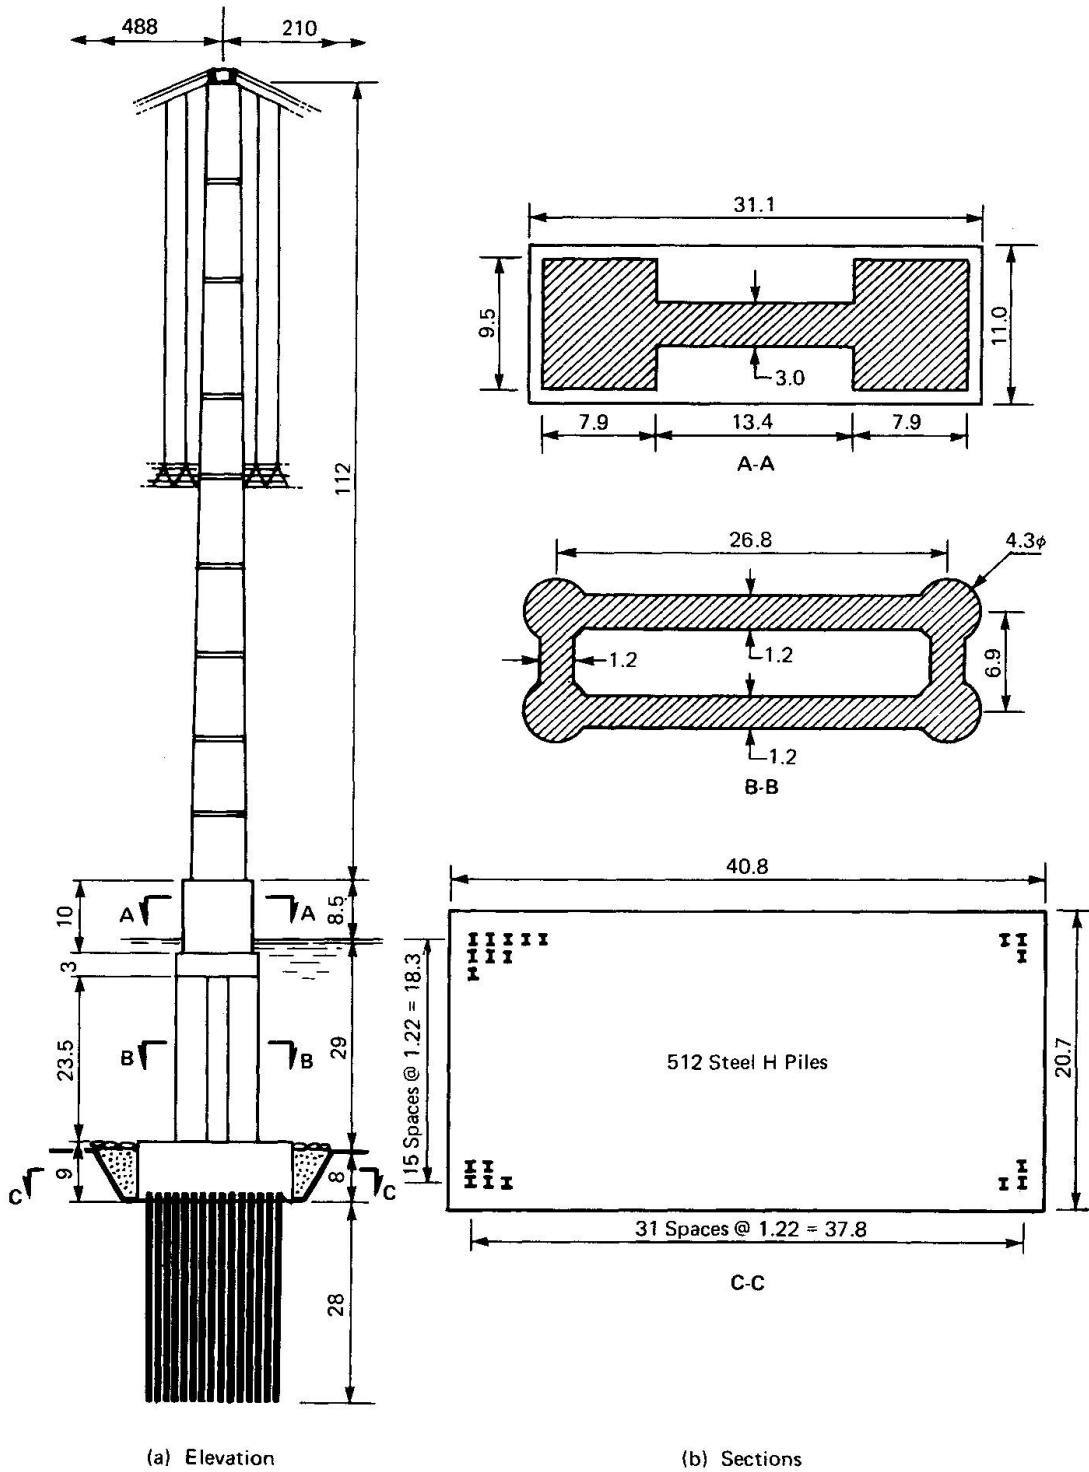
Fig. 5. Details and dimensions of pier.

Damage to the bridge was negligible. The pier suffered no displacement or rotation, and there was no misalignment of the roadway deck joints or any other superstructure elements. The side of the pier suffered extensive surface scrapes, gouges, and spalls of the concrete (Fig. 3) to a depth of 2 to 5 cm over an area roughly 7 m wide by 20 m high, approximately equally above and below the water line (Fig. 4).

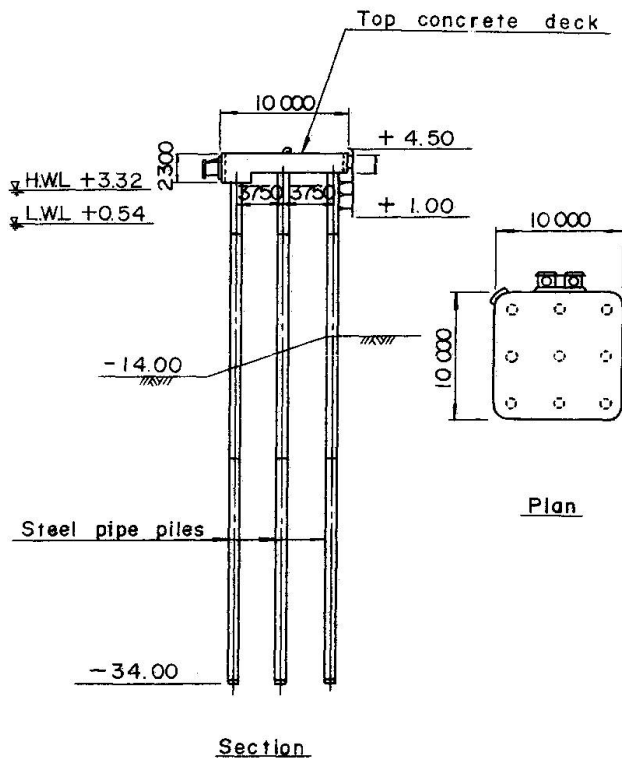
Fig.2 Structure of Dolphin B-3

The results of our inspection carried out immediately after the accidents are briefly as follows: (See Fig.5)
