Zeitschrift: IABSE reports = Rapports AIPC = IVBH Berichte
Band: 42 (1983)

Case Stories of Recent Ship Collision Accidents

Ship Collisions with Danish Lighthouses

Newport Brückenzusammenstoß

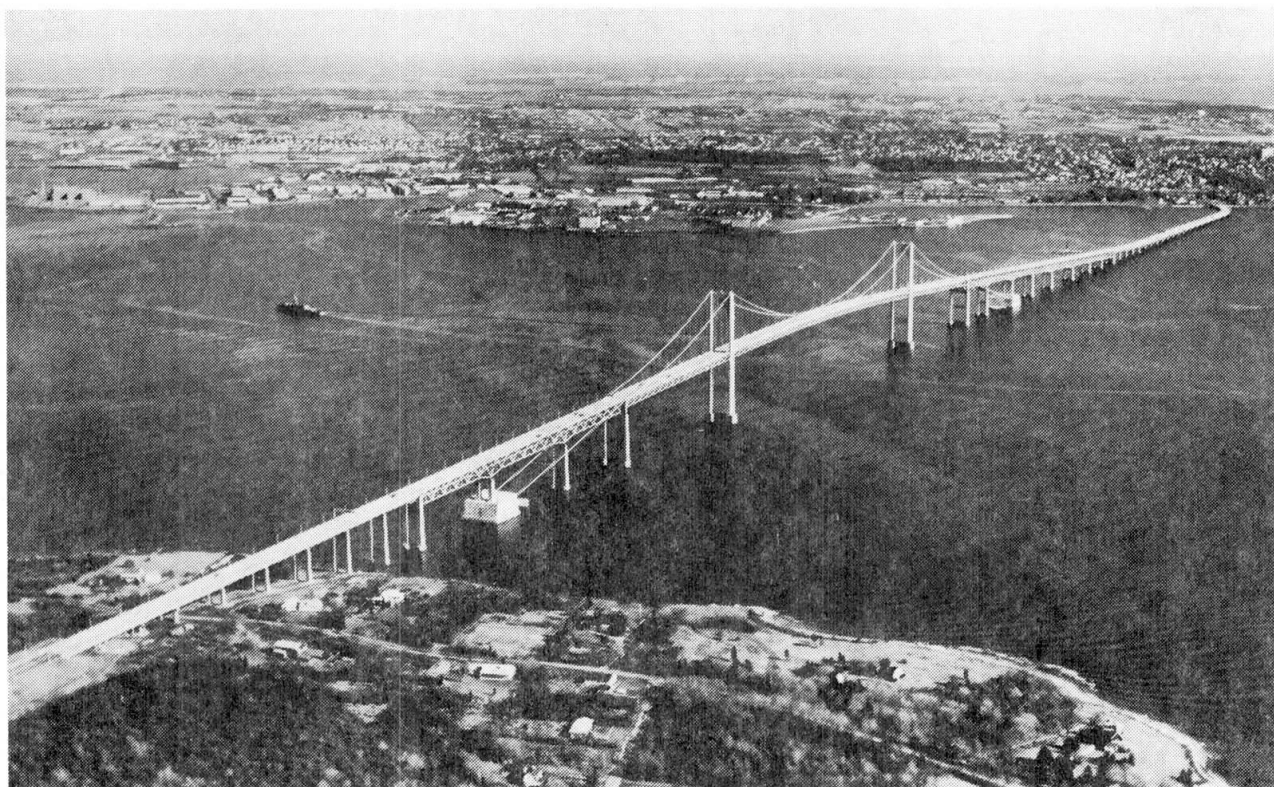
Fig. 1. Newport Bridge, Newport, Rhode Island, USA.

The Newport Bridge is approximately 3 km long, crossing the Eastern Passage of Narragansett Bay at Newport, Rhode Island (Fig. 1). The main shipping channel is bridged by a suspension span 488 m long, with a clear height of 66 m at the center of the channel. The water depth beneath the suspension spans ranges from 30 to 45 m. The tower piers are of "Potomac type" caisson construction, founded on steel H-piles driven into sands that fill the glacial gorge underlying the bay.

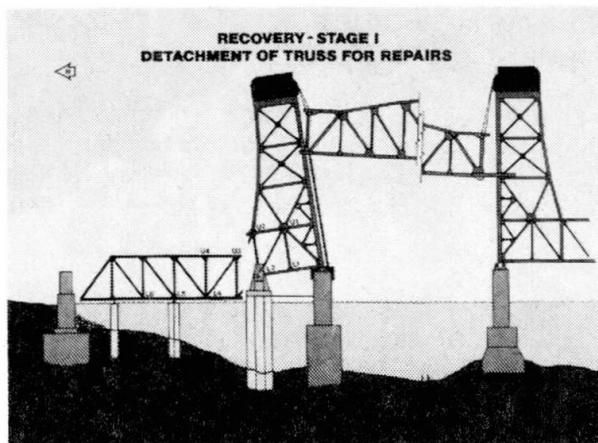
Figure 8

The jacking bent was capped by 4 - 1800 mm deep plate girders which supported the jacking frames during the jacking stage and later supported the skidding frames as the tower was re-aligned. The jacking frames each contained two welded channel members braced in position. A box beam which spanned between these members supported the truss which was raised through the box beam by two 318t jacks in each jacking frame.

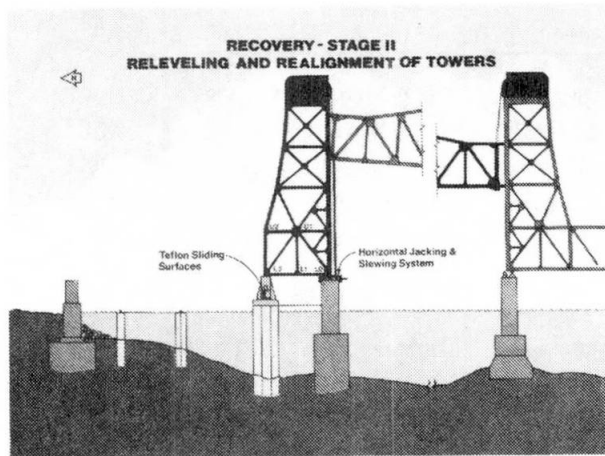
Figure 9

Prior to separating the tower from the horizontal truss, the tie-downs were installed to the box beam and the 318t jacks at L2 were loaded to provide a positive reaction of 45t per side. This ensured no sudden movement of the tower when the chords were cut. The pivot bearings on bent L5 were brought into contact by flat jacks and shimmed in place and thus prevented sudden movement during chord cutting.

span by two 363t jacks in each leg of the bent. Support under the lift span was through a teflon-coated rocker bearing on a traversing girder. This bearing allowed easterly traversing of the lift span as the tower was plumbed.

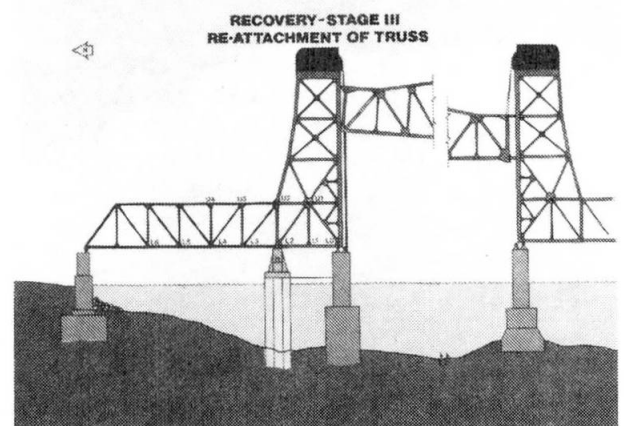
Figure 10

This required the provision of falsework under the back legs of the tower of sufficient capacity to carry the heaviest vertical reaction and provide a base large enough to carry a jacking frame, and a transversing system which would be required to re-align the tower after plumbing (Fig. 10). Support for this falsework, which was designed for 1091t, was provided by two groups of 12 - 500 mm dia. pipe piles supporting a transverse girder system of adequate size to

The temporary bottom chords and the crippled top lateral bracing from U2 to U3 were subsequently parted. The U3W-U2E diagonal was cut using oxy-acetylene torches and the load released by retracting the jacks. The top chords were then cut simultaneously by use of oxygen lances. The east chord was the first to be cut completely and showed to be in a state of zero stress. The load in the west chord was released after cutting by retracting the jacks. The

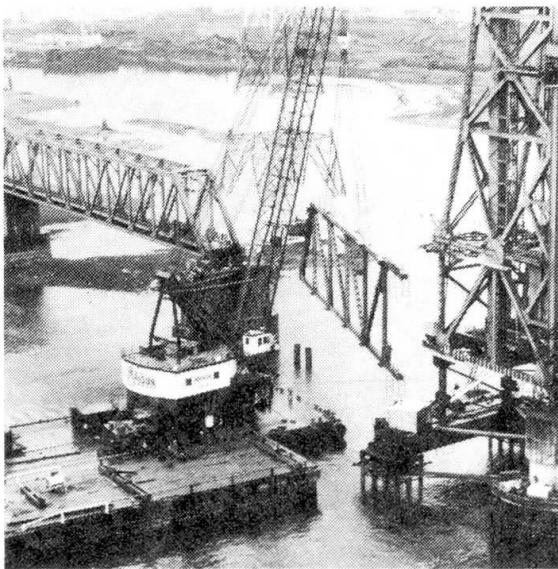
Figure 11

carry the jacking-skidding system (Fig. 11). This platform braced to Pier 3 with 610 mm dia. pipes. The attachment to the pier was made with Dywidag bars in holes cored through the foundation legs. 914 mm dia. pipe piles supported falsework of 455t capacity at L5, and 91t capacity at L7. The L5 and L7 bents were necessary to support the partially submerged span after separation from the tower. Bent L5 was designed to act as a

Similarly, the skidding frame at L2 was supported on teflon bearings moving on a polished steel surface. Total movement at L2 was 3100 mm.

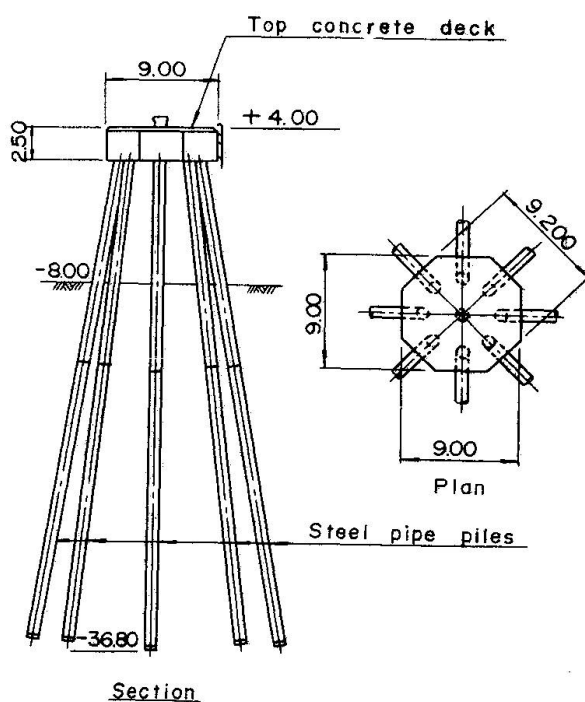
Fig.3 Structure of Dolphin M-1

In the structure of the Dolphin M-1, 9 steel pipe piles (609.6 mm in diameter, 12.7 mm in thickness, and 40.5 m in length) composed of 8 radial battered piles and 1 vertical pile are rigidly connected with the top concrete deck. This mooring dolphin has a rigid structure in contrast with the breasting dolphin, that is, the static load worked through mooring ropes is borne by the structure so that a ship can keep a certain distance with the berth.

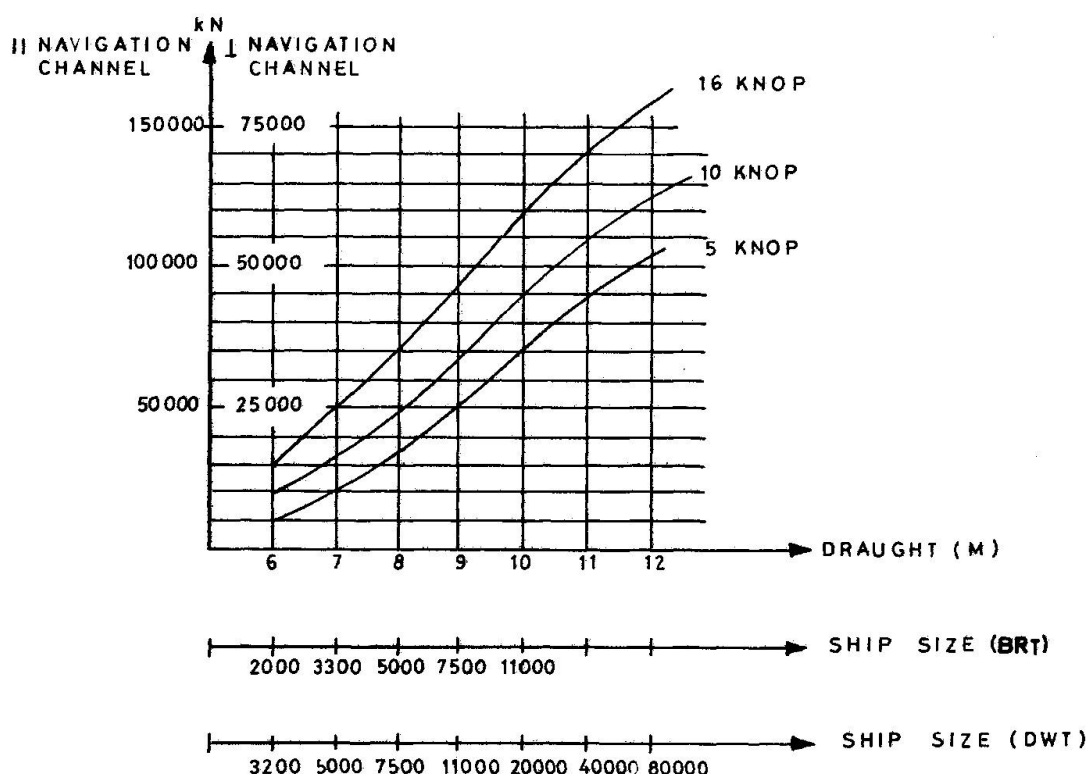
Fig. 1 Magnitude of ship collision force as a function of ship size and speed

As part of the work done by the association of nordic road administrations, specifications for the static forces to be used in the design has been worked out. These are related to the size of the ship, the ship depth and velocity. See fig. 1. (1).

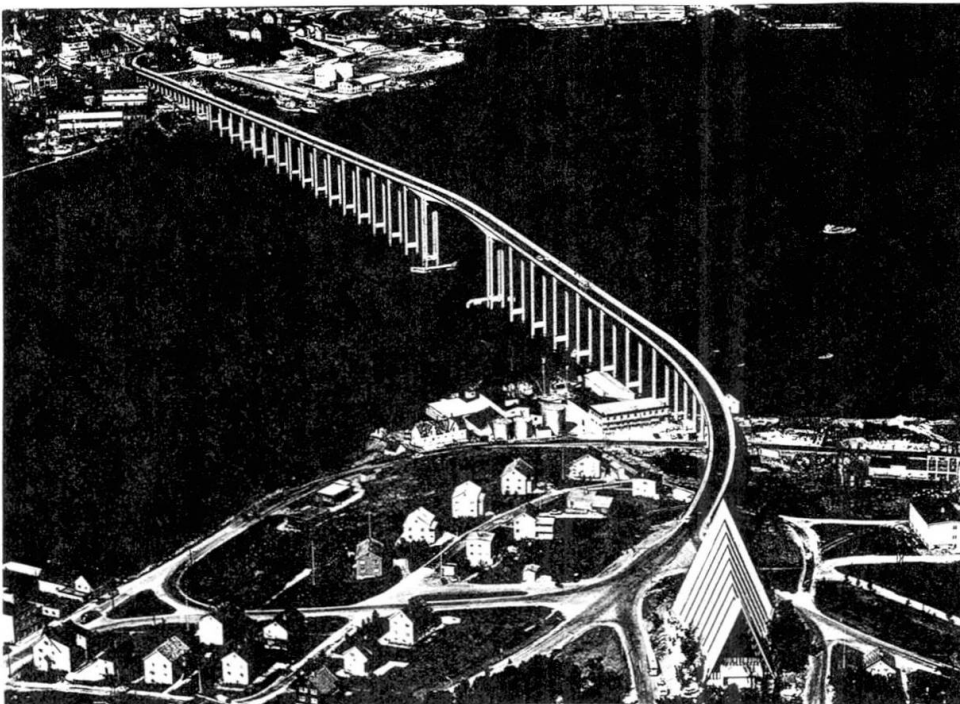
Fig. 2 Tromsø Bridge

With its 1016 metres long superstructure resting on slender columns above Tromsø Sound, it is, together with the near situated "Artic Cathedral", perhaps the most well-known landmark in Northern Norway. Fig. 2.

To day, having learned by experience from several serious accidents around the world, and also a great number of smaller accidents in Tromsø Sound, we must state that the risk of collision between passing ships and the columns of Tromsø Bridge, was not satisfactorily judged when the bridge was planned.

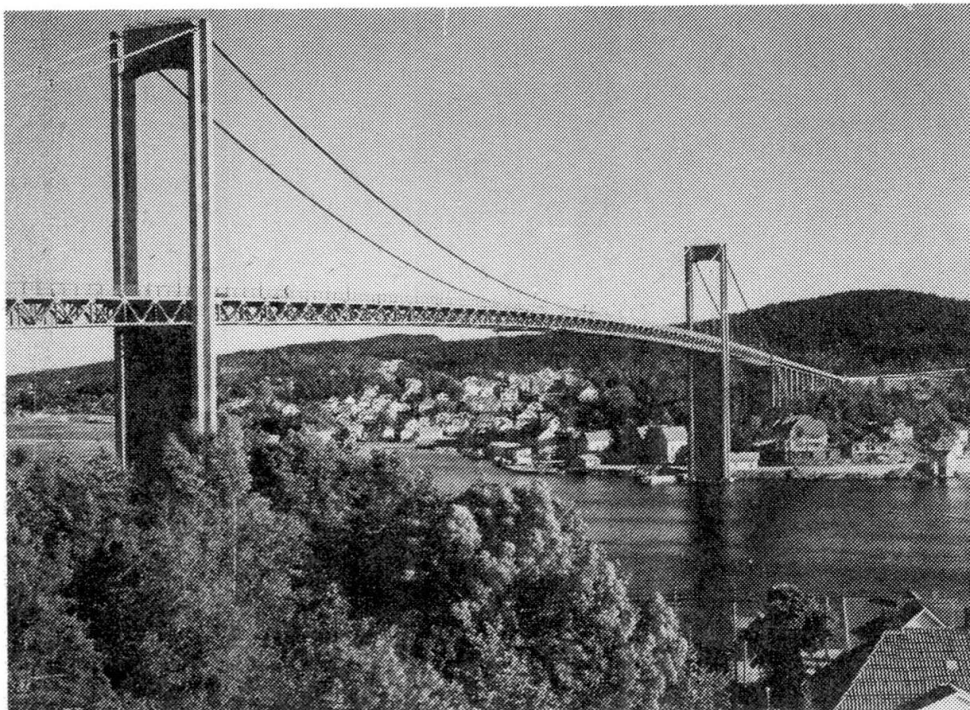
Fig. 6 Brevik Bridge

The 677m long structure consists of suspended main- and sidespans of 272m and 85m respectively in addition to 16 viaducts. Fig. 6.
