Recovery and repair of the Second Narrows Railway Bridge

Zeitschrift: **IABSE reports = Rapports AIPC = IVBH Berichte**

Band (Jahr): **42 (1983)**

Recovery and Repair of the Second Narrows Railway Bridge
R habilitation et r paration du pont ferroviaire de Second Narrows
Wiederherstellung und Reparatur der zweiten Eisenbahnbr cke
von Second Narrows

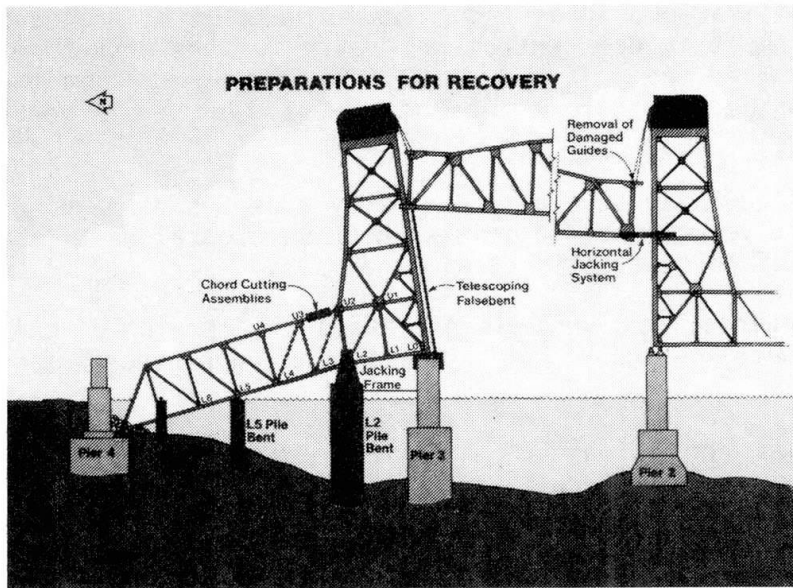
Figure 5
severed truss span would rotate as it was raised to the horizontal for subsequent dismantling in large sections.

The philosophy of the recovery procedure envisaged isolating the lift span and tower from the partially submerged portion of the span.
