**Artikel:** Recovery and repair of the Second Narrows Railway Bridge  
**Autor:** Jamieson, Donald H. / Calder, David G.  
**DOI:** <https://doi.org/10.5169/seals-32400>

**Recovery and Repair of the Second Narrows Railway Bridge**  
R  habilitation et r  paration du pont ferroviaire de Second Narrows  
Wiederherstellung und Reparatur der zweiten Eisenbahnbr  cke  
von Second Narrows

The paper describes the damage caused by a ship collision with the Canadian National Railway Lift Span in Vancouver, British Columbia. The theoretical and practical consideration of the stabilisation and recovery schemes are discussed and the equipment and procedures used in the twenty weeks it took to restore the train service are described in detail.

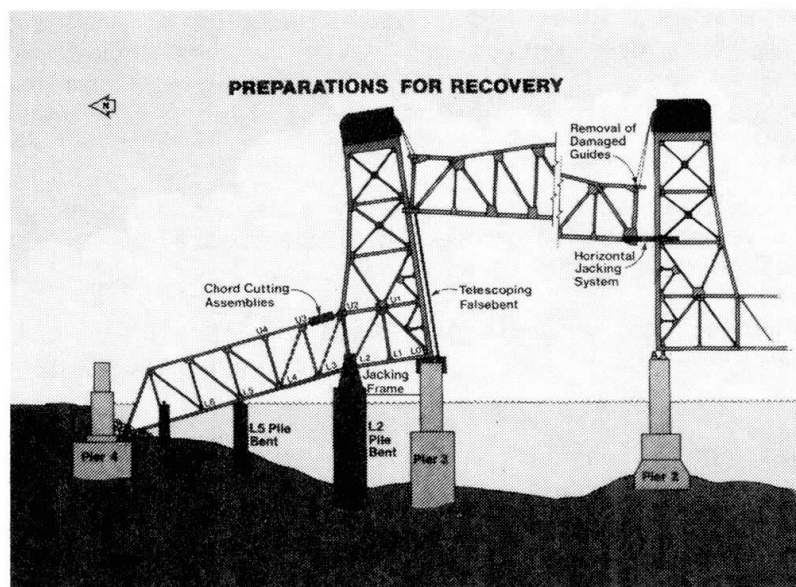
Figure 5  
severed truss span would rotate as it was raised to the horizontal for subsequent dismantling in large sections.

The philosophy of the recovery procedure envisaged isolating the lift span and tower from the partially submerged portion of the span.
