## Strengthening of a Prestressed Concrete Shell Structure

Hassan HOSNY Dr., Assoc. Prof. Mansoura Univ. Mansoura, Egypt

In this paper, strengthening of a prestressed concrete shell in a chemical factory, in Cairo, is presented. The valley beams were strengthened by external prestressing cables anchored outside the building in precast end blocks. The shells were strengthened by casting 4 cm thick resin concrete on top of the existing shell.

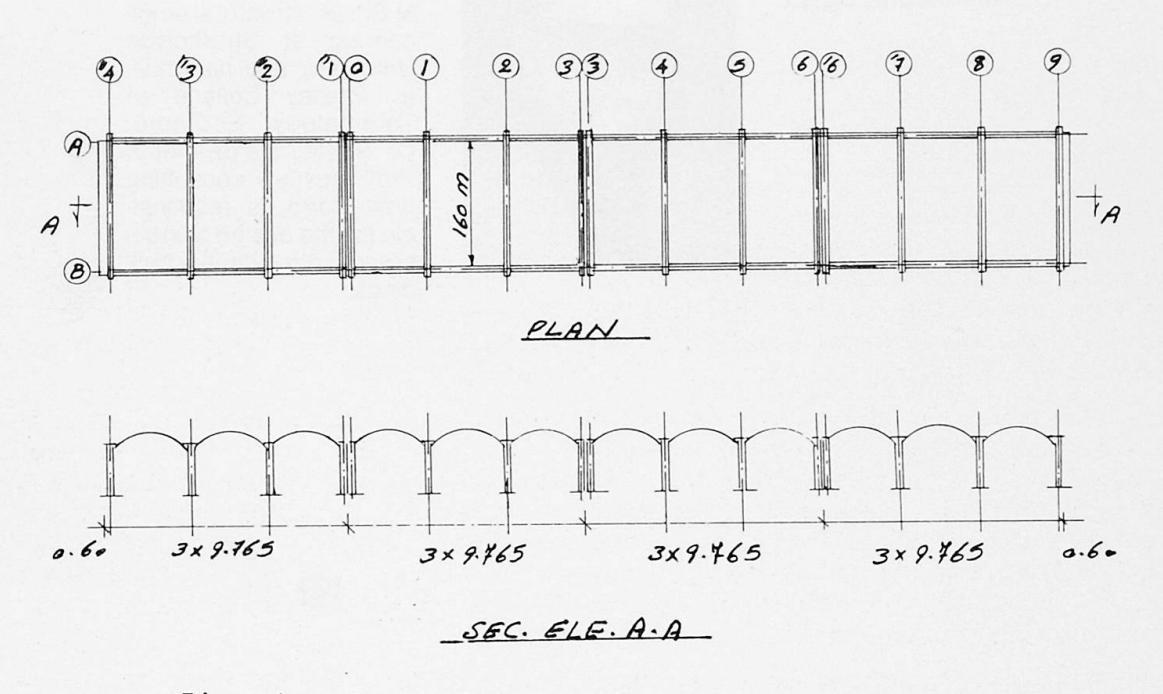
Fig. 1 General Layout

The building is devided in to four identical parts separated by three expansion joints as shown in fig.1. Each part is composed of three cylindrical reinforced concrete shells with prestressed edge beams. Each shell is 10ms wide, 16ms long and 6cm thick. The intermediate edge, valley, beams were prestressed with three FREYSSINET cables 12 o 5 mm while the exterior beams were prestressed with only two cables of the same type.

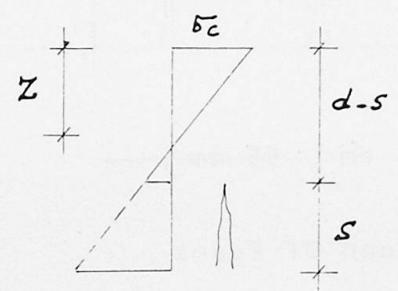
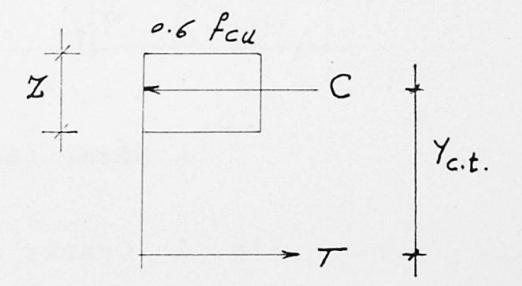
### Fig. 3 Assumptions Of Stress Distribution

- In the first case, fig. 3a, the stress distribution was assumed to be linear. In this case it was assumed that the tensile stress at the level of the top end of the crack is equal to the tensile strength of the concrete which can be evaluated. The actual external moment applied on the section was calculated, i.e. it was known. Thus from first principals, the total compression was calculated which is equal to the total tension. The effective prestressing force was accordingly estimated.

- In the second case, fig. 3b, it was assumed that the compressive stress in

the concrete has reached about 0.6 of the ultimate cube strength with a nonlinear stress distribution. In this analysis, the external moment is known which is equal to the total compression multiplied by the lever arm, Y. Both the total compression and the lever arm are functions of the depth of the nutral axis, z. Hence, z was calculated and accordingly the effective prestressing force was calculated in a similar manner as in the first case.

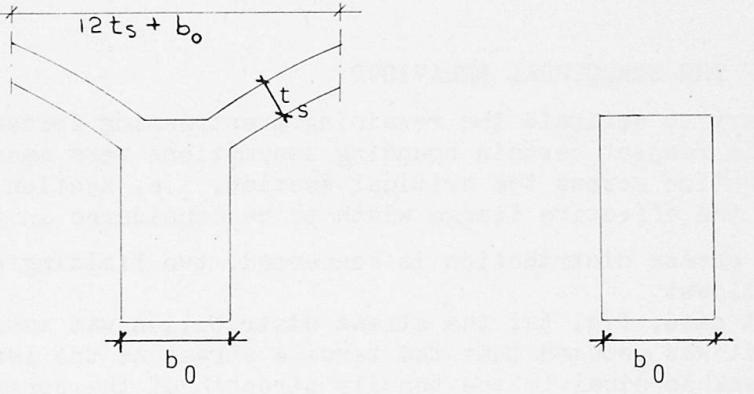
Fig. 4 Assumption Of Effective Flange Width Acting

- The beam was considered to be as a rectangular section without any flanges acting as shown in fig.4a. This case gave the heighest value of loss of pre-stressing.

- The beam was considered to have an effective flange width equal to the web bredth plus twelve times the shell thickness as shown in fig. 4b.

It should be noted that the problem under consideration is not that straight forward and some engineering judjment had to be made. From the crack pattern in the valley beams together with the above mentioned calculations, it was estimated that a maximum loss of about 40% in the original prestressing force has taken place.
