# Additional insulation of flat roofs with thin-walled metal structures

Autor(en): **Höglund, Ingemar / Andersson, Patrick**

Zeitschrift: **IABSE reports = Rapports AIPC = IVBH Berichte**

Band (Jahr): **49 (1986)**

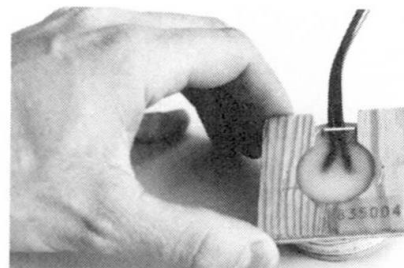
**Fig. 2** Moisture-measuring gauge used in the field investigations. The gauge is built into the roof decking. The electrodes, insulated except at the tips, measure the electrical resistance of the plywood. The thermocouple helps to correct resistance measurements for temperature. By using a relation curve of electrical resistance and moisture content in the measuring gauge, it is possible to determine the moisture ratio in the measuring gauge and thereby the moisture ratio in the roof.
