Zeitschrift: **IABSE reports = Rapports AIPC = IVBH Berichte**

Additional Insulation of Flat Roofs with Thin-Walled Metal Structures

Ingemar HÖGLUND

Patrick ANDERSSON

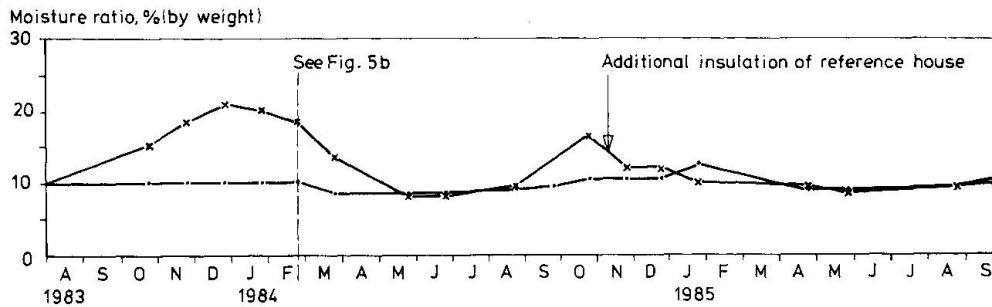
Fig. 5a Example of results. Moisture and temperature measured in three houses at the fibre board. Two houses additionally insulated and instrumented in summer 1983; the third house acted as a reference house and was not insulated until November 1984. During the winter of 1983-84 the effect of these measures could clearly be observed. In the additionally insulated roofs the moisture ratio remained at a low level, c. 10% during the whole period. In the house without additional insulation, however, the moisture ratio rose during the autumn and winter and reached its highest level c. 20% in Dec.-Jan. During the warm spring of -84 the roof dried out and the moisture ratio dropped to about 8%. During the autumn of -84 the moisture ratio rose again, only to drop immediately after the roof was additionally insulated in November -84. Since additional insulation all the roofs have had a low moisture ratio.
