Artikel: Strengthening of a bridge with epoxy beam and prestressed steel
Autor: Engelhardt, Victor L.
DOI: <https://doi.org/10.5169/seals-44304>

Strengthening of a Bridge with Epoxy Beam and Prestressed Steel
Renforcement d'un pont avec de l'époxi et des fils d'acier précontraints
Instandstellung einer Stahlbrücke mit Epoxyharz und Stahldrahtvorspannung

Victor L. ENGELHARDT
Civil Engineer
D.E.R.
Curitiba, PR, Brazil

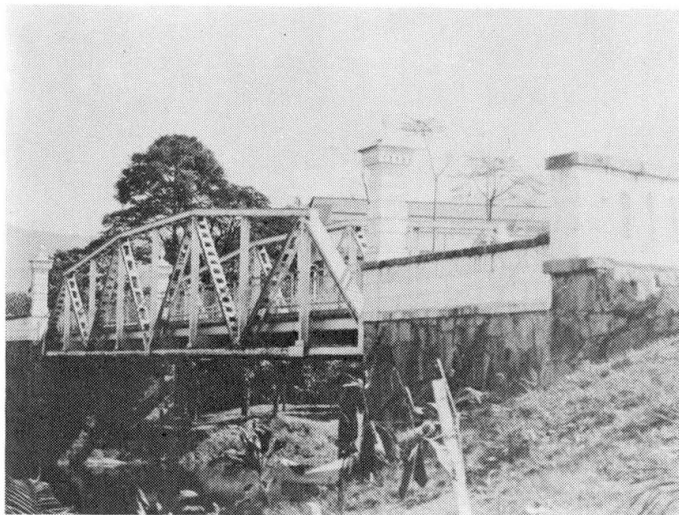
Fig. 1 General View

Its superstructure consists of a double metallic truss-frame "Warren" type with a 35.20 meters span and rests on a masonry infrastructure of excellent quality. Due to the proximity of the sea, lack of maintenance and total carelessness the bridge structure was so thoroughly eroded by the corrosion that its crumbling was foreseen even without traffic.
