Vibration Fatigue of Steel Bridges of the Bullet Train System

Kenji SAKAMOTO

Chitoshi MIKI

Fatigue cracks caused by out-of-plane vibration were observed in steel bridges of the Tokaido Shinkansen. Crack growth behaviour, measured cyclic stresses, evaluation of fatigue damage, and retrofitting methods are described.

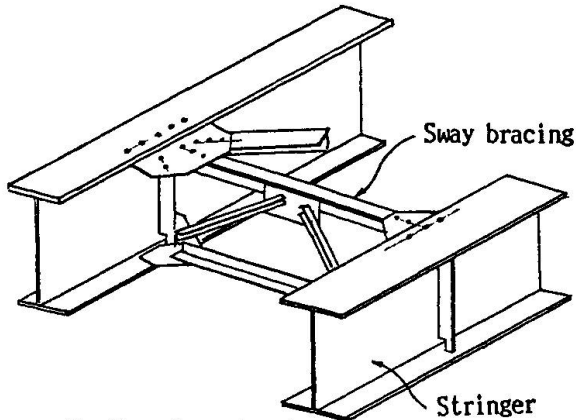
Fig.5 Sway bracing

The stringer of a truss bridge was selected for cyclic stress study. This truss bridges has a standard floor system of the Tokaido Shinkansen whose span is 60 m, and the span of stringers is about 10 m. Measurement was made by comparison concerning whether there are sway bracings (Fig.5) and differences in train speeds. Dynamic strain measurement was conducted by placing strain gauges to the back and surface of the web plate at the lower end of the welded portion. The strain gauges were located 5 to 10 mm away from the lower end of weld toes (Fig. 6) stress records were processed as follows.

As a countermeasure against these fatigue cracks, it is most effective to stop local horizontal vibrations of lower flange which cause fatigue cracks. In some truss bridge stringers, fatigue cracks were removed by applying of arc air gouging and rewelded and then an additional plates were installed by high-strength bolts (Fig. 10). In some cases a sway bracing was also added. Another possible measure is to increase the fatigue strength of the detail. As it is costly to add plates to a slight fatigue crack, it was necessary to consider an economic method for raising fatigue strength. It is advisable to improve the fatigue strength of the toe of a fillet weld and prevent occurrence of additional crack in a part where occurrence of a fatigue crack is not confirmed as a preventive measure. Application of TIG (Tungsten Inert Gas) arc remelting has considered as an effective and economic method for repairing a fatigue crack at the toe of a fillet weld and improving fatigue strength.

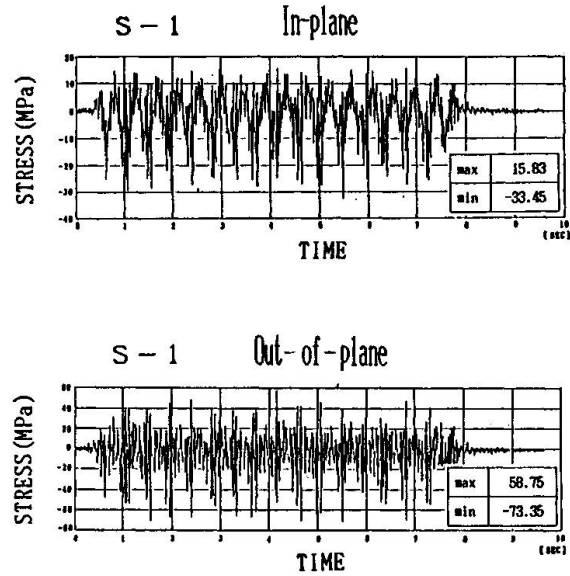
Fig. 8 Stress component in In-plane and Out-of-plane of web

Stresses in S-1 is the largest measured value in this structure and its stress waveform exhibits a resonating behavior. However, S-2, the stress waveform of a low-speed train ($v=178$ km/h) does not produce as large stress as S-1 ($v=203$ km/h). Therefore, horizontal vibration of the lower flange was induced only by the passage of high speed trains. In order to examine this resonating behavior, a stress was separated into the in-plane component and the out-of-plane component as shown in Fig.8. Its results indicate that the stress at the lower end of the stiffener without sway bracing detail is mainly caused by out-of-plane distortion of the web plate. From this, it seems possible to say that the source of a predominating stress which occurs at the lower end of a stiffener is horizontal vibrations of the lower flange.
