Artikel: Strengthening of an unreinforced masonry building
Autor: Heintz, Jon A. / Wosser, Thomas D.
DOI: <https://doi.org/10.5169/seals-55176>

Strengthening of an Unreinforced Masonry Building Renforcement d'un immeuble en maçonnerie non armée Verstärkung eines unbewehrten Mauerwerkbaus

50 Green Street is a historic brick building located in San Francisco's warehouse district. Originally built for warehouse and manufacturing use, the massive structure possessed many of the deficiencies common to unreinforced masonry construction. The strengthening scheme was sensitive to the architectural fabric of the building and included steel knee-braced frames, steel tension-rod roof diaphragm strengthening, and a pioneering effort incorporating the use of "CenterCore" reinforcement in the existing brick walls. The owner was actively involved in the process and his special concerns for cost, time, appearance, and tenant disruption were incorporated as the system evolved.

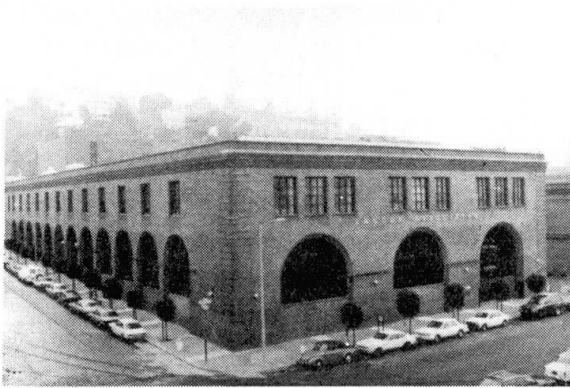
Fig. 1 Building Exterior

50 Green Street is a two-story brick structure located north of Market Street in San Francisco's warehouse district. It occupies the entire city block between Green, Commerce, Battery, and Front Streets. The exterior facade consists of an arcade of slender piers and graceful semicircular arches along all four elevations. Ornate brick relief patterns around the arches, raised detailing in the four corners, and corbelled courses of brick at the parapet give the building a distinctive appearance.
