Structural Rehabilitation of a Reinforced Concrete and a Prestressed Concrete Bridge

G. CROCI
Professor
University of Rome
Rome, Italy

Two examples of works on reinforced and prestressed concrete bridges are described, each involving different aspects of problems faced by the maintenance programs that the Italian Roadway Board has carried out in recent years. The first case involves an old reinforced concrete bridge whose heavily damaged structures required radical repairs and anti-seismic measures. The second case concerns prestressed concrete span cantilever cables to be inserted in the cross section in order to restore safety margins and correct some of the deflections due to creep.

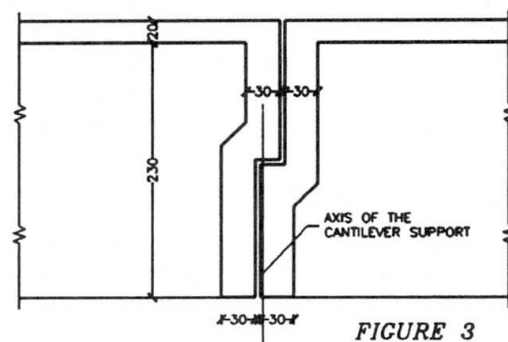
FIGURE 3

maintenance costs for the Board. The two viaducts, each of which has separate decks for each direction of traffic, consist of six 37.4-meter cast-in-place spans, three of which are cantilevered and three consist Gerber beams with 26.6-meter spans supported on six 6-7 meter high piers (photo n. 2). The Gerber beams are supported by very narrow joints girder (figure 3) with four ribs connected by a lower slab for a short distance from the pier along the cantilever.

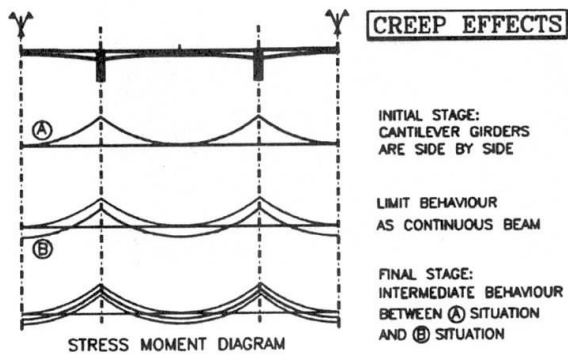
FIGURE 12

The phenomena observed are related to creep processes that cannot easily be predicted at the design stage. On account of the construction method, based on a cantilevered section-by-section procedure that involved building a structure with provisional boundary conditions that differed from the final ones, the creep effects have produced a redistribution of the stress for permanent loads and, in particular, an increase in positive bending moments in the middle of the spans and a reduction near the piers (figure 12). The individual sections of the cantilevers were poured in different stages, with non-homogeneous pouring and weathering conditions, so that they presented different creep functions. Even minor uncertainties in calculating the dead or prestressing loads could also have led to considerable variations in the creep deformations, bearing in mind the effective reciprocal influences between the creep and the steel relaxation of the prestressing cables. Another factor that should be considered is the possible effect of the insertion of provisional hydraulic jacks in the middle of the central span, which may have partially compensated the creep deformations of the third span, jeopardizing the second and fourth spans.

The strengthening measures were designed to enhance the bending and shear strength of the deck and consisted in inserting prestressing cables in the lower part of the section in the middle of the lateral spans and also, to a lesser extent, in the central span. Prestressing was achieved by inserting new cables within the box-girder and tensioning them prior to the casting the new levelling pavement. The new prestressing forces thus compensate either the creep effects or the loads corresponding to the new pavement. Each cable was protected by a grease sheath and anchored anchored to the diaphragms of the pierheads; they were placed along an almost rectilinear course to reduce the deviation devices. 192 six-inch wobblers were used, to provide an overall force of about 16000 KN for the lateral spans and about 10800 KN for the central one (photo 13).
