Zeitschrift: IABSE reports = Rapports AIPC = IVBH Berichte
Band: 78 (1998)

SESSION 6

Maintenance and repair

Session 6 - MAINTENANCE AND REPAIR

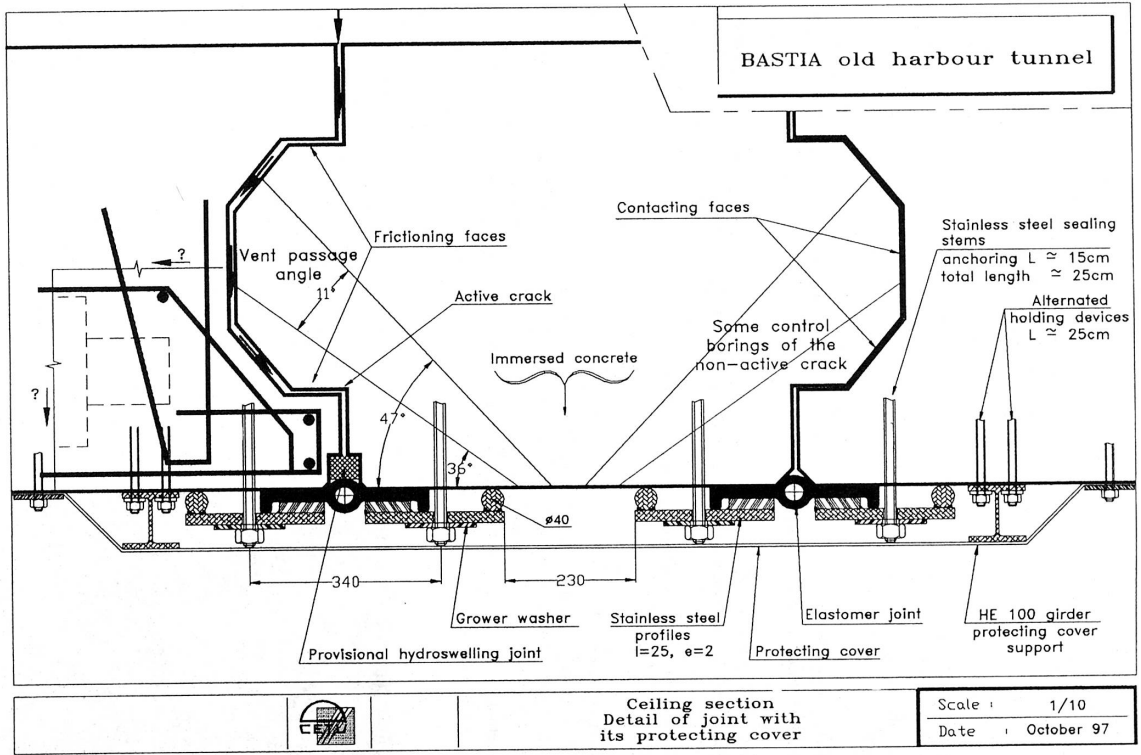
Fig. 5 BASTIA old harbour tunnel. Ceiling section: detail of joint with its protecting cover

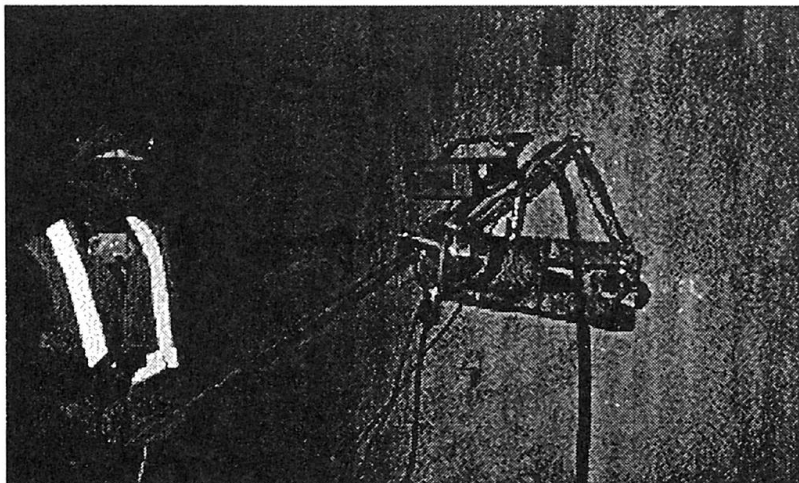
Fig. 8 After sprayed concreting, tearing tests on pins to test the equipment securing conditions

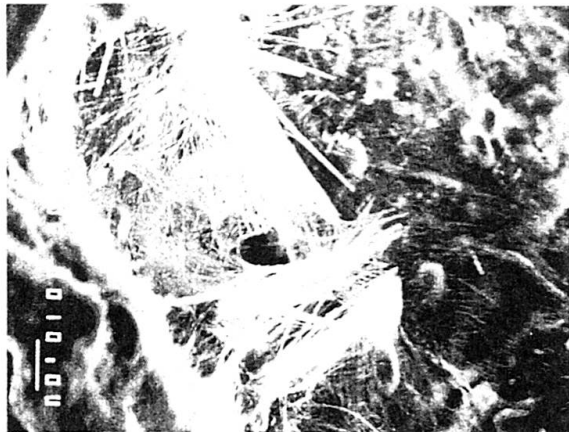
shown in Figure 5 and Figure 6. Each photo is 1000 times enlarged photo of inside the pore of thereabout 100 μ m in diameter in size of hardened cement structure of each sample. Figure 5 is the SEM photo of core No.1 and Figure 6 is the core No.3. In Figure 5, increased cement crystals in the pore are observed.

Figure 5. Inside the pore of core No.1

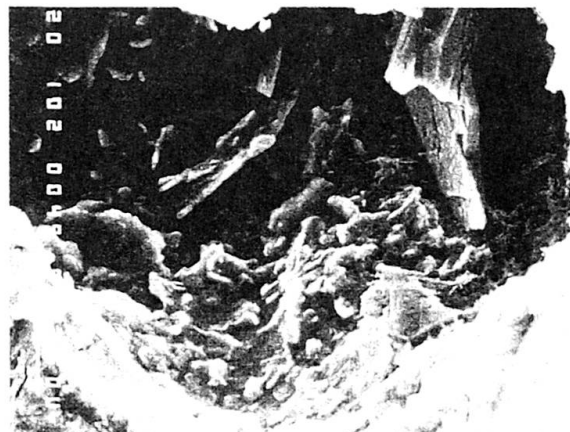
Figure 6. Inside the pore of core No.3

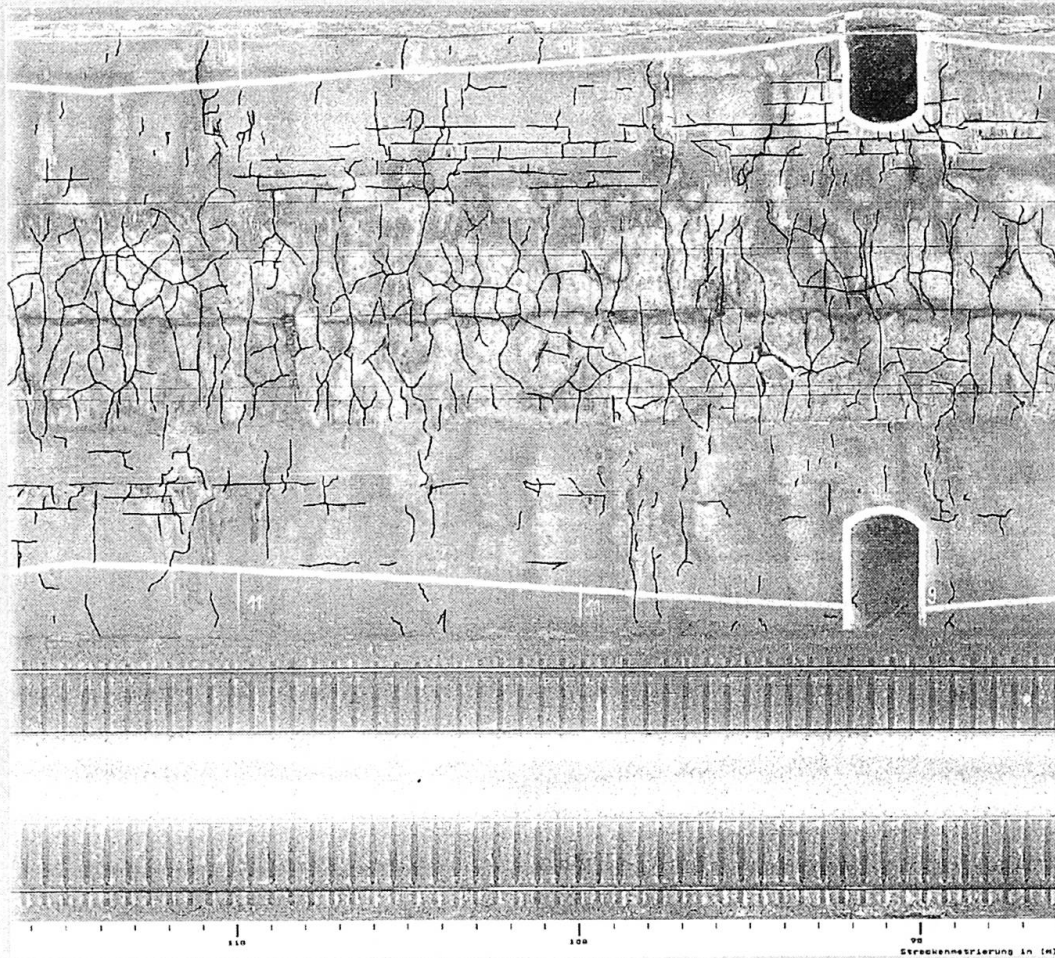
Figure 4: Crack chart

The high-resolution scanner is used for charting small surface structures. Cracks in the walls larger than 0,3 mm can be charted with close surface coverage (Figure 4). If these surveys are repeated at regular intervals, objective results on cracks and crack development can be obtained and repair works can be planned and calculated.

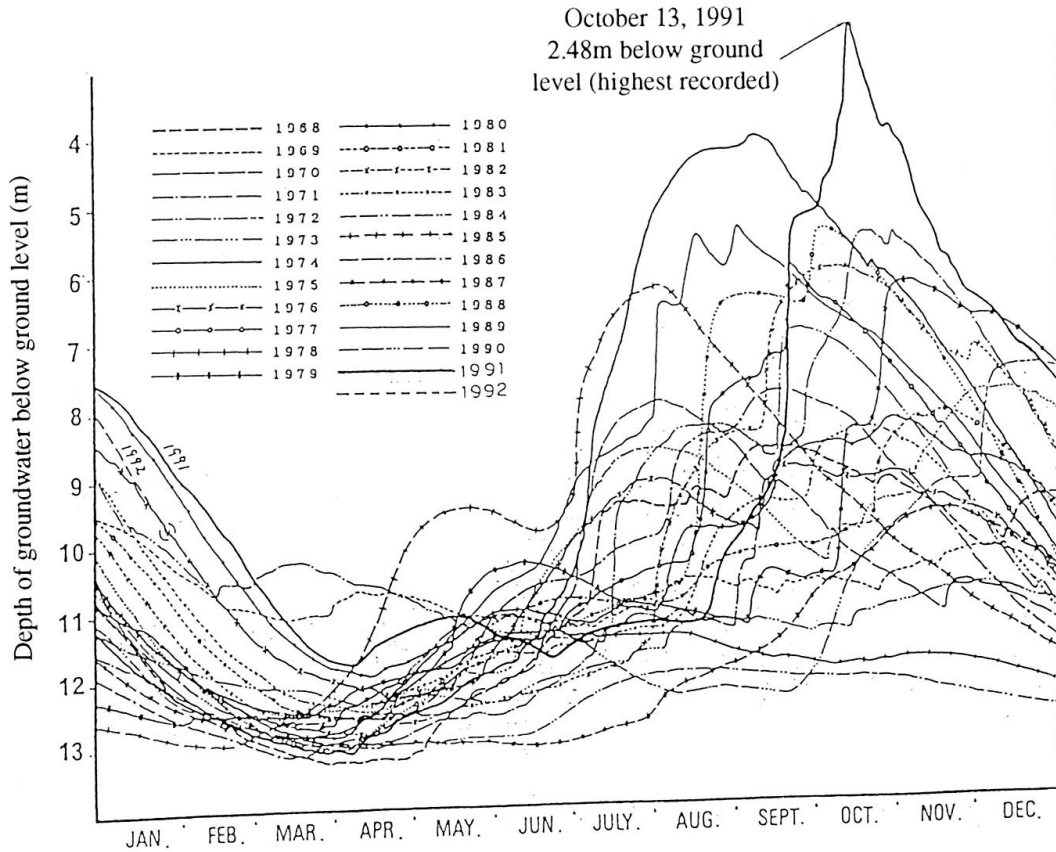
Investigation of the relation between the groundwater level and rainfall over these 23 years confirmed that the amount of rainfall over the preceding several months combined with the rainfall over the immediately preceding days produced a rapid rise in groundwater level. A relationship between cumulative rainfall over the preceding 60 and 90 days and the rise in groundwater level was also confirmed. Using 116 years of the precipitation data from the Central Weather Agency in Otemachi, Tokyo (27km away) the period of recurrence of the cumulative rainfall seen in the 60 days and 90 days surrounding the disaster was studied. In either case the recurrence period was 100 years (Tables 1 and 2). Calculations based on actual water level data put the recurrence period at 66 years.

The balance point between the self-weight of the structure of Shin-Kodaira station and buoyancy due to groundwater (neglecting the effects of friction with the soil) is reached when the groundwater level rises to approximately 5m below ground level. Thus it can be inferred that the continuing rain from mid-August to early October raised the groundwater to a level unprecedented in the life of the station and caused buoyant upheaval of the U-shaped retaining walls.

Fig. 3 Changes in Water Level Over Time in a Well at Kodaira-Nakamachi (produced by Hosono committee member)

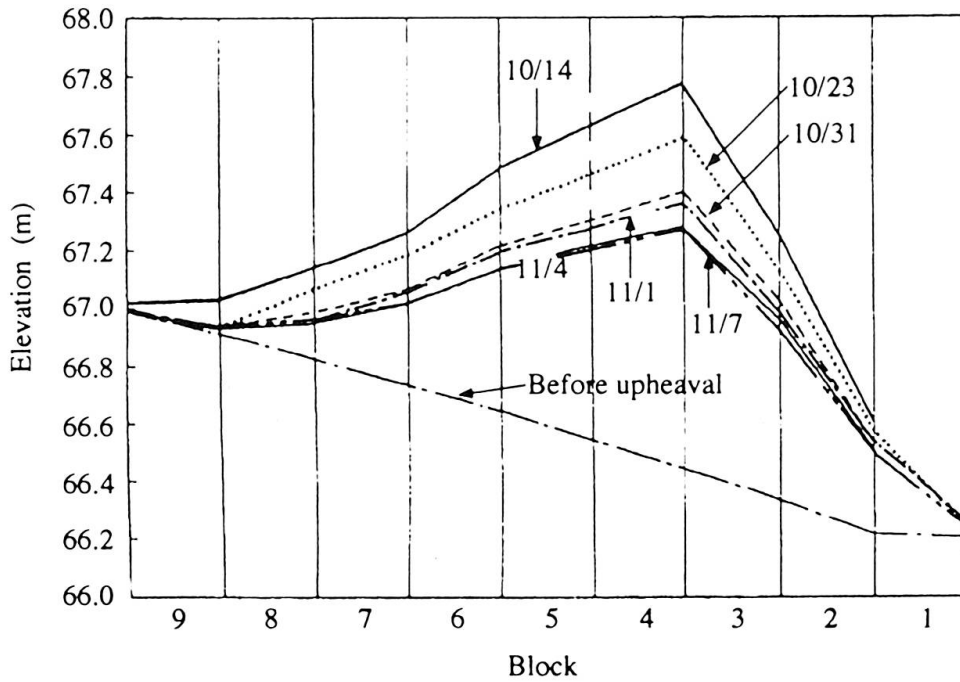
Reduction of the buoyancy through lowering of the water level was chosen as the method for lowering the structural frame, as this was judged to be the quickest and most efficient method. Deep wells were arranged to lower the water level, seven inside the U-shaped retaining walls ($l=7\text{m}$, $\varnothing=650\text{mm}$, lifting pipes: 100A, high lift underwater pumps: 15kw) and nineteen surrounding the outside of the retaining walls ($l=20\text{m}$, $\varnothing=700\text{mm}$, lifting pipes: 100A, high lift underwater pumps: 15kw). Pumping began gradually on 22nd October and continued until 30th November, after the completion of the new slabs. There had been no past cases, however, where complete lowering of the structural frame was achieved after an upheaval as large as 1.3m and there were concerns as to whether adequate lowering of the water level could be achieved through use of deep wells. (Figure 4).

Fig. 4 Elevation of Lower Slabs (Slab Crests) : Measurement Results

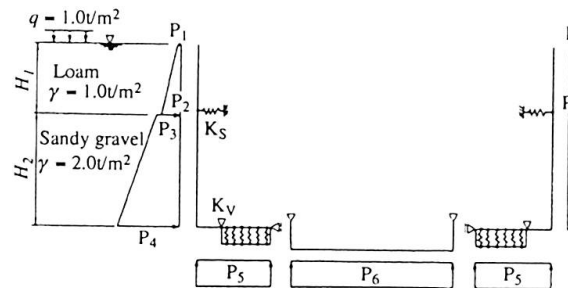
Fig. 5 Analysis Model

The analysis model of the structural frame is shown in Figure 5. In the analysis, four rows of vertical anchors were installed to provide resistance to buoyancy and struts were installed on the upper parts of the structural frame. Through a comparison of the construction periods required, roller bearings were selected for use in the connections between the old slabs and sections where excavation was to be conducted below the slabs.

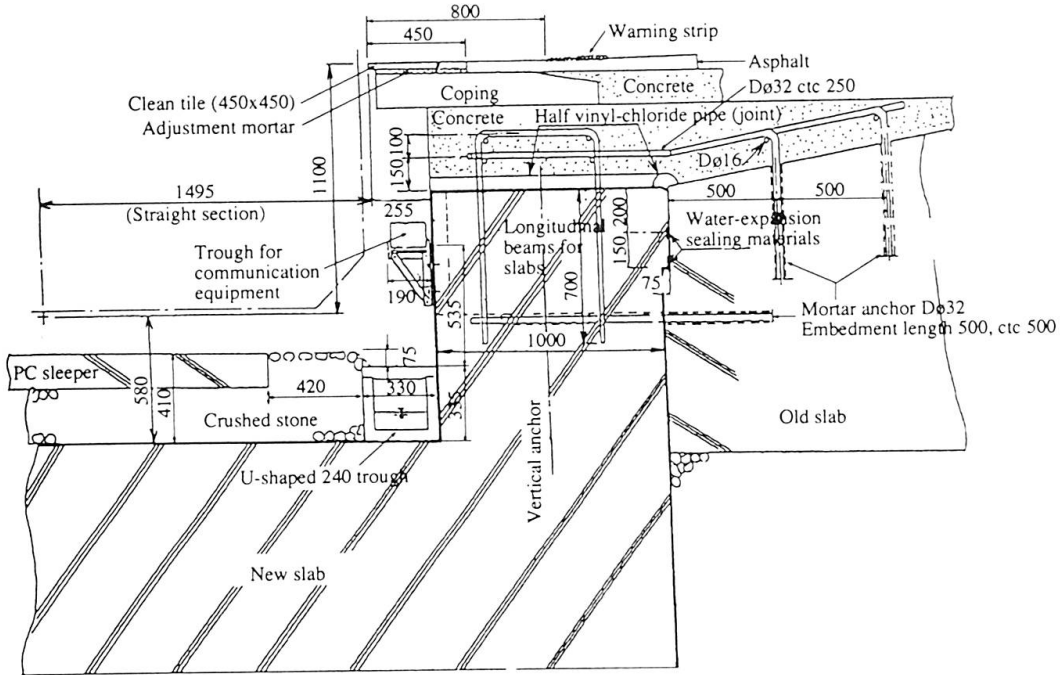
Fig. 6 Connection (Details)

The analysis results are given in Table 4. It was confirmed that the stress generated in the lower slabs would not exceed the resistance stress. At the connections between the old and new slabs, taking into account the fact that complete roller bearings and pin bearings cannot be created in concrete structures, reinforcement was provided with steel rebars and anchors to prevent opening and dislocation. The details are given in Figure 6. To ensure early generation of strength, the concrete strength was set at $\sigma_{28}=360\text{kgf/cm}^2$ in the mix design.
