Artikel: Rehabilitation of two existing tunnels in West Malaysia: a case study

Autor: Singh, Parnam

Rehabilitation of Two Existing Tunnels In West Malaysia: A Case Study

Parnam Singh
Manager
L&M Structures Sdn
Bhd, West Malaysia

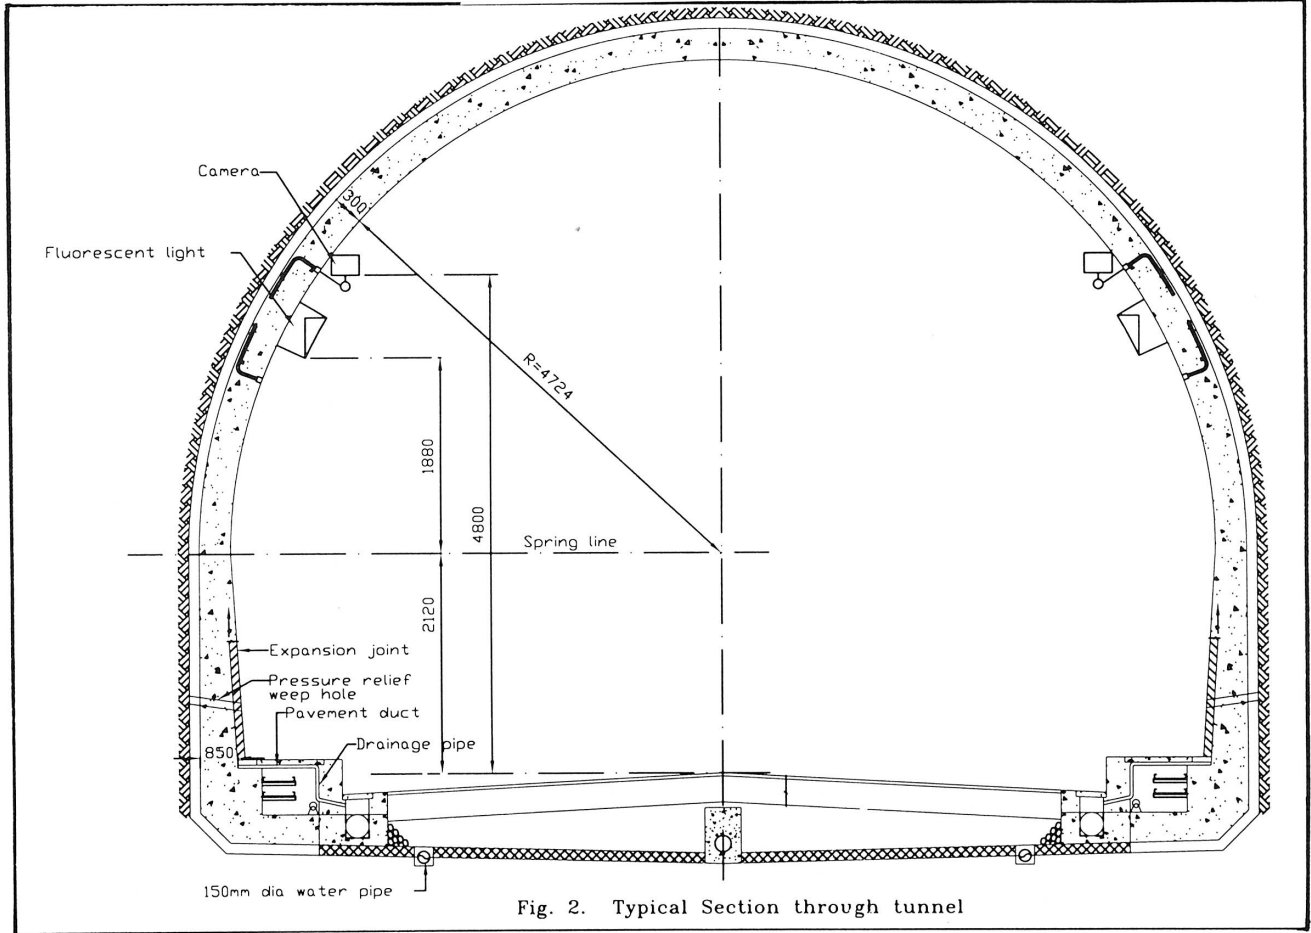
Fig. 2. Typical Section through tunnel

A detailed visual inspection carried out on the cracked concrete did not reveal signs of rust or corrosion of rebars. Localised break-outs were carried out to confirm the absence of rebar corrosion. Leaching of cement through wet cracks was evident in cracks located above the spring line of the tunnel. A detailed crack mapping exercise was carried out to document the extent and pattern of cracks in the lining. This was done by dividing the entire length of the tunnel into chainages and marking individual cracks according to their chainage. The total length of cracks measured for both the tunnels was close to 8500 metres. Most of these cracks were between 0.3mm to 3mm wide.

A detailed inspection was also carried out to determine the extent of damage in the existing expansion joints. It was noted that most of the sealant in the expansion joint was loose and damaged. A separate inspection was carried out to check on the efficiency of the existing fire hydrant system. The inspection confirmed that a section of the existing fire hydrant system in the north bound tunnel was faulty. Further inspections were carried out on the existing drainage system along side the kerbs. This was to ensure that water collected behind the concrete lining could be effectively conveyed into the drainage system via the existing weep holes.
