## CONSTRUCTION AND MAINTENANCE PROBLEMS OF KALIABHOMARA BRIDGE ACROSS RIVER BRAHMAPUTRA NEAR TEZPUR ON NH-37A

C.S.BALRAMAMURTHI  
Chief Engineer, Ministry  
of Surface Transport  
(Roads Wing), New Delhi  
India

SATISH KUMAR  
Superintending Engineer  
Ministry of Surface  
Transport(Roads Wing)  
New Delhi, India

The Kaliabhomara Road Bridge across Brahmaputra near Tezpur, Assam (India) has 24 main spans 120.00m and two shore spans 67.50m each. The span arrangement consists of Pre stressed Concrete balanced cantilever arms of 52.50m long on either side of piers with a central Reinforced Cement Concrete suspended span of 15.00m.

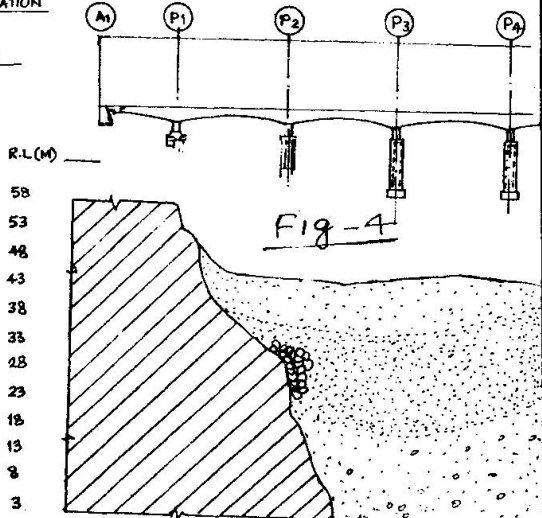
Fig. 4  
LEGEND FINE SAND MED. FINE SAND COARSE SAND BOULDER'S ROCK (SOFT/WEATHERED)

During initial sub-soil investigations conducted in 1980 it was observed that the founding strata for pier well P1 would be on a dipping surface of rock. To overcome this the bridge was shifted by about 60m towards northwards. However when detailed boring was conducted at the shifted location of P1, it indicated the presence of a combination of hard

strata in northern half at a higher location and soft strata in southern half. On practical considerations, it was clear that it was not possible to provide a well foundation for shallow depth due to risk of tilting. Thus there was a design problem.

A separate design for pier P1 was carried out by providing a raft foundation for supporting the pier. The raft was designed in the following way: -

- 1) On the south side where the strata was soft, the raft was supported on 6 No. of bored piles of 1.50m dia.
- 2) On the north side where hard strata was found, the raft was anchored into the rock by means of 98 Nos.36 mm dia HYSD rock anchors.
