**Artikel:** Damage detection and repair control of marble elements  
**Autor:** Tommaso, Angelo di / Pascale, Giovanni / Cianfrone, Francesco  
**DOI:** <https://doi.org/10.5169/seals-53301>

## **Damage Detection and Repair Control of Marble Elements**

This paper presents an experimental study carried out using the microseismic method on blocks of marble in which defects such as cracks and cavities were created artificially. The purpose is to evaluate the ability of the method to detect internal defects in stone blocks, and to judge the effectiveness of resin repairs.

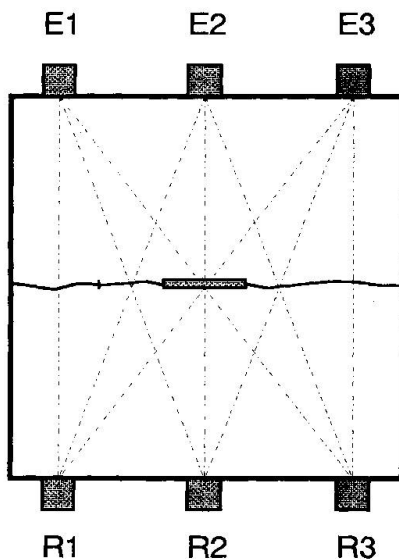
Fig. 1 Marble block and paths

Initially the probes (three emitting and three receiving) were glued to a block in the positions indicated in figure 1.

The probes were glued on the block surface during the experiment in order not to introduce disturbing parameters due to repeated removal and repositioning of probes and thus to avoid variations in coupling points, acoustic coupling between probes and material, electric connections, etc. Using two specially-built commutators, each of the emitting probes was then connected to each of the receivers, and the microseismic parameters were determined (P-wave propagation velocity and attenuation) along the paths indicated in figure 1. An average tension of 12  $\text{N/mm}^2$  was applied to the sample.

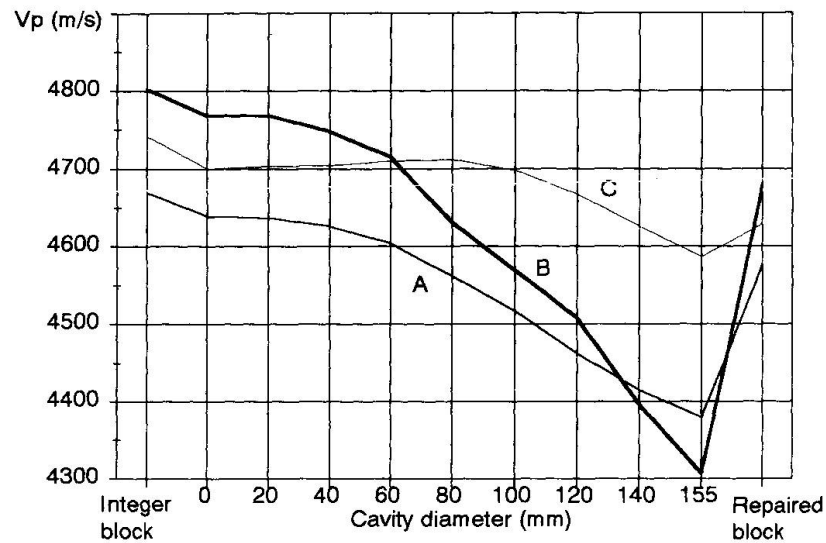
Fig. 6 Pulse velocity along different paths

Along the path A, the velocity in the cracked block is slightly lower than that in the integer block, and the attenuation slightly greater. This is due to the applied pressure, which creates good contact between the edges of the crack. In the presence of the cavity, the velocity decreases as the diameter increases, more so for diameters greater than 60 mm. The total increase is approximately 10%. The attenuation increases progressively, with a total increase of approximately 10 dB. After repair, the velocity returns to a value quite similar to that of the integer block, while this is not the case for attenuation, which remains very near to that found with the largest cavity surface area.

The paths B show a similar velocity pattern to that of the path A. For attenuation, the pattern shows a certain anomaly, due to the formation of a vertical crack.

The paths C do not intersect the cavity until the diameter exceeds 100 mm. Beyond this value, the velocity graph shows a limited decrease. Attenuation instead shows the defect from the very beginning, increasing progressively.

The results obtained are shown in tables 1 and 2, and in graphic form in figures 6 and 7. In the latter, the data regarding the measurements taken along equivalent paths have been grouped together and averaged.

The graphs in figures 6 and 7 show a different response by the two parameters *velocity* and *attenuation* according to the presence and size of the internal cavity. The cavity reflects a part of the energy, and thus causes an increase in attenuation even if the defect is not directly on the line joining the two probes. The transit time, and thus the apparent velocity, show instead a change only if the joining path crosses the defect. Variations in attenuation may therefore indicate the presence of defects, while in order to determine the position and dimensions it is more appropriate to perform a series of velocity tests.

Another purpose of the study was to examine the ability of the method to determine whether a resin filling has been successful. When this technique is used to repair internal cracks or cavities in blocks of stone or marble, it may occur that the filling is incomplete and air bubbles remain, or that the resin separates from the edges of the hole while hardening. In the case in question, the filling was performed correctly, as was subsequently verified by dividing the two parts of the block along the adhesive surface. By examining the graphs in figure 6, we note that in the repaired block the velocity returns very close to the values of the integer block.

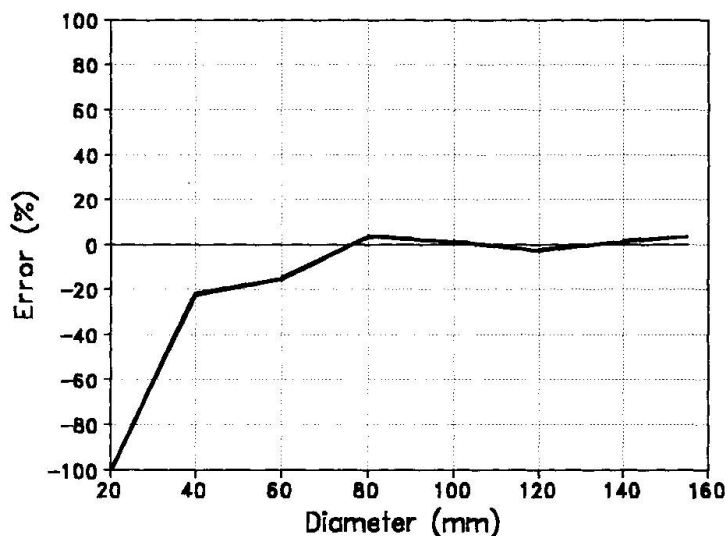
Fig. 8 Error in the evaluation of the diameter

Based on changes in the transit time along the trajectory E2-R2, the known diameters are compared to the calculated diameters using the above formula. The graph in figure 8 indicates that the estimate becomes reliable beyond 80 mm in diameter.
