Zeitschrift:	IABSE structures = Constructions AIPC = IVBH Bauwerke	
Band:	8 (1984)	
Heft:	C-29: Structures in Canada	
Artikel:	NOVA Head Office buildings, Calgary (Alberta)	
Autor:	Culham, G.A.	
DOI:	https://doi.org/10.5169/seals-18817

# 3. NOVA Head Office Buildings, Calgary (Alberta)

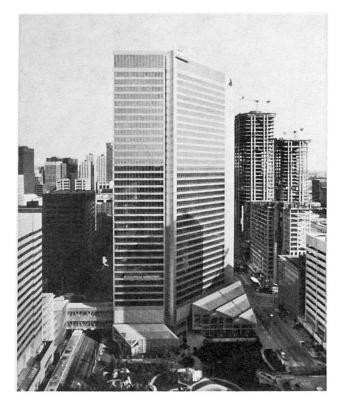
Fig. 1 Completed building

The 37 storey building contains the Corporate Headquarters for NOVA, An Alberta Corporation (Fig. 1). In addition to providing unique office space, the complex includes a North Service Building, Cafeteria, glass enclosed Restaurant and Garden Court, connecting bridges to adjacent buildings and below grade parking for 340 cars. The floor areas are as follows:

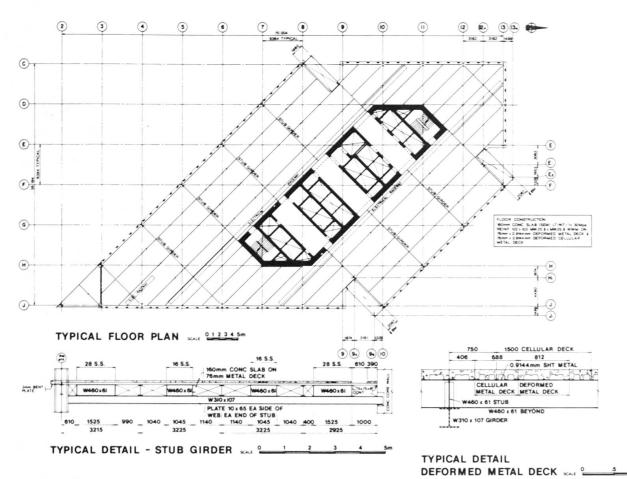
Fig. 2 Typical floor plan and details

The unique configuration of the building (Fig. 2) derives from the requirement that a maximum amount of sunlight should be permitted into the adjacent Century Gardens Park. The non-symmetrical eccentric shape of the building presented an interesting and challenging engineering problem. The building exhibits unique aerodynamic properties such that it behaves like a crude air foil in addition to having a significant torsional mode of behavior. This behavior resulted from the building's unusual non-symmetrical shape and the eccentricity of its mass centre from the centre of resistance.

Electrical trenches and cellular decking were provided on a 1.5 metre module in the structural slab for electrification of the floor. The modular layout of the floor and the use of the stub girder system permitted complete integration of the structural, mechanical and electrical systems (Fig. 2).

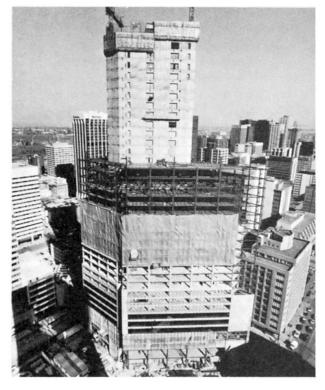
(G.A. Culham) Fig. 3 Tower under construction

Lateral and torsional wind loads are resolved by the composite floor deck diaphragms to the central concrete core, and structural steel post and beam construction is utilized to efficiently follow the irregular configuration of the outside wall of the tower and to carry gravity loads (Fig. 3).
