### **Case Stories of Recent Ship Collision Accidents**

**Accidents Involving Bridges**  
Accidents impliquant des ponts  
Brückenunfälle

**Aksel G. FRANDSEN**  
Consulting Engineer  
Cowiconsult  
Copenhagen, Denmark

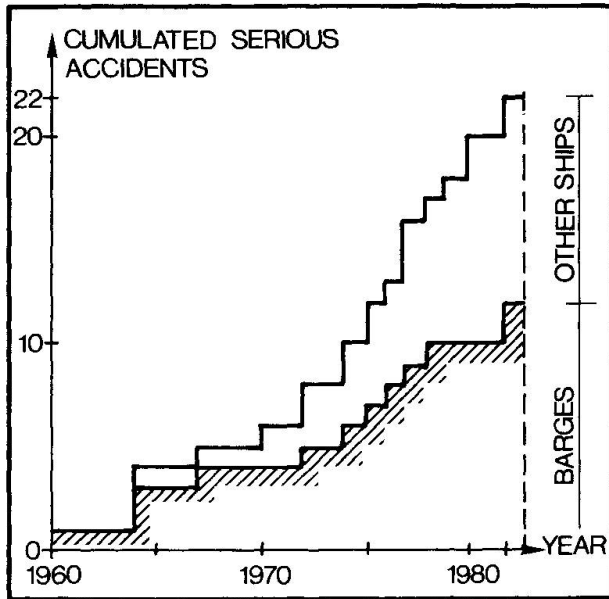
Fig. 1 Serious ship collisions with bridges 1960-1982.

Fig. 1 shows the cumulated number of serious ship collisions since 1960. It can be seen, that the annual rate of such collisions has increased from 0.5 to 1.5 during the last two decades. It can also be seen from this figure, that collisions involving barges constitute about 55% of all the cases. This corresponds well with the above mentioned distribution of the accidents on rivers and channels, as one group, compared to the group of all the other navigable waters.
