# Session 1: Evaluation of deterioration of buildings

Zeitschrift: **IABSE reports = Rapports AIPC = IVBH Berichte**

Band (Jahr): **77 (1998)**

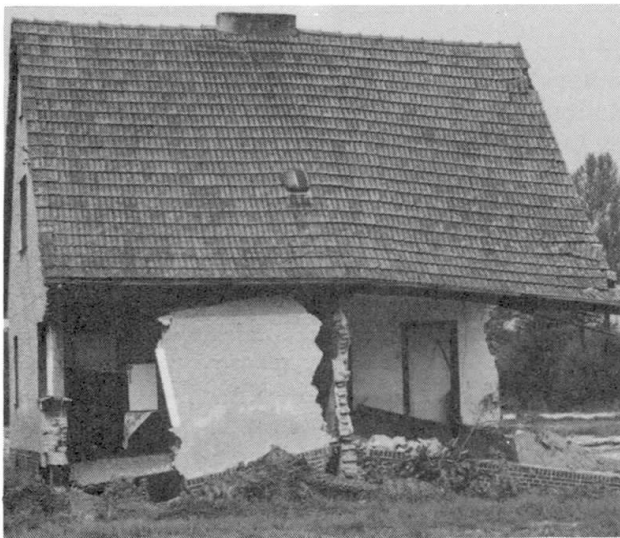
*Fig 1. Sudeten development destroyed by the flood in 1997.*

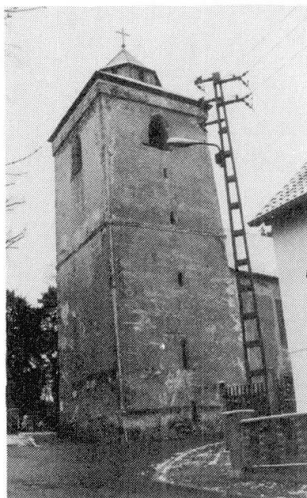
Fig. 1 : The bell tower, view from south-west

The appearance of the medieval Krölpa church tower is significantly characterized by its inclination which was caused by an uneven settlement of the ground. Today the tower is about 2.2 degrees out of the vertical and shows deep vertical cracks in the masonry of its four walls. These damages gave the reason for an investigation of the dynamic structural behaviour of the tower in its current state. It was intended to identify dynamic system properties as well as to model the structure with its specifics numerically.

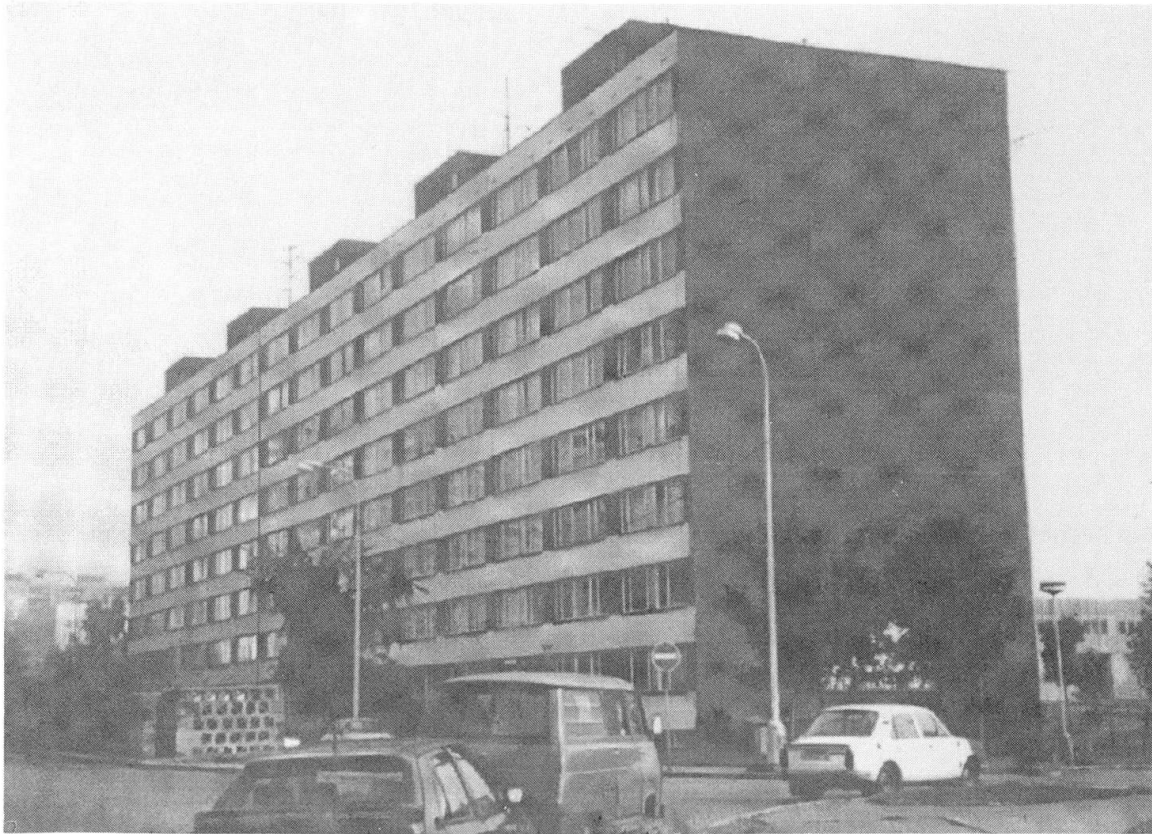
*Fig. 1: Photograph of the tested panel building*

The panel building that was chosen for the purposes of experimental verification (Resovska street, No. 22, 23, 24) was accomplished in the late seventies in Prague. It is an eight storey building consisting of three equal sections in a row, which are firmly attached to each other (see fig.1). The bearing system is formed by transversal walls 6,0 m apart and one 6m-long longitudinal wall in each section (see fig.2). The joints between the panels (0.19 m thick reinforced concrete slab-elements) consist of concrete and reinforcement. According to the visual survey some of the joints are weakened by hair-thin cracks. The front walls hang on the transversal walls and are not designed for load carrying purposes.

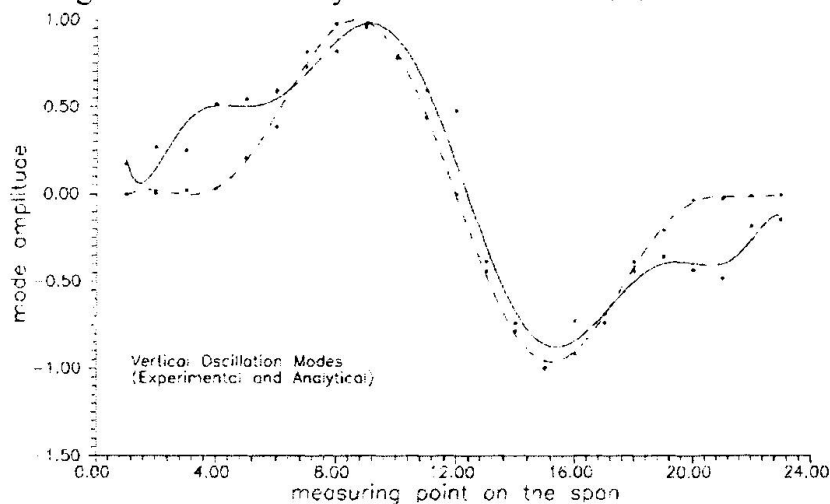
*Fig. 3 Vertical mode shapes*

The measured mode shapes revealed that for vertical loading bridge behaves as an arch but of a smaller span, while for the perpendicular direction it behaves as a beam with fixed supports. Based on the experimental results, analytical model was modified until a satisfactory correlation among measured and analytical results was achieved.

Good correlation is obvious, and such mathematical model could be used for structural analysis and to check the influence and meaning of the various strengthening methods.
