Session 1: Evaluation of deterioration of buildings

Zeitschrift: **IABSE reports = Rapports AIPC = IVBH Berichte**

Band (Jahr): **77 (1998)**

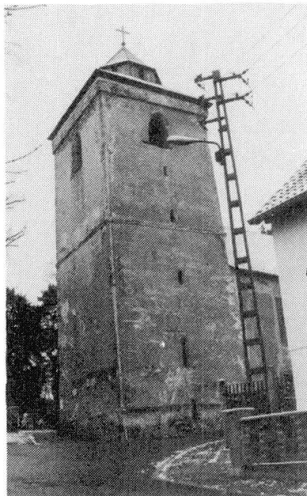
Fig. 1 : The bell tower, view from south-west

The appearance of the medieval Krölpa church tower is significantly characterized by its inclination which was caused by an uneven settlement of the ground. Today the tower is about 2.2 degrees out of the vertical and shows deep vertical cracks in the masonry of its four walls. These damages gave the reason for an investigation of the dynamic structural behaviour of the tower in its current state. It was intended to identify dynamic system properties as well as to model the structure with its specifics numerically.
