# Session 8: Rehabilitation & Preservation

Zeitschrift: **IABSE reports = Rapports AIPC = IVBH Berichte**

Band (Jahr): **83 (1999)**

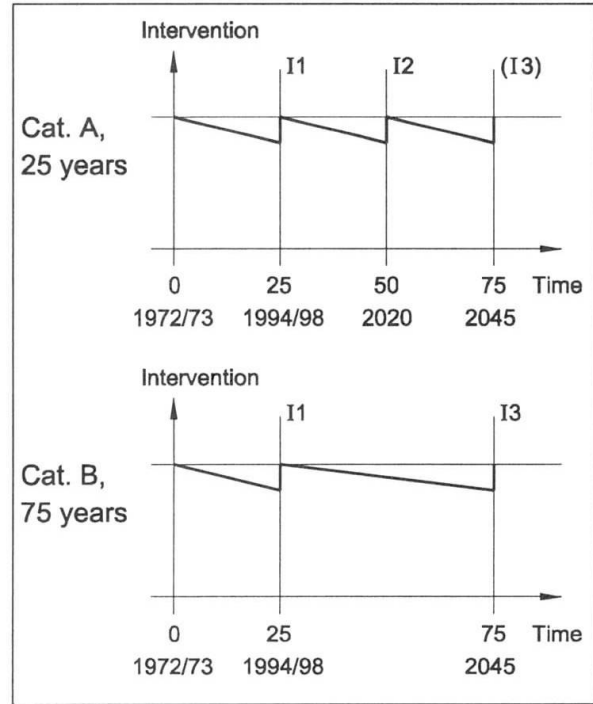
Fig. 7 Categories of interventions

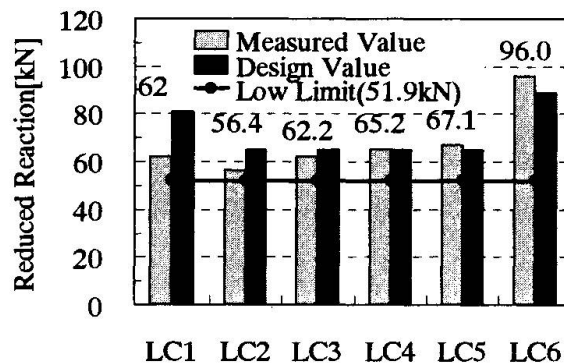
Fig.3 : Reduced Reaction in Gerber Hinge Support

The strengthening effect was confirmed by the field test on the bridge which was carried in parallel to the work. As examples of the test results, *Figs. 3 and 4* show the reduced reaction at each gerber hinge, and comparison of girder deflections between before and after strengthening work, respectively. From the results, the following are confirmed: (1) the effectuality of the proposed strengthening system, (2) validity of the adopted design and analytical model, and (3) validity of the construction procedure. In addition, it can be said the application of PC technology to the new field in the point of using PC tendons with the purpose except for stress introduction means.

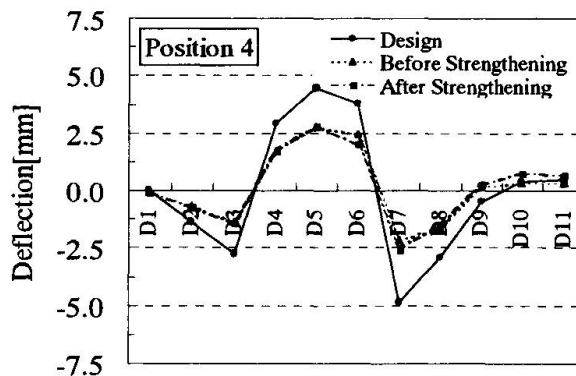
Fig.4 : Deflection of Girder

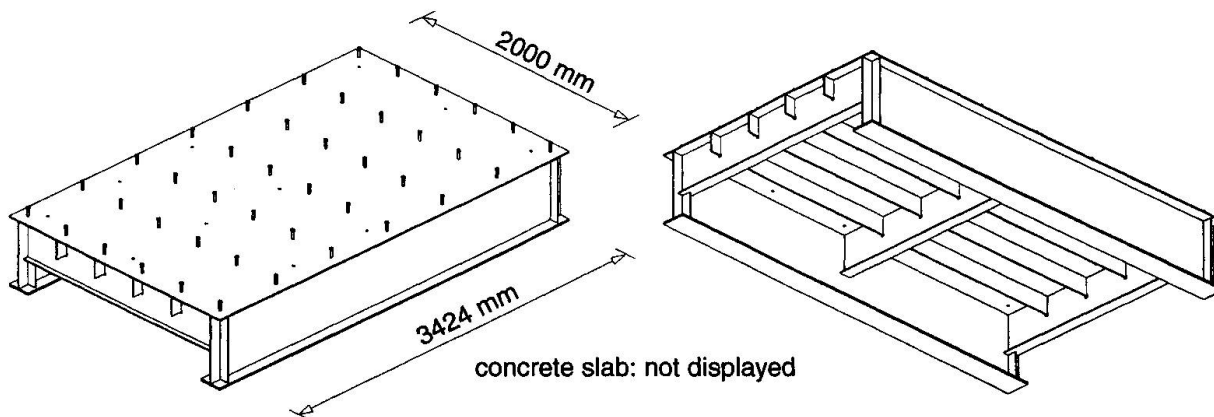
Fig. 2 Local test model

For a realistic basis of design experimental and numerical investigations were performed. The tests were performed by models which represent a cut out of the traffic deck in the scale 1:1. The boundary conditions were adapted to the global plate behaviour of the deck construction by specific support girders. Fig. 2 illustrates the test model and the constructional details of the composite deck. The test loading was defined by local wheel-loads, which were derived from the load models given by EC1-2. The dominating local load resulted in the wheel-load of 200 kN acting on the base area of 40·40 cm. The test loading was carried out statically as well as dynamically up to  $3 \cdot 10^6$  load cycles for  $\Delta P=140$  kN. Vertical deformations of the deck surface, differential deformations between the horizontal planes of steel plate and concrete slab as well as strains of the steel ribs were measured.

Four test models were investigated. Test model (1) and (2) differ in its strength class of the concrete. The results show that the effect of the two concrete classes is practically insignificant. The tests further verified that the fatigue effect in the composite action due to about  $3 \cdot 10^6$  load cycles was very low, resulting in an increase of deformation up to about 10% only. Among the numerically investigated alternatives the closest accordance with the test results was obtained for the assumption of rigid composite action. Further to the tests with the EC-load model 2 increased load steps were investigated up to 980 kN. At the load step 740 kN the test indicated acoustically as well as by a jump of the differential deformation between concrete plate and steel deck that the adhesive strength in the contact plane had been exceeded.

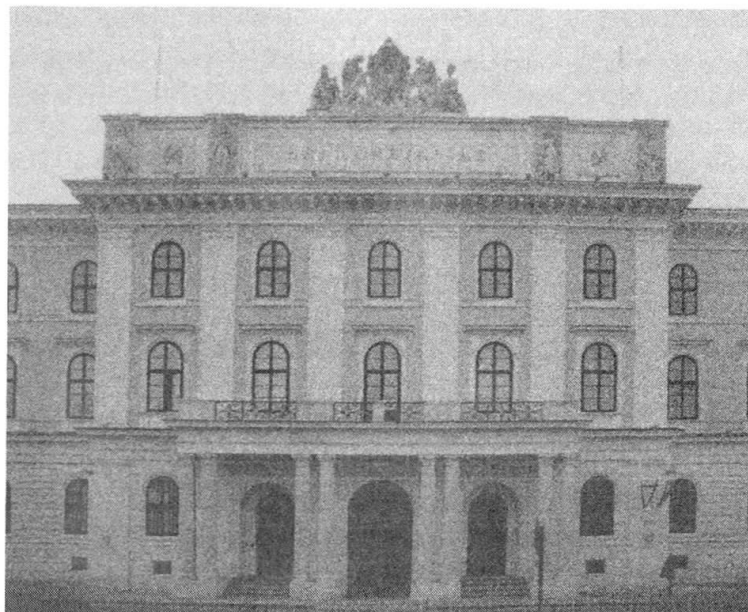
*Fig. 1: Aspect of the renovated and strengthened edifice from the main road "Am Heumarkt 1"*

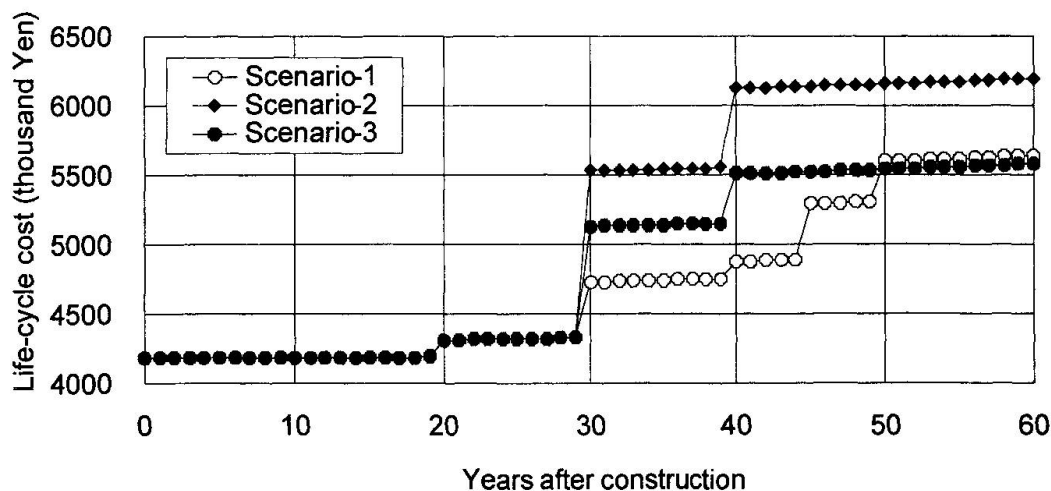
Figure 3 shows the life-cycle cost calculation with the three scenarios. Scenario 3 gave the most economical results at the end of life span. Accumulating cost data and establishing its database will enable to provide more accurate cost estimation. Life-cycle cost estimation is one of the sophisticated decision support tool for establishing maintenance strategies for port facilities. The life-cycle cost estimation was proposed for providing a prospective answer for future maintenance strategy.

Fig. 3 Life-cycle cost calculation with three scenarios

Figure 3 shows the life-cycle cost calculation with the three scenarios. Scenario 3 gave the most economical results at the end of life span. Accumulating cost data and establishing its database will enable to provide more accurate cost estimation. Life-cycle cost estimation is one of the sophisticated decision support tool for establishing maintenance strategies for port facilities. The life-cycle cost estimation was proposed for providing a prospective answer for future maintenance strategy.
