The worst railway accident in Switzerland

Zeitschrift: **Swiss express : the Swiss Railways Society journal**

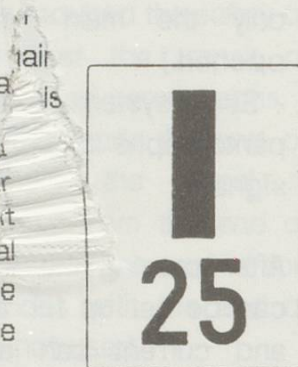
b) Endsignal:

Yellow board with vertical black band above number. The number indicates the current system after the neutral section, and has the same meaning as on the zone signal (below).
