Zeitschrift:	IABSE proceedings = Mémoires AIPC = IVBH Abhandlunger		
Band:	8 (1984)		
Heft:	P-74: Failure of stub-girders due to longitudinal shear		
Artikel:	Failure of stub-girders due to longitudinal shear		
Autor:	Gosselin, G.C. / Hosain, M.U.		
DOI:	https://doi.org/10.5169/seals-38336

# Failure of Stub-Girders due to Longitudinal Shear

The paper summarizes the results of experiments performed on two full size stub-girders. In both beams, failure was caused by the longitudinal splitting of the concrete slab over the end stubs. A significant reduction in the shear strength of the stub-girders resulted from the prying and ineffective transverse reinforcement. The research reported here forms the first phase of a conntinuing investigation at the University of Saskatchewan.

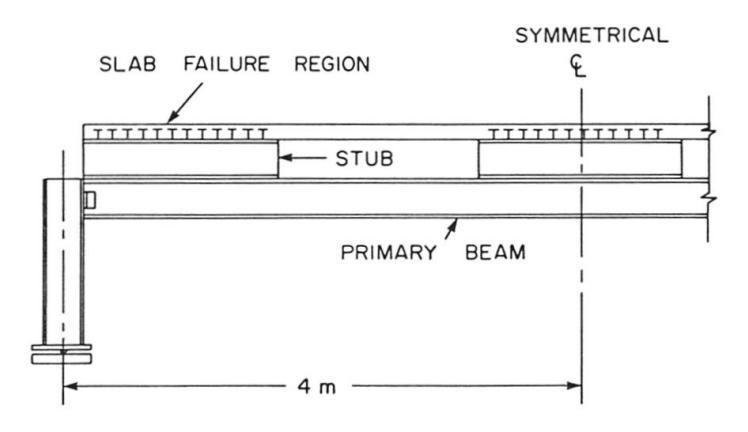
Fig.1 Longitudinal shear failure in test girder(Ref.3)

The stub-girder tested by Buckner et al. [3] incorporated a solid concrete slab which permitted placement of the transverse reinforcement near the bottom surface of the slab. This configuration, however, is not typical of any stub-girder system used to date. A stub-girder system invariably utilizes a ribbed metal deck which prevents the placement of transverse reinforcement in the bottom half of the slab. In a typical floor slab consisting of approximately 75 mm of concrete on top of a 76 mm metal deck, the transverse reinforcement ends up at best in the upper half of the slab after allowing for the minimum clear cover requirements. Moreover, since the ribs are normally parallel to the girders, the effective shear transfer area of the concrete is considerably reduced. The design criterion proposed by Buckner et al. is therefore not applicable to a stub-girder system which utilizes composite metal decks.

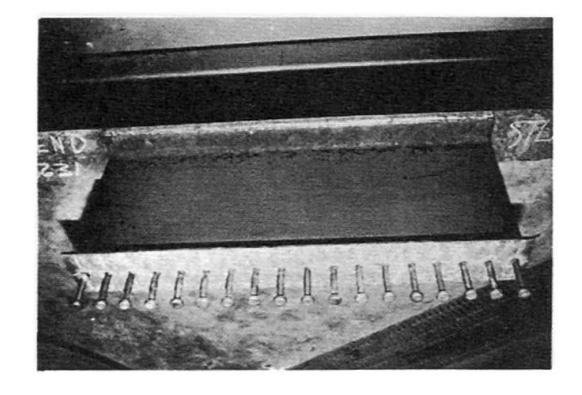
Fig.2 Headed stud arrangement used for phase one

This paper briefly summarizes the results of experiments performed on two full size stub-girders with slabs on ribbed metal decks. The main objective is to study the shear failure mechanism and the ultimate shear strength of stub-girders in relation to specific variables such as the length of the stub, the distance between stubs and other slab-related variables. As the first phase of a continuing investigation, this study considers the special case of stub-concrete connections with headed studs arranged in a single line as shown in Fig. 2.

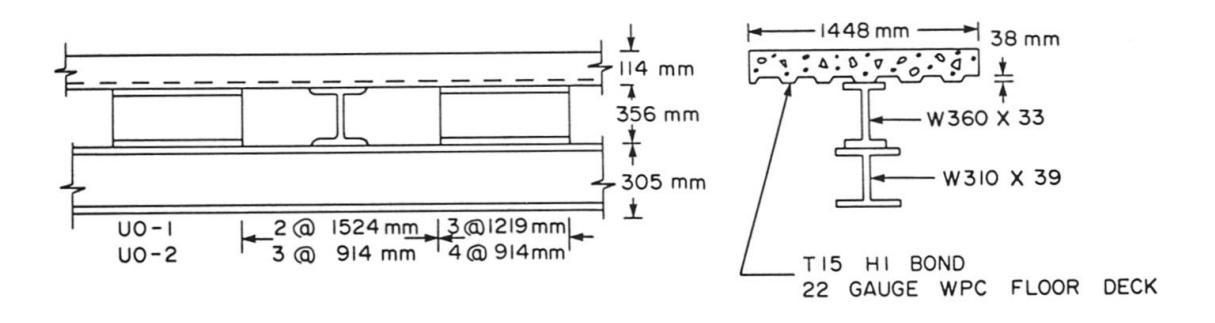
Fig.3 Specimen dimensions

A summary of the geometric properties of the two specimens is given in Fig. 3. The dimensions of the steel beams, the stubs and the concrete slab, which were identical for the two specimens, conformed to those for a stub-girder of 10 to 12 metre span. However, the span of the test beams was intentionally reduced to 7.31 m to induce failure through the stub-concrete connections. While the total length of the stubs was maintained at 3658 mm for both beams, the number of stubs was: three (1219 mm long with 24 studs) for specimen UO-1 and four (914 mm long with 18 studs) for specimen UO-2. Thus specimen UO-1 contained only two interior panels (1524 mm long) whereas three interior panels (914 mm long) were located within specimen UO-2. An 1829 mm long W360 X 33 section was placed at the midlength of each interior panel to simulate a floor beam. It was welded to the primary steel beam and connected to the concrete slab by means of eighteen studs. All headed shear studs were 76 mm long and 13 mm in diameter. For both specimens, the longitudinal reinforcement consisted of eight 13 mm diameter deformed bars whereas the same size bar at 305 mm centre to centre served as the transverse reinforcement. A clear cover of 25 mm was provided between the longitudinal reinforcement and the metal deck.

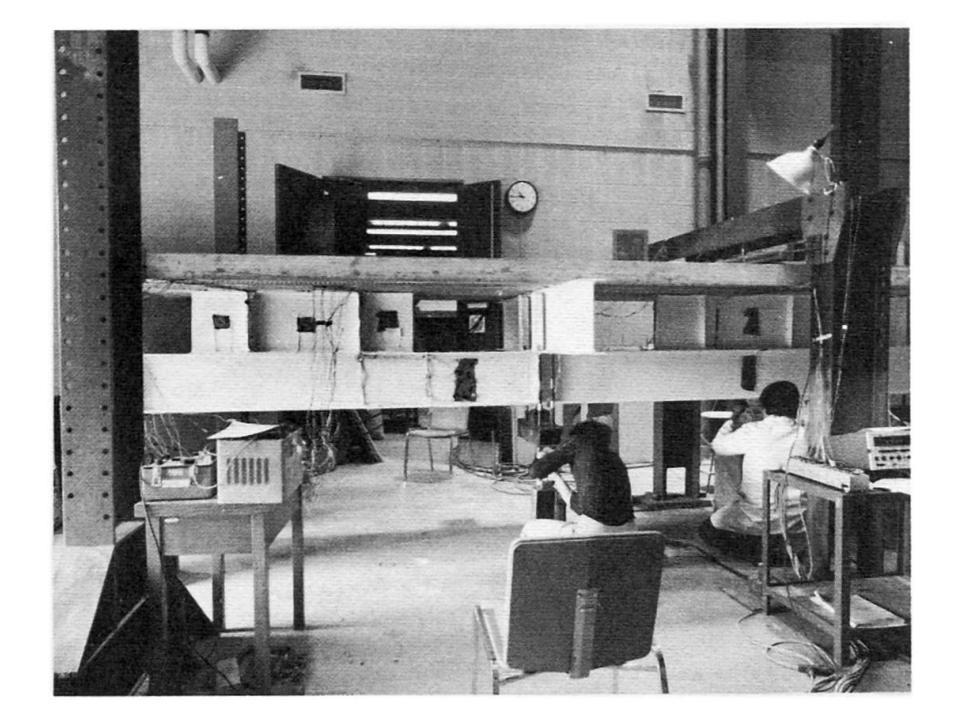
Fig.4 Test set-up

The test set-up used is shown in Fig. 4. Each stub-girder was mounted on load cells which were placed on concrete pedestals at each end of the stub-girder. The concrete slab was laterally braced at the supports and also at mid-span. The bracing system at midspan was based on Watt's mechanism [4] to permit free vertical movement. Vertical loads were applied through the floor beams in order to simulate the loading condition expected in an actual stub-girder system. This resulted in a 2-point loading arrangement for specimen UO-1 and a 3-point loading arrangement for specimen UO-2. The loads were applied by Enerpac hydraulic rams which were located below the test floor. Applied loads on each floor beam was monitored by four 25.4 mm diameter instrumented and precalibrated steel bars. Strains in the steel and in the concrete as well as deflections were recorded.

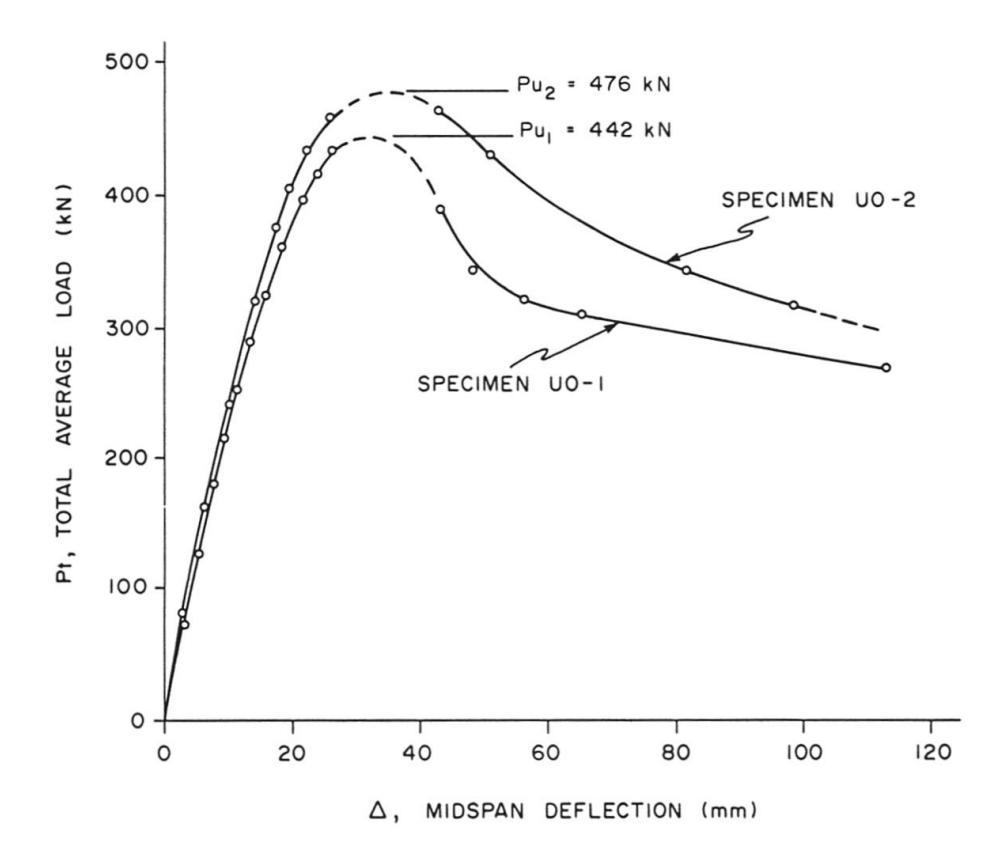
Fig.5 Load-deflection curves

The load vs midspan deflection curves for specimens UO-1 and UO-2 are presented in Fig. 5. For both specimens, the deviation from the initial elastic behavior was due to longitudinal cracking on the underside of the concrete slab on both sides of the end stubs. With increasing load these cracks widened and, eventually, a sudden drop in the load was observed. It is believed that this rapid unloading was caused by sufficient widening of the cracks to allow bending of the headed studs.

After the initial rapid drop, the load-deflection curve exhibited ductile behavior with relatively small reduction in load. This behavior is attributed to the transverse reinforcement becoming effective in restraining further splitting of the concrete. Simultaneous resistance to splitting from the concrete and transverse reinforcement steel was not achieved because the transverse reinforcement was located too high in the slab (near the head of the studs). As indicated earlier, this placement of the transverse steel was dictated by the floor deck and the clear cover requirement for the longitudinal reinforcement. This practical problem needs further study especially if the use of wire mesh is envisaged. Fig. 6 shows the slab failure region over the end stub.

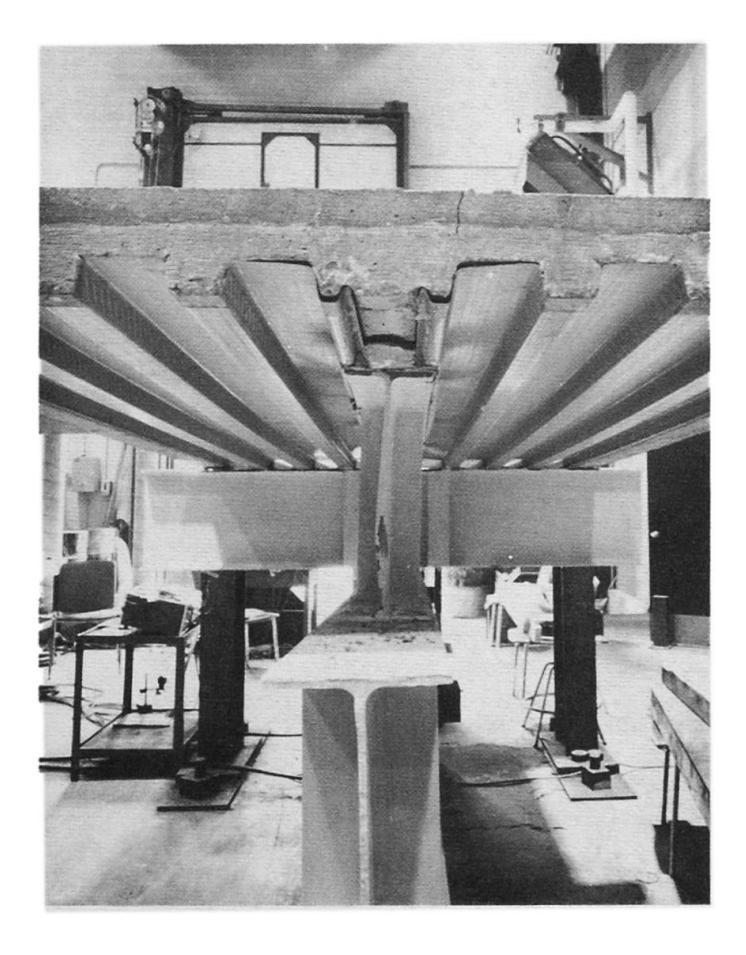
Fig.6 Slab failure region over the end stub

Eccentricity of the compressive force in the concrete slab induced prying forces [5] in the studs on the inner ends of the end stubs and produced compression between the concrete and the flange of the stub at the far ends.

More full-scale tests should be conducted to investigate the effectiveness of different transverse reinforcement schemes such as varying the amount of reinforcement, widening the flute over the stubs or using irregular-shaped reinforcing bars.

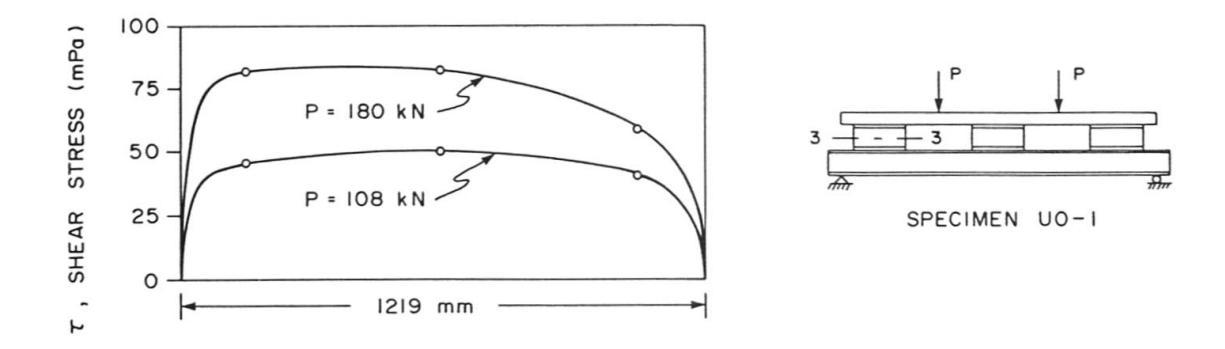
Fig.7 Shear stress distribution across section 3-3

The observed shear stress distribution across one of the end stubs is shown in Fig. 7. The deviation from the basic parabolic shape which occurs at higher loads is believed to be caused by local concrete failure at the tensile (prying) end of the stub. Localized failure could reduce the shear resistance of studs subjected to tension, giving rise to the skewed distribution in Fig. 7. The design equation for headed studs of a conventional composite beam therefore, would not seem to be applicable to the

Using the shear stress distribution across the end stubs at the ultimate load (similar to Fig. 7), the maximum horizontal shear force was calculated for both specimens. This gave an average shear resistance per stud of 26.7 kN for specimen UO-1 and 33.68 kN for specimen UO-2. The maximum capacity that can be developed in shear, based on the CSA standard CAN3-S16.1-M78 [6] for conventional composite design, is 64.2 kN for the high strength concrete used. The difference between the observed and calculated shear resistances is due to several reasons. First, the use of a single row of studs resulted in a wedge action that triggered a somewhat premature concrete splitting along the end stubs. Second, both specimens were subjected to considerable prying. Due to higher prying force induced by the larger open panel in specimen UO-1, the resistance per stud was smaller compared to that of
