Ship Collisions Against Bridge Piers

CHR. OSTENFELD

Chapter 1

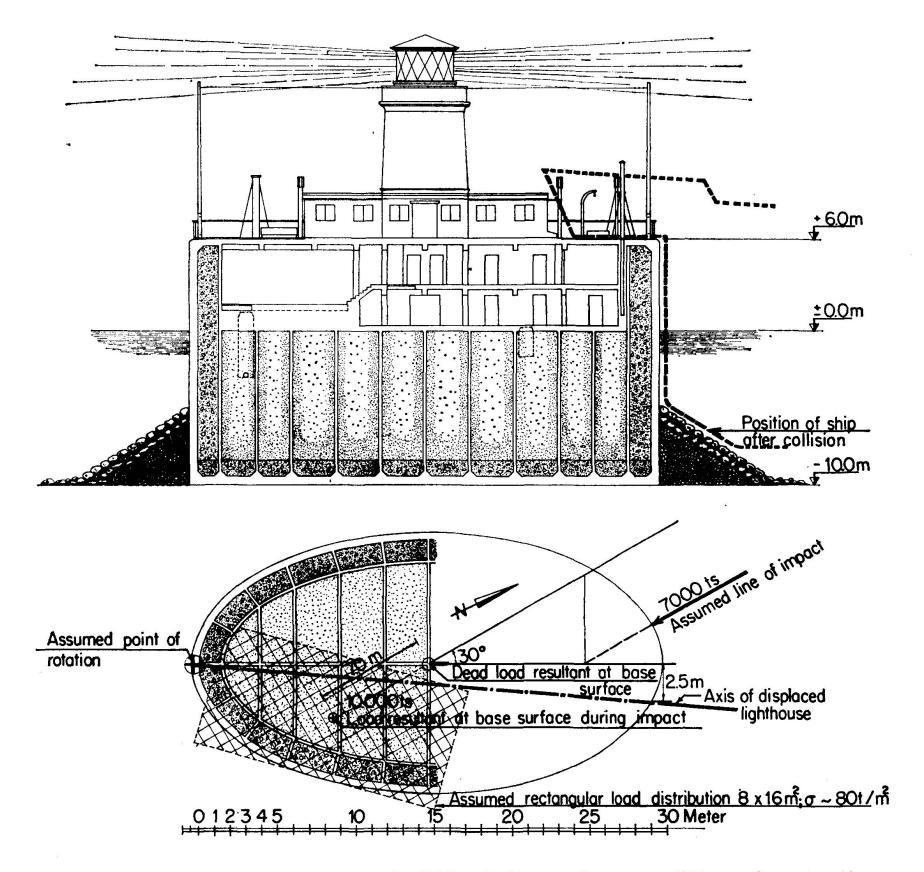
Fig. 1. Drogden Lighthouse, in Øresund, SE of Copenhagen. The plan indicates the ship's line of approach, the displacement of the foundation and the assumed distribution of pressure in the underlying soil at the time of collision.

Northern end of lighthouse (the end involved in the collision) displaced 2.5 m eastward (refer fig. 1). One metre below water level a hole in the concrete resulted, $2.1 \times 2.5 \times 0.7$ m deep, probably caused by a deck in the ship at this level.

Speed, etc.: about 16 knots (8.25 m/sec.); the ship struck the lighthousestructure at an angle of about 30° with the major axis (refer fig. 1).

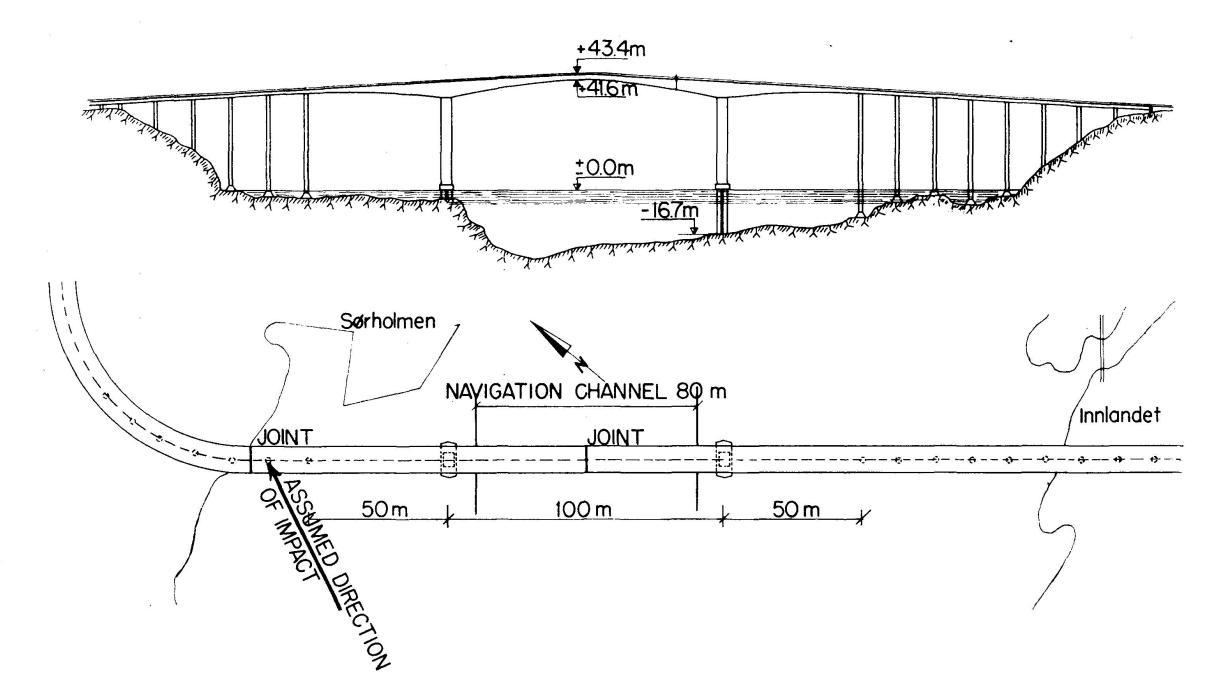
Fig. 2. Sørsund Bridge at Kristiansund, Norway. On the plan is indicated the supposed line of approach of the ship.

The column broke in two places: at the bottom and at the collision-point (the location is not exactly known). The deflection of the column at the collision-point was about 65 cm. The bridge deck was not damaged but was deflected upwards and warped. At a dilatation joint in the deck, located between the column involved and the next landward column, a deformation of 3 cm was observed on one side and 8 cm on the other.

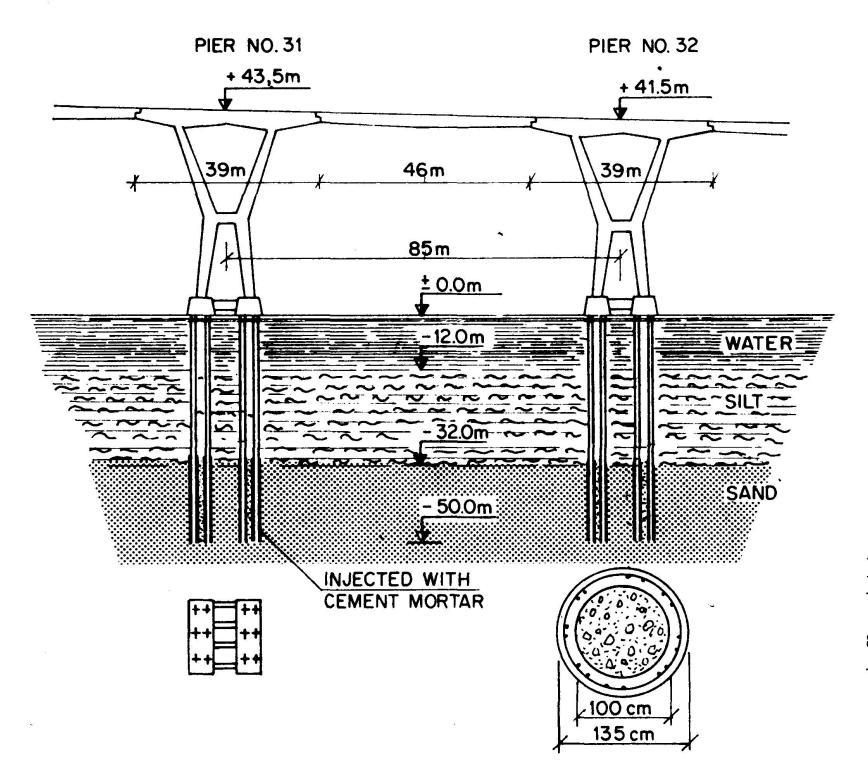
Fig. 3. Maracaibo Bridge, Venezuela. The figure shows the two piers, which were destroyed by the collision.

A pier consists of four reinforced concrete frames, designed as a combined H and V structure. The weight of the pier is about 10,000 t (see fig. 3).

Two piers (Nos. 31 and 32) and their cantilever structures were destroyed (the piles broke). Three suspended spans fell into the water, and several persons perished, driving in motor cars which happened to be on these spans, or during darkness running their cars into the gap. The damage is estimated at about 5 million dollars.

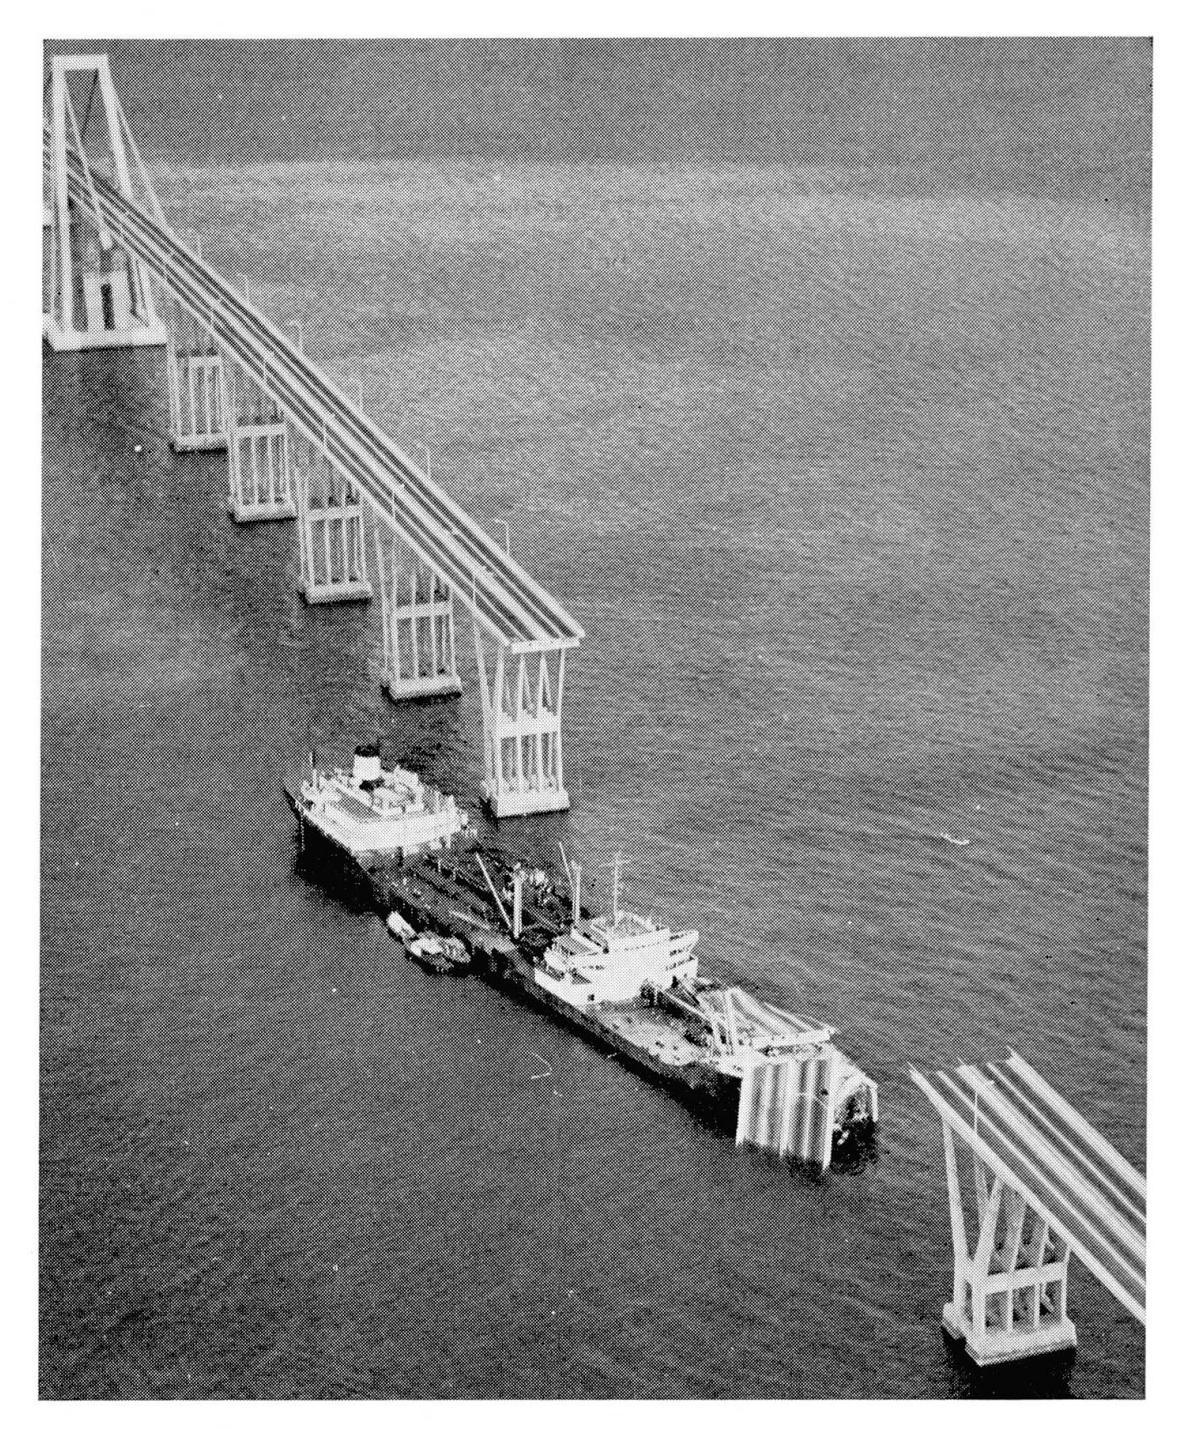
Photo 1.

Suspended spans fell down upon the bow of the ship and considerable damage resulted. The ship sprang a leak, it remained afloat, however (see photos 1 and 2).

Maracaibo bridge after the collision.

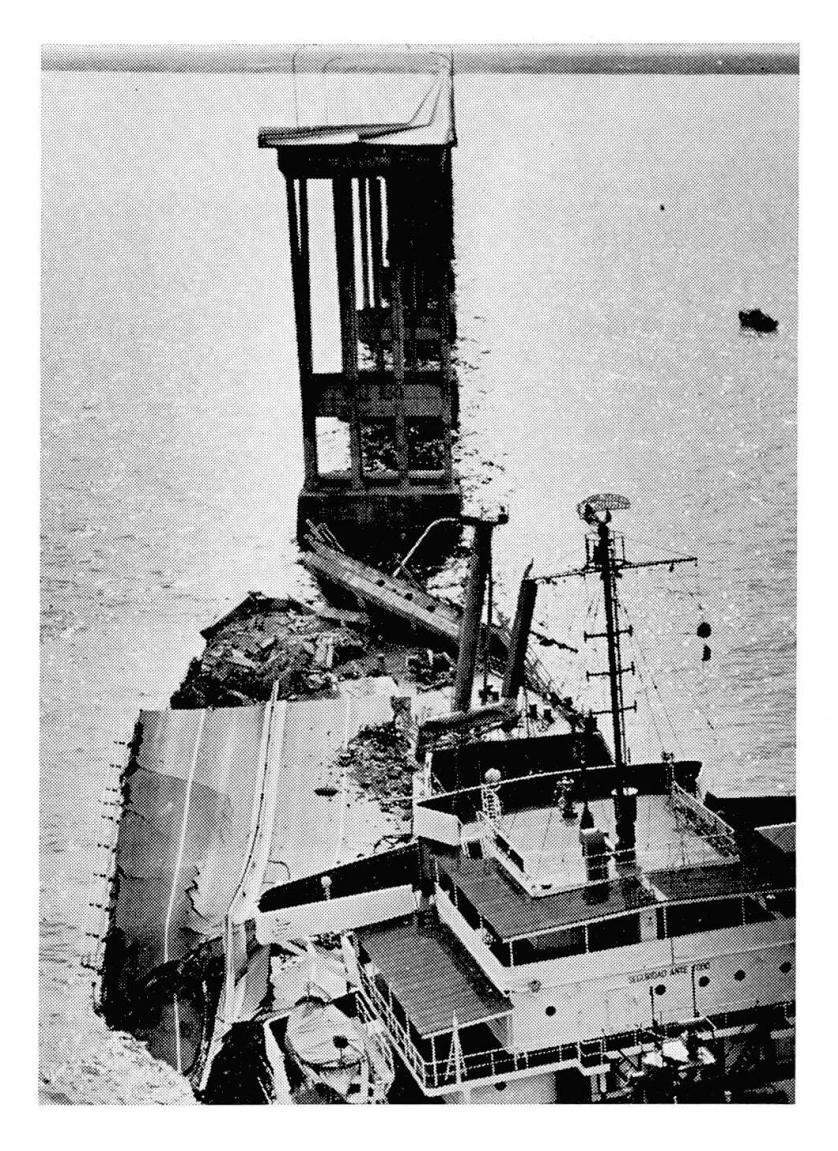
Photo 2.

Maracaibo bridge after the collision.

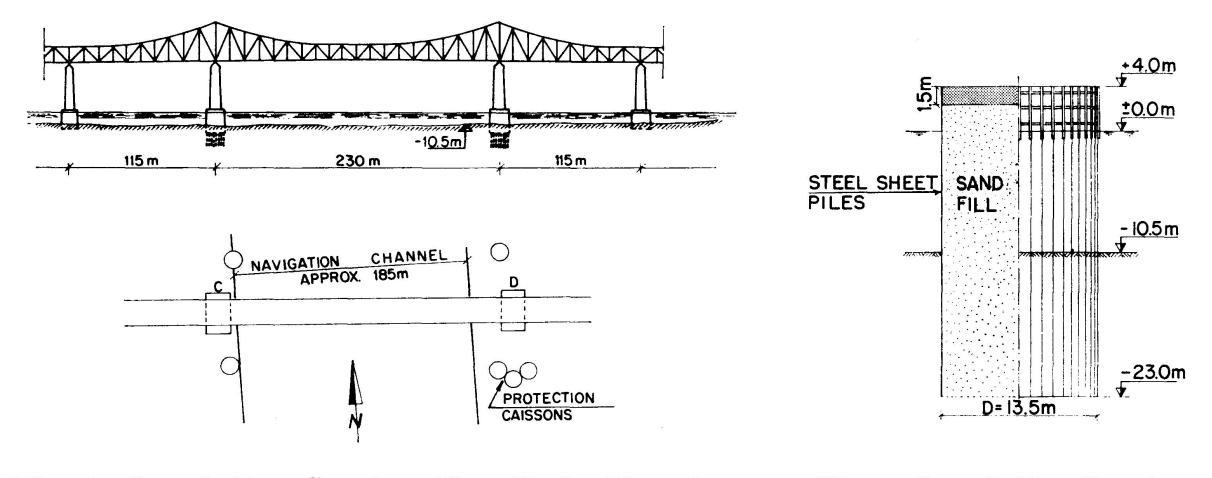
Fig. 4. Outerbridge Crossing, New York. The plan shows the location of the protection caissons in relation to navigation channel and piers.

Fig. 5. Outerbridge Crossing, New York. Protection caisson.

For the Goethals Bridge, located north of the Outerbridge Crossing and likewise crossing the Arthur Kill Strait, it is intended to build protecting caissons corresponding to the caissons for the Outerbridge Crossing. Rock is to be found at a depth of 5—6 m below the sea-bed, however, and the caisson is anchored to the rock through a number of bolts reaching from the concrete slab down into the rock.

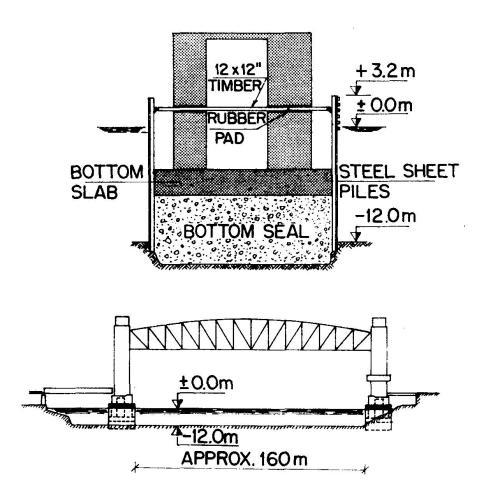
Fig. 6. Lift bridge across Arthur Kill, New York.

channel stand in about 12 m of water. The piers were built within cofferdams of steel sheet piles, which were left in place, constituting permanent protections; they reach about 3 m above water level. Bracing of the sheet piling against the piers is established by timber, and 3" rubber padding is used. On the outside of the sheet piling normal timber fendering is furnished.

Just north of the Goethals Bridge a lift bridge with a free span of about 160 m has been built recently (refer fig. 6). The piers next to the navigation

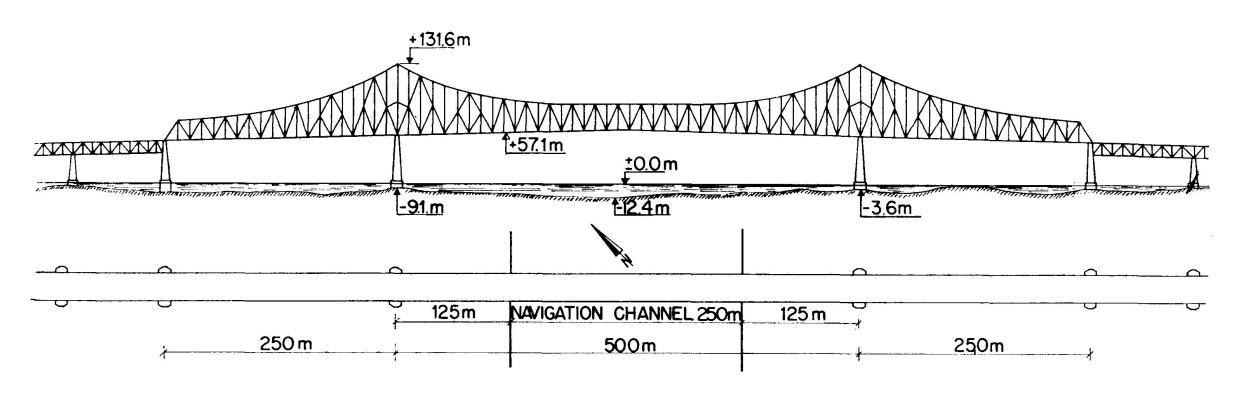
A new bridge across the Delaware River: the Chester-Bridgeport Bridge has now been planned, the spans being 250—500—250 m (see fig. 7).

Fig. 7. Chester-Bridgeport Bridge, Philadelphia.

The present navigation channel has a width of 250 m, one half of the navigation span; it is found desirable, however, to have it extended to a width of 300 m. At normal high water the depths of water in the vicinity of the two piers are 5.6 m and 11.4 m on the east side and the west side respectively. As a consequence, the pier on the east side is protected against impact from large ships by shoal water. On the west side rock is to be found both upstream and downstream of the pier, preventing extension of the navigable channel beyond a limit of about 100 m from the pier, so that collision should only be possible in case of faulty manoeuvre. However, as a further precaution, it is proposed to construct a protective fill around the westerly pier to simulate the shoal conditions at the easterly pier. In considering the necessary protective measures, it has been assumed that a large ore-carrier might run into the pier from various directions and at speeds varying within the range of 1.5-6 knots. The weight of the pier (without any deduction for buoyancy) is about 40,000 t. Hence, on the basis of the calculations the stability of the pier should not be endangered. On the other hand, damage to fenders and to the pier might result, the extent thereof depending on circumstances.

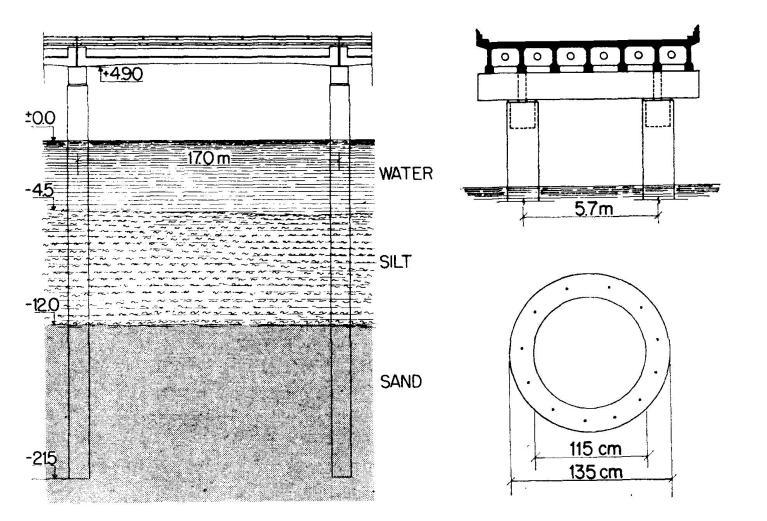
Fig. 10. Pontchartrain Bridge at New Orleans.

3 trestles were hit by the collision, 4 bridge deck elements fell into the water. Two of the trestles were renewed (new piles driven), the third was repaired. Four new bridge deck elements were erected. Total cost of repair about 150,000 dollars.

Due to the frequent collisions (five up to now) the repair service of this bridge is exceptionally well organized. Piles and deck elements are ready in stock. A floating derrick-crane drives the piles and erects the elements. In this particular case the bridge was ready for use within five days.

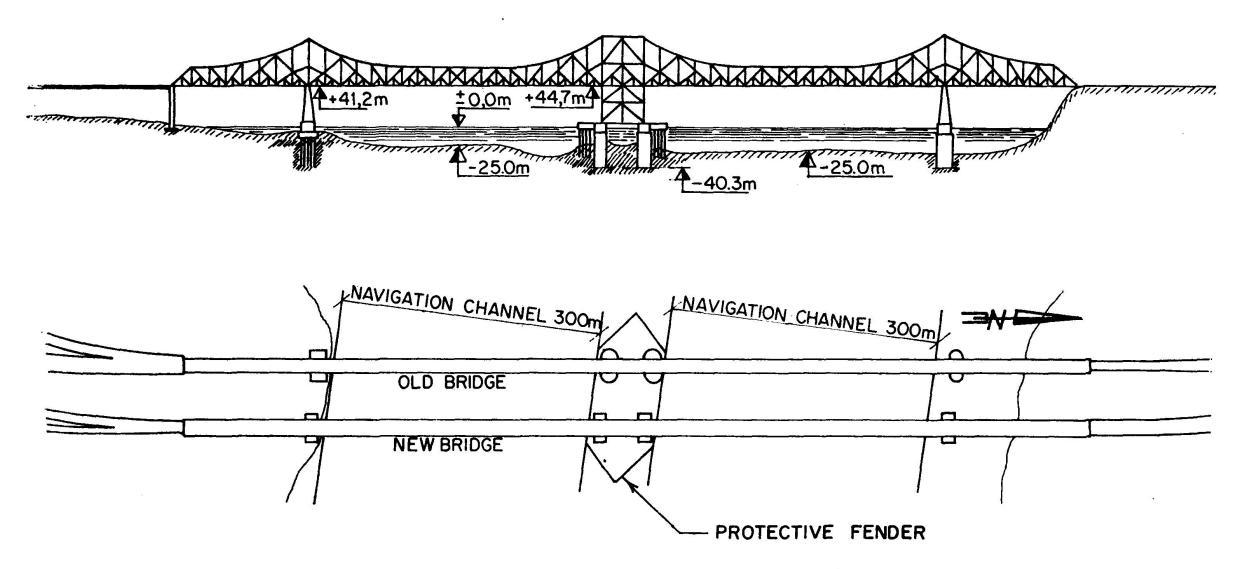
The central pier for the old bridge has a superstructure (tower) of steel, and the substructure consists of four cylindrical reinforced concrete caissons, 12 m diameter. The water depth is about 26 m, and the caissons are founded on rock at a depth of 40 m.

Fig. 11. Carquinez Strait Bridge, California.

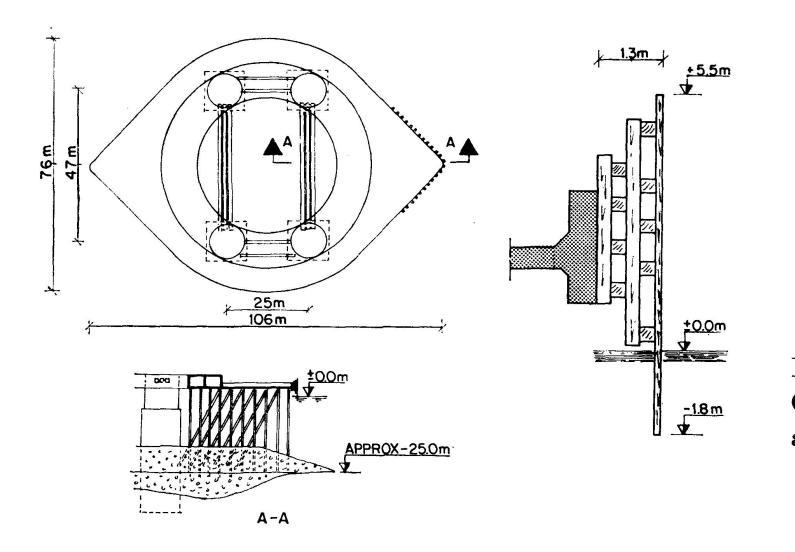
This permanent protection, refer fig. 12, consists of a heavily reinforced horizontal concrete slab, supportéd on vertical piles and rakers, brought down

Fig. 12. Carquinez Strait Bridge, California. Pier protection, plan and section, and detail of fender.

into a thick layer of rock debris. The concrete slab is interconnected with the four reinforced concrete caissons, so that the construction in its entirety functions as one unit with a view to absorption of impact. The outer edge of the concrete slab is relatively thin, it is assumed that this part of the slab will be crushed and, partly, be forced into the ship; in this way adequate provision is found to have been made for absorbtion of the greater part of the kinetic energy. Moreover, the concrete slab is provided with a fender, consisting of vertical and horizontal timber with a total depth of about 1.3 m. When the new bridge was built, in 1958, the steel tower of the central pier was founded on two rectangular reinforced concrete caissons, each 33×16 m. A protecting structure corresponding to the protecting structure for the old bridge was provided also for the new bridge, and the two protecting structures are now constituting one unit.

As far as is known the fender structures have been involved in two collisions, the first time caused by an unknown ship, and the second time, in 1963, by a barge in tow, in both cases a slight damage to the fender structure resulted.

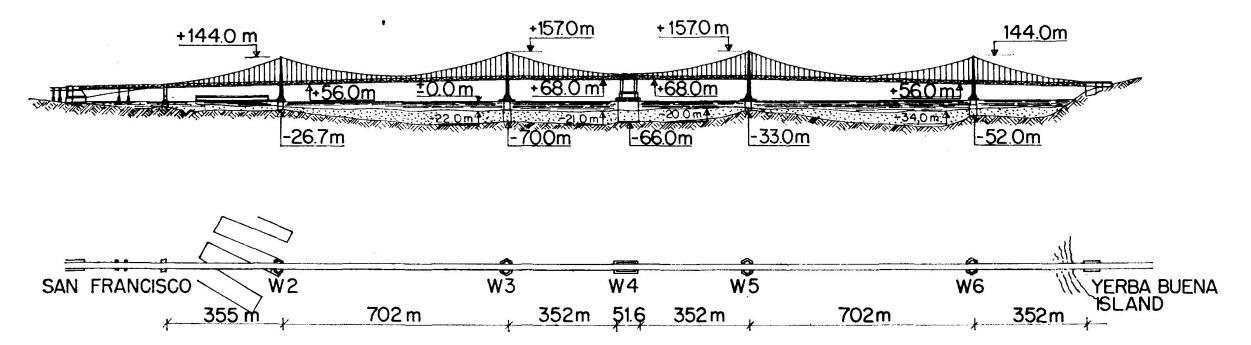
This bridge, crossing the bay between San Francisco and Oakland, has a total length of about 6.5 km and consists of two suspended bridge sections, each having a main span of about 700 m, cantilever spans of maximum about 425 m, and a number of girder spans (refer fig. 13). In the suspended bridge

Fig. 13. San Francisco-Oakland Bay Bridge, California.

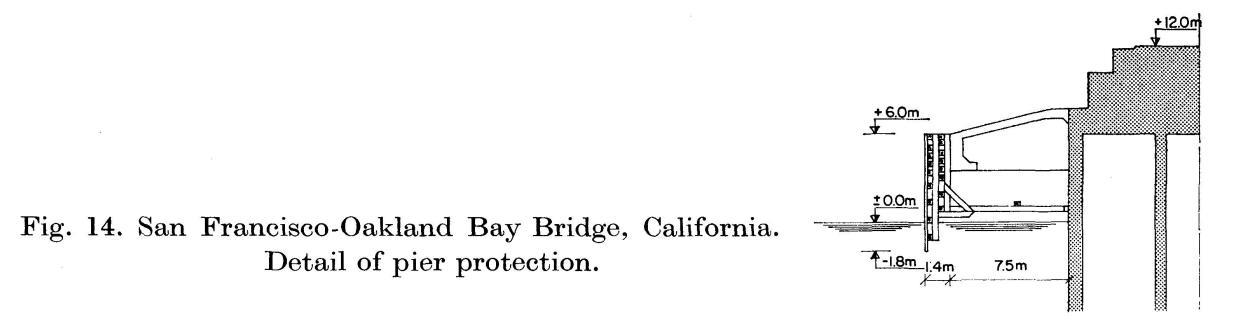
The protecting structure (refer fig. 14) is a ribbed concrete slab cantilevered 7.5 m from the ends of the pier and 3.6 m from the sides. To the concrete slab is attached, moreover, a timber fender structure, consisting of several layers of vertical and horizontal timber with a total depth of about 1.4 m, reaching from about 6 m above to about 2 m below water level. Hence, the total distance the ship has to pass before reaching the pier proper will be about 9 and 5 m respectively, whereby a considerable amount of kinetic energy can be absorbed.

In the past, ships have collided with piers W3 and W5 in a number of cases. On W3 part of the fenders has been destroyed on two occasions through impact from an unknown ship. W5 has been involved in collisions three times, hit at the same place, whereby some damage to the fenders resulted: in 1949 an oiltanker collided with the pier, in 1957 a maintenance ship belonging to the navy, displacement 1700 t, ran into the pier in a dense fog, and in 1963 it was hit by an unknown ship. None of these collisions resulted in damage to the protecting concrete slab.

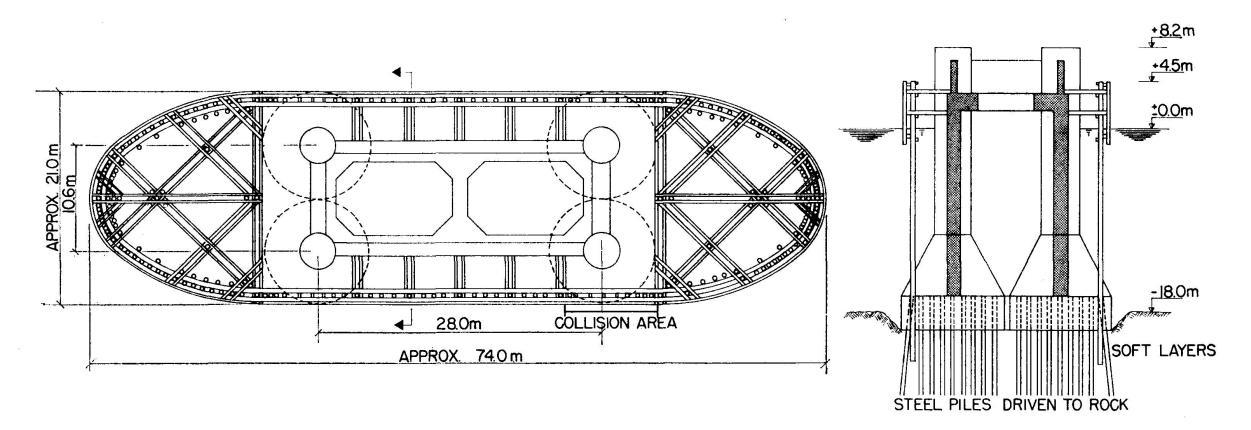
Fig. 15. Richmond-San Rafael Bridge, California. Pier protection, plan and section. Note particularly the extent of the protection in comparison to the four slender bridge piers.

embracing the entire circumference of the pier, refer fig. 15. In principle the protecting structure is detached from the shafts of the columns and consists of horizontal and vertical timber reaching from about 4.5 m above to 1.5 m below water level and attached to vertical piles driven down into the seabottom. Upstream and downstream of the pier, where the risk of collision is greater, the protecting structure reaches about 20 m beyond the columns.

The part of the protecting structure that was hit (opposite to a pier shaft) was completely destroyed. The damage amounted to about 23,000 dollars. The pier suffered no damage.

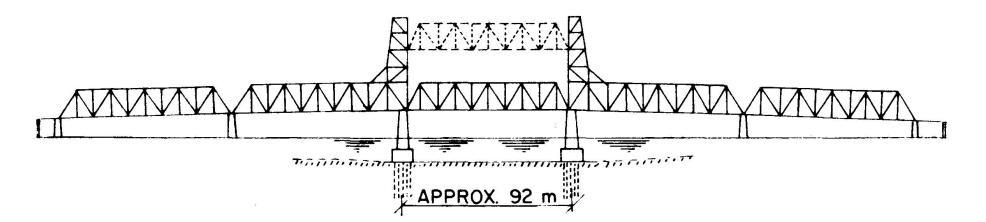
The bridge has five main spans, the central span, bridging the 80 m wide navigation channel, being a lift span. The piers flanking the navigation channel have a base area of about 18×8 m. They stand in about 13 m of water and are supported on piles. The weight of a pier, including shaft, is about 5000 t.

Fig. 16. San Mateo-Hayward Bridge, California (old bridge).

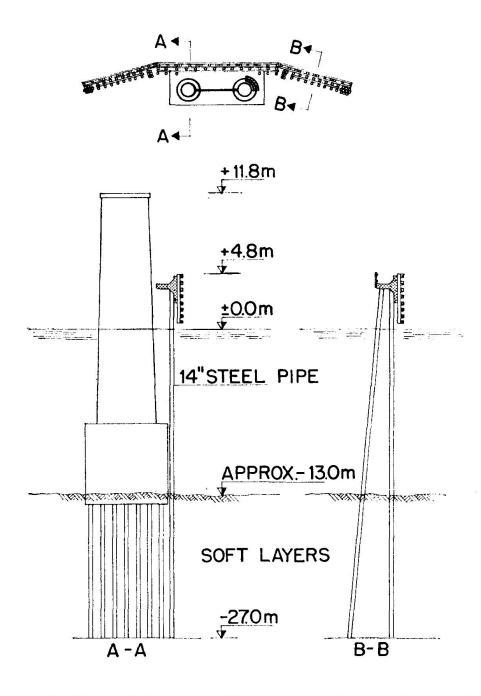
On the channel side of the piers they are provided with a protecting structure (see fig. 17) extended into guiding structures, about 18 m upstream and downstream of the pier. The protecting structure which is detached from the pier, consists of horizontal and vertical timber attached to a T-shaped concrete slab, supported on pile trestles consisting of a vertical pile and a raker of 14" steel tube, driven down to a depth of about 27 m, i. e., about 14 m into the ground. Moreover, a group of piles is placed at each end of the protecting structure.

Fig. 17. San Mateo-Hayward Bridge, California (old bridge). Plan and section of pier protection.

The part of the protecting structure directly involved in the collision was totally destroyed. The damage amounted to about 75,000 dollars.

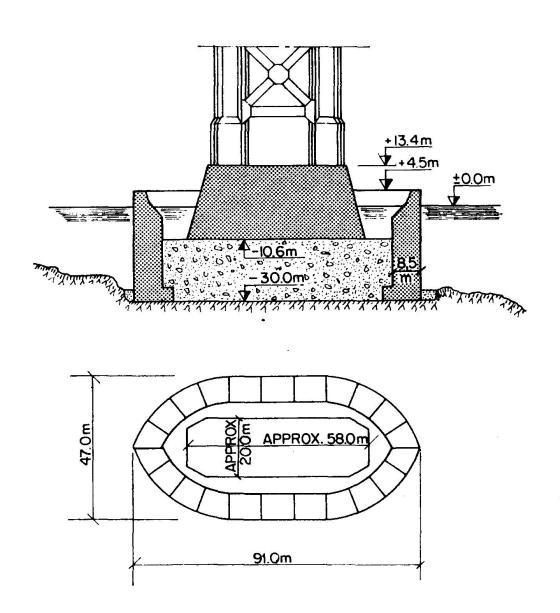
The pier construction, refer fig. 18, includes an external concrete cofferdam, with an about 8.5 m thick wall, a sealing layer about 20 m deep, and the pier proper, reaching from level about -10.6 to +13.4 m.

Fig. 18. Golden Gate Bridge, California. Plan of South Tower with concrete wall which was acting as cofferdam during the construction period and which is now acting as permanent protection.

The cofferdam is of approximately elliptic shape, the outer dimensions being about 91×47 m. The concrete was placed under water, in a movable steel shuttering, and carried up to level +4.5. Thereafter, the 20 m sealing layer was placed as under-water concrete. The water inside the concrete wall was pumped out, and the pier proper was concreted in the dry. The cofferdam remains in place and constitutes a very effective protecting structure for the pier proper. The weight of the cofferdam is about 135,000 t, whereas the weight of sealing layer + pier amounts to about 115,000 t.

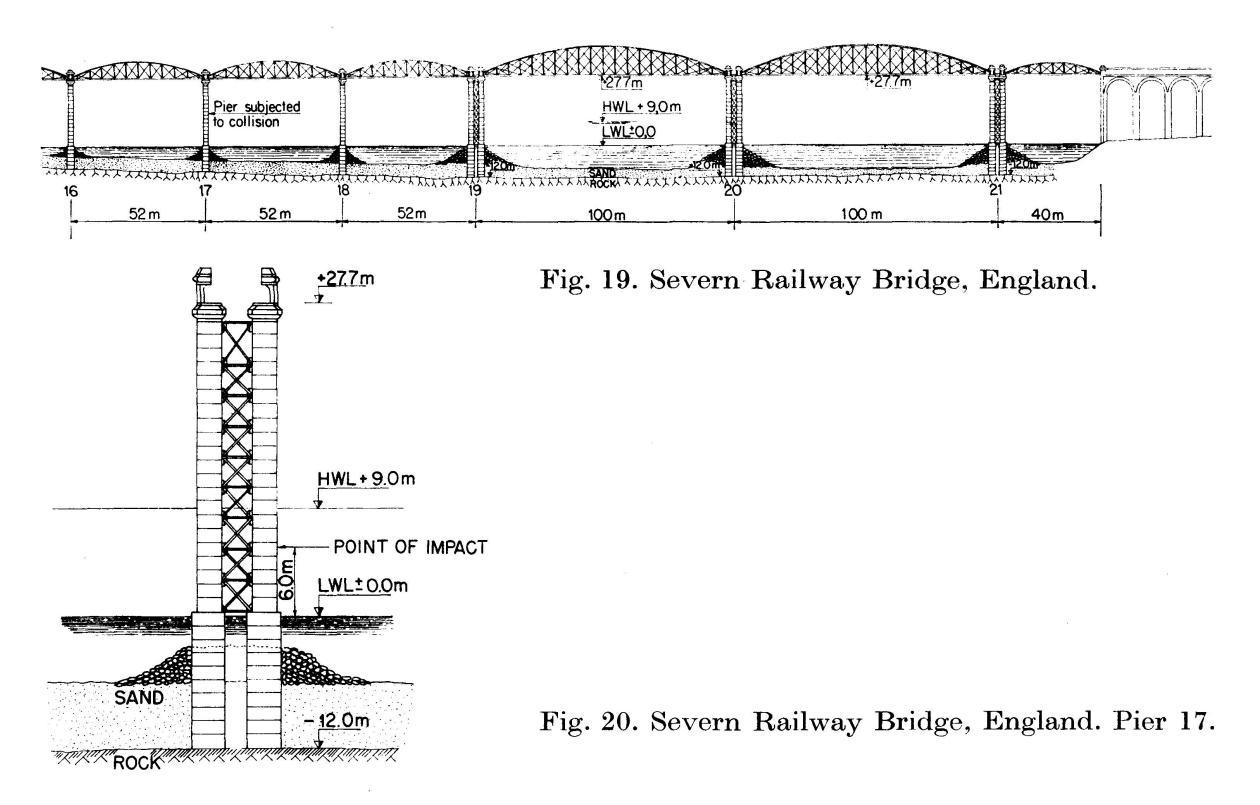
The bridge was built in 1875—1879. The superstructure is of old-fashioned design: Parabolic steel trusses. Clear height under the bridge about 20 m, above high water level (tidal changes amount to about 10 m). Most of the piers, including the pier involved in the collision, consist of two cast iron cylinders, of diameter 2.1 m, filled with "Roman Cement" (see fig. 20). These cylinders stand on two similar cylinders of 2.7 m diameter, carried down to

rock, about 12 m below low water level. A stone filling is placed around the lower cylinders. The upper cylinders are mutually braced, interconnected by a cast iron lattice system.

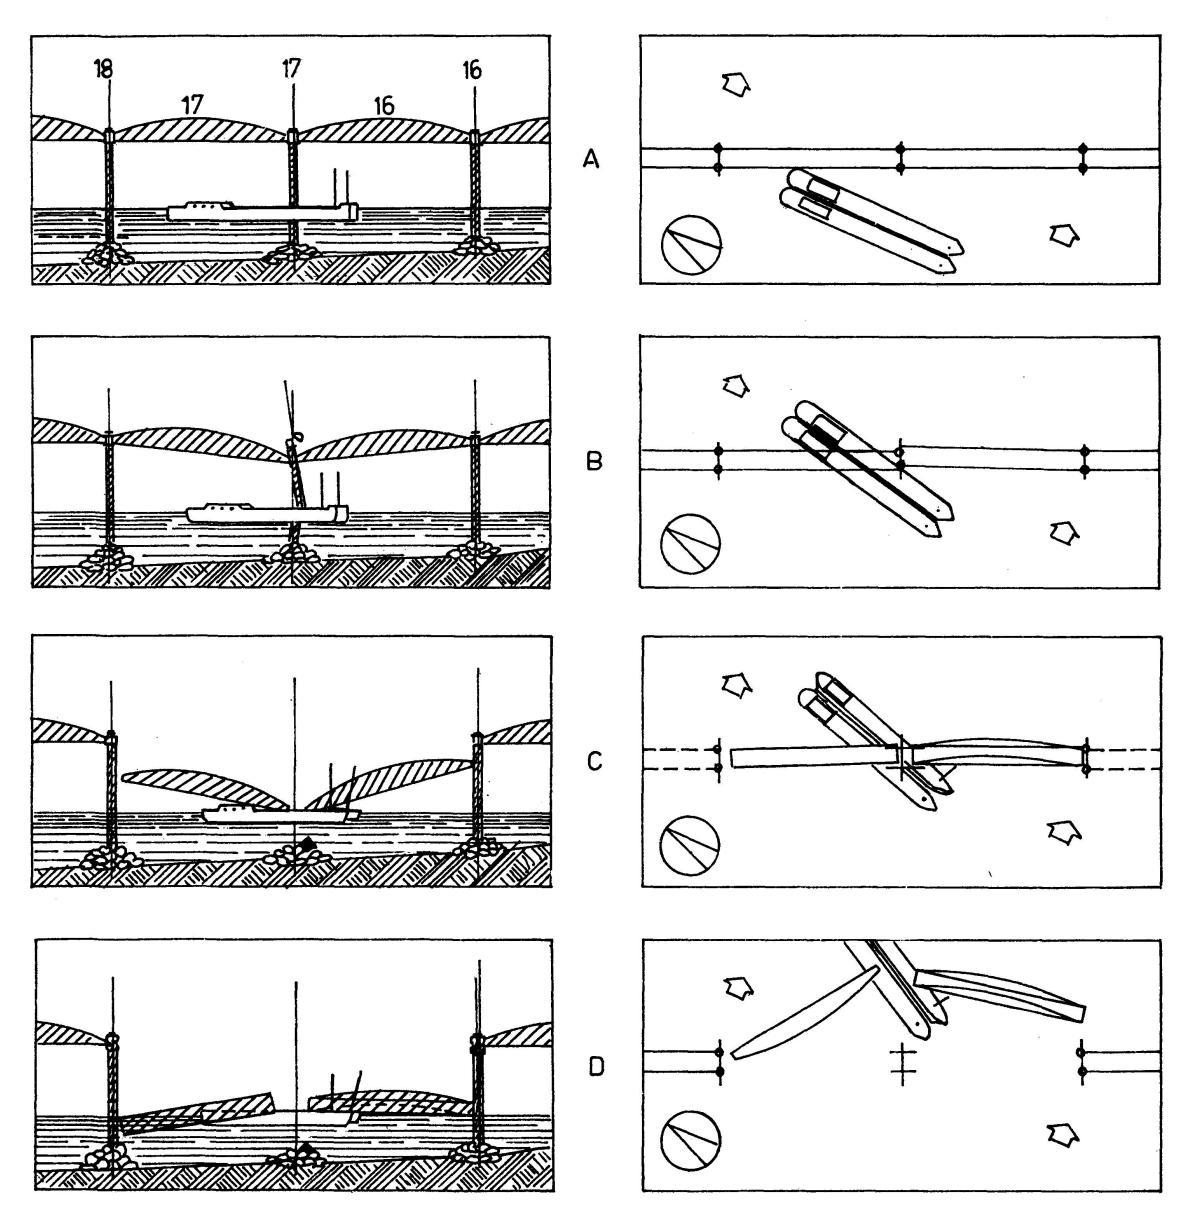
Fig. 21. Severn Railway Bridge, England. Reconstruction of events.

Fig. 21 illustrates the results of a thorough investigation undertaken by Peter Mason, Consulting Engineer. As a matter of course, Peter Mason undertook, among other investigations, a calculative analysis of the impact, and found — quite naturally — that the pier could not take any impact of importance.
