## 4. Kaitavesi Bridge, Tampere (Finland)

Owner:	Finnish Roads and Waterways Administration (RWA)
Design:	RWA and Insinööritoimisto Pontek Ky
Contractor:	Perusyhtymä Oy
Construction Work Duration:	10.5 months
Completion:	1983

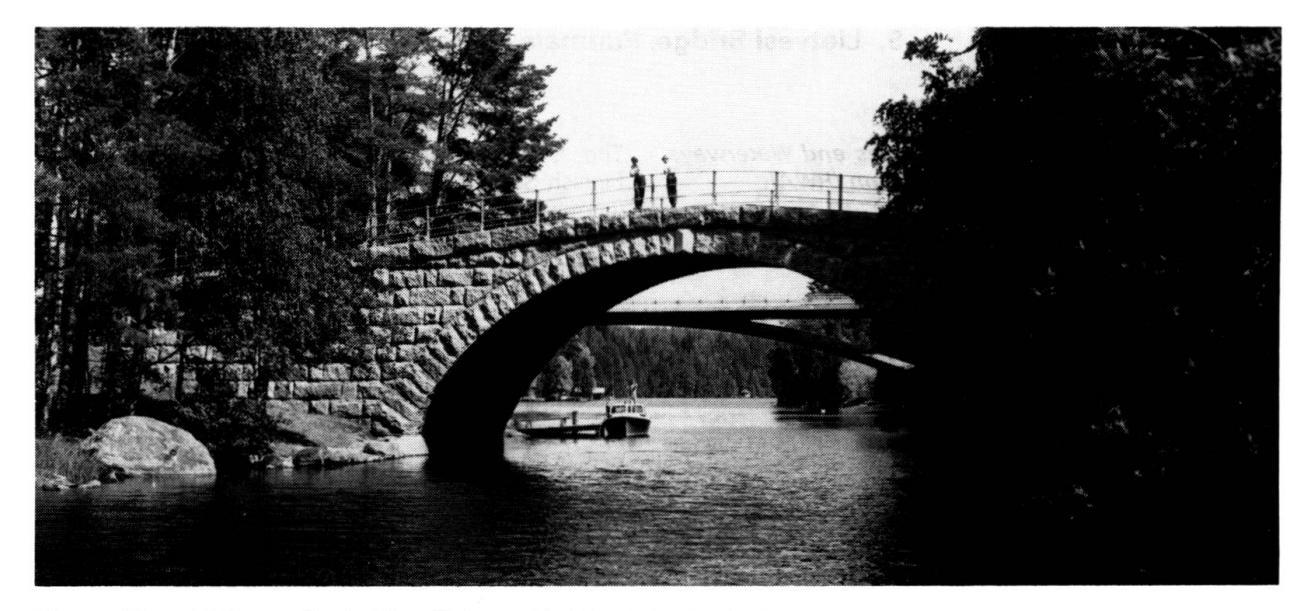
Fig. 2 The old Aunessilta bridge. Kaitavesi bridge is in the background

Aunessilta bridge, constructed in 1899, situated 25 km northeast from the center of the town of Tampere, is one of the most beautiful stone vault bridges in Finland. Its span is 19.0 m wide at water level and the clear headway at midspan is 6.0 m from flood level. The bridge is in very good condition, however, it was too narrow for the present traffic. Its horizontal clearance is only 4.6 m, and sight distances at the bridge are too short due to the bulging shape of the upper surface of the bridge.
