7. Fujigawa Bridge Rehabilitation Project (Japan)

Owner:	Shizuoka Prefecture
Contractor:	
Substructure:	Sumitomo Construction
Deck remplacement:	Japan Bridge
Superstructure:	Yokogawa Bridge Works
Work's duration:	6 months
Date of repair:	1987 – 1988

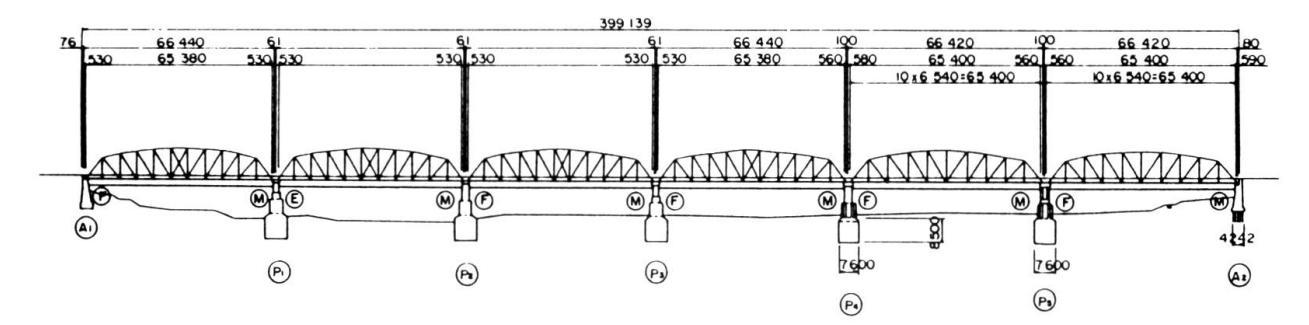
Fig. 1 Elevation

The Fujigawa Bridge, completed in 1924, over the Fuji River on Route 1 is a bridge with six-span curved chord pratt truss having a bridge length of 300.1 m, roadway width of 7.3 m and span of 65.4 m (Fig. 1). Route 1 is the most important road in Japan, and 60 years after completion of the bridge, the daily traffic flow was 21 000 vehicles, though bypass roads had been completed upstream and downstream of the bridge.

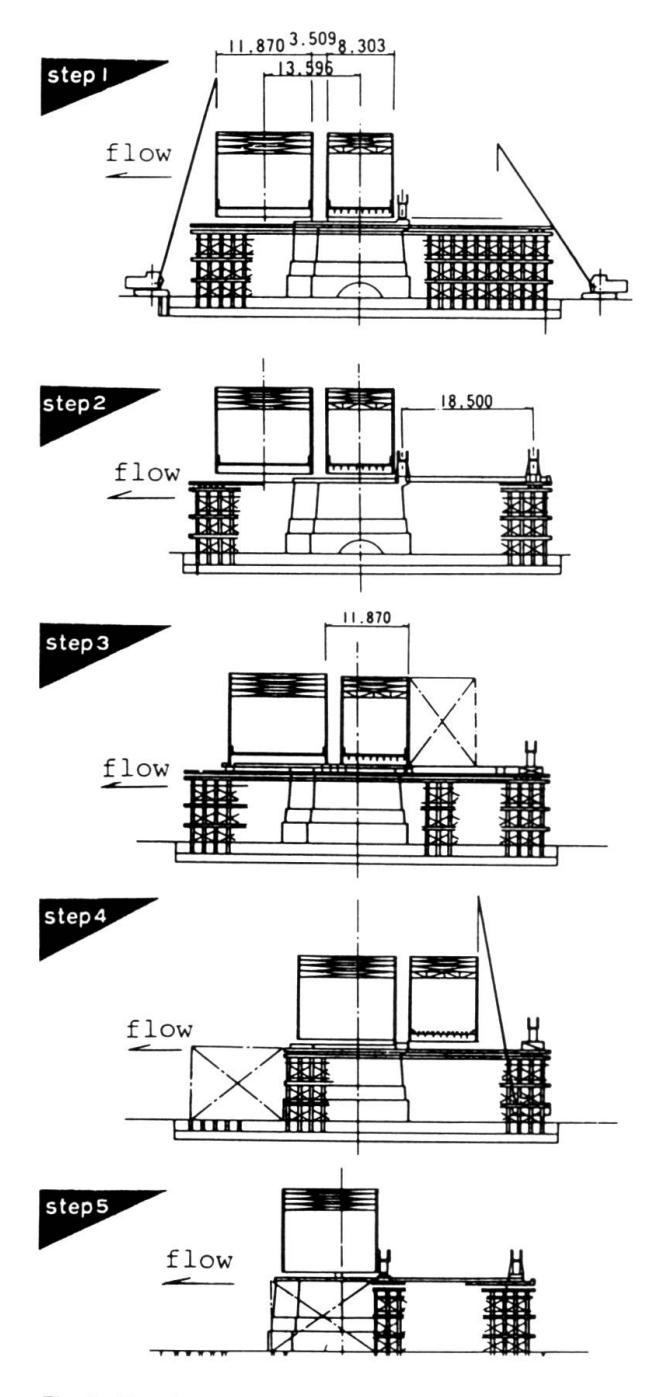
Fig. 2 Erection sequence

The superstructure replacement procedure is as follows (Fig. 2):

- step 1. Make foundation for erection work.
 - Assemble bent for assembly and lateral transfer. Assemble new superstructure along side of

existing bridge.

Concrete deck is finished.

- step 2. Two span of walkway bridge is transferred upstream to make room and replaced by temporary walkway bridge.
- step 3. Lateral transfer equipment are set in place. Two span of new and old superstructures are lateral transferred separately upstream (Fig. 3).
- step 4. Disassemble existing superstructure. Disassemble assembly bent.
- step 5. Lateral transfer walkway bridge to original position.

Disassemble lateral transfer bent.

For widening on the two spans to the right bank side, the roadway could not be widened by just adding stringers because the original bridge was a through truss. Because of this, it was decided to replace the bridge with the same type of truss (curved chord pratt truss) having wider floor beams. According to the replacement procedure, a new bridge was erected along the existing bridge, and the deck work, pavement work and painting work were carried out for the new bridge. Then, the bridge was laterally transferred in place of the original bridge while the traffic was stopped for a short period. A walkway bridge alongside the bridge will be also laterally transferred in the process.

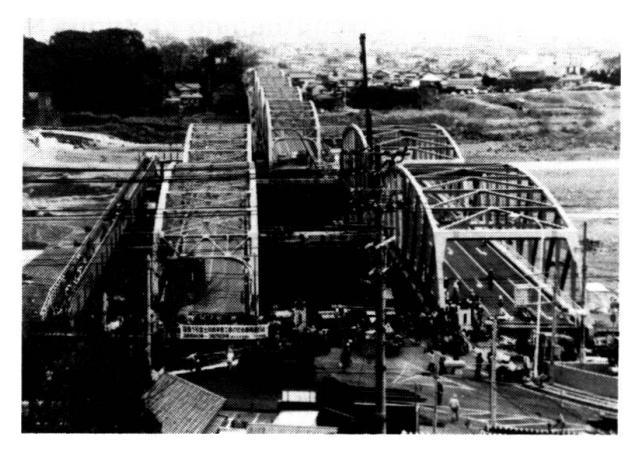
Fig. 3 Lateral transfer

The replacement of the bridge after assembly, deck and pavement completed required the handling of a large weight (830 tons/series). But the lateral transfer method was still capable of moving the superstructure with the least period of traffic stop. The lateral transfer procedure took 60 hours but a considerable time was taken for setting and anchorage of bearings. This was due to the time required for opening anchor holes and bearing mortar to harden. With some modification and improvements, it may be possible to reduce the time. The lateral transfer itself took only a short time with the up-to-date equipment that was employed.
