Assessment of a Bow-String Bridge 50 Years Old in Pavia

Evaluation d'un pont de type bow-string de 50 ans à Pavie Beurteilung einer 50-jährigen Stahlbeton-Stabbogenbrücke in Pavia

Giorgio MACCHI Prof. of Struct. Eng. University of Pavia Pavia, Italy

Gaetano NOCCA Consulting Engineer Pavia, Italy

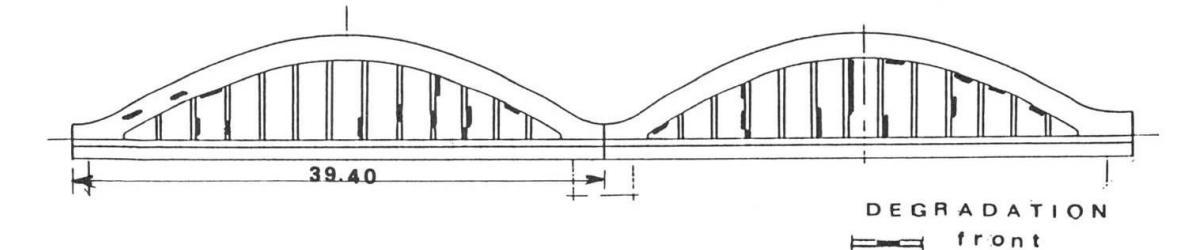
Built in 1932, the bridge (Fig.1) has two spans of 38 m, with a bow-string statical scheme, a popular structure in the 30ies.

Fig.1. The bridge in Pavia and deteriorated parts in elevation

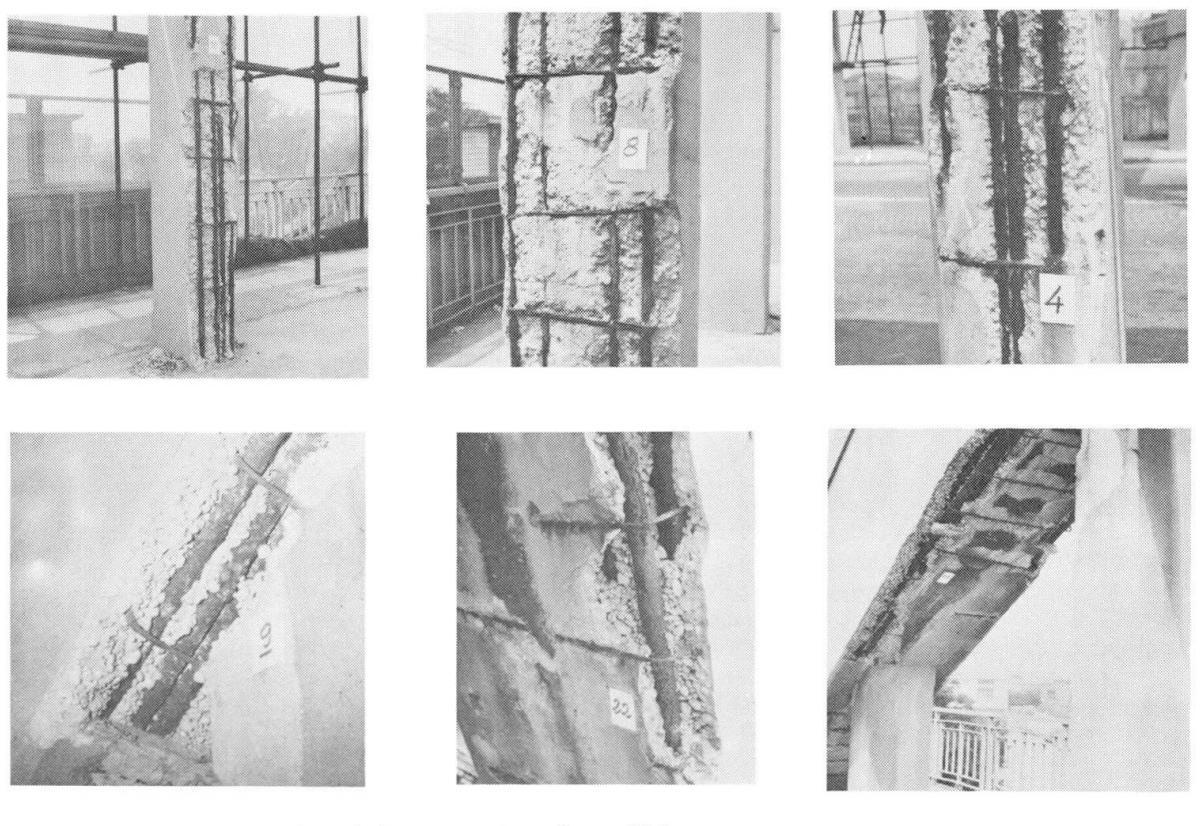
If the deficiencies were obvious in the grid of the superstructure, they were not evident for the main resisting elements of the bridge, because of the great preminence of permanent loads. However, a dramatic spalling of concrete and corrosion of reinforcement (Fig.2) led to the need of a deep diagnosis for the assessment of the residual carrying capacity and for decisions about its possible repair or necessity of replacement.

Fig.2. Corrosion of reinforcement and spalling of concrete on various elements of the bridge

The dramatic spalling of concrete, mainly in vertical elements, as shown by Fig.2, is in complete agreement with the description of the phenomenon given in literature: the expansion of steel due to oxidation creates a pressure causing the spalling of the concrete cover; and oxidation is due to the destruction of the passivation layer caused by the carbonation of concrete.

At the time of the diagnosis the corrosion was already in progress on most reinforcing bars of the vertical tendons (all bars being disposed near to the external surface).

A reduction of 40% of the initial section of one bar has been observed locally; this value cannot obviously be generalized, but it caused a serious concern for the safety of the structure, because the progress of corrosion process in time cannot be estimated at present with reliable models.

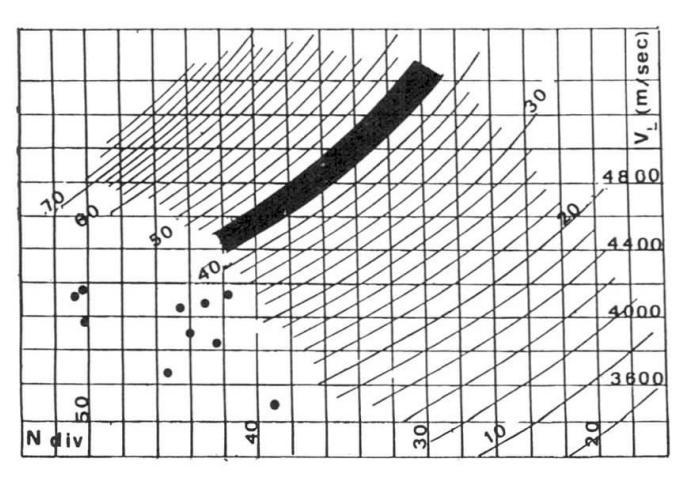
Fig.3. Decrease of ultrasonic pulse velocity for increasing path length (detecting intermediate cracks

Fig.4. Concrete strength from hammer rebound index (sclerometer Schmidt)and ultrasonic pulse velocity (m/sec.). Shaded area is drilled core strength.

Non-destructive testing shall combine hammer rebound (Schmidt sclerometer) with ultrasonic pulse velocity (the RILEM SONREB method, Fig.4), because the first procedure is sensitive to superficial hardening due to carbonation, and the second one is sensitive to microcracking.

The detection of cracks and the elimination of their effects on measurements has been obtained by measuring the speed on different lengths on the same line (Fig.3); the highest values of speed have been retained as a property of the uncracked material.

The values of non-destructive tests are compared with the strength obtained on drilled cores, in the diagram SONREB (Fig.4).

The experimental points are plotted on the standard chart (the measurements in the damaged areas have been excluded); the band 42 to 46 MPa of the drilled core strength has been shaded.

It clearly appears that all the experimental points fall out of the area calibrated for new concretes. It means that the hammer rebound is measuring a skin hardness which is not correlated in the usual way with E modulus and strength, and this is due to the carbonation of concrete.

On the other hand, the ultrasonic velocity seems to underestimate the strength, perhaps due to a microstructural damaging of the old concrete. We cannot state anything of this kind at present; nevertheless, a warning is necessary: the use of non-destructive testing requires a special calibration for old structures.

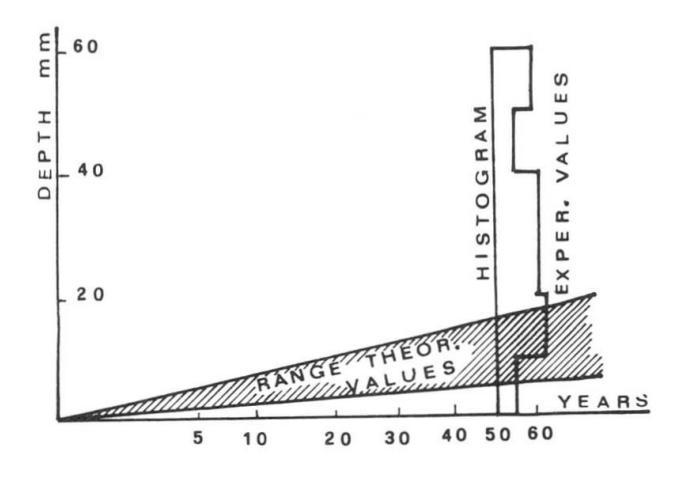
The observed depth of carbonation was variable, but by far larger than expected according to the existing knowledge.

The measured values are plotted in Fig.5, and compared with the curve given in [10] for the development of carbonation with time.

Such unexpected level of the phenomenon cannot be associated with a bad quality of concrete; the strength was in fact exceptionally high for the time.

Fig.5. Carbonation depth vs time; plots indicate measured values.

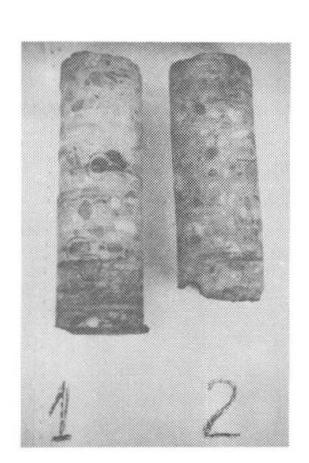
Fig.6. Drilled concrete cores.
