| Zeitschrift: | IABSE reports = Rapports AIPC = IVBH Berichte |
|---|---|
| Artikel: | Performance assessment of cap-column joints under seismic loading |

Performance Assessment of Cap-Column Joints Under Seismic Loading

2.2 The Oakland Southbound Connector, I-980, Bent 38

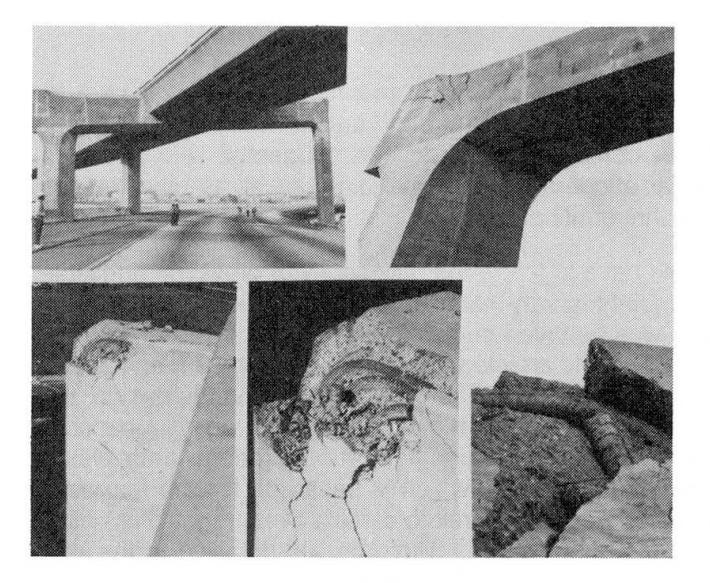
Fig. 1 Outrigger bent joint damage

A single-deck outrigger bent (bent #38) with only a 0.92 m (3 ft) outrigger cap beam extension past the superstructure on I-980 featured heavy joint damage as shown in Fig. 1c,d,e. Built in 1985, the column was well confined with an interlocking spiral, see Fig. 3, however, this spiral did not continue into the joint region

A capacity check on the cap beam and column capacities showed that the cap beam capacity is critical for positive moment due to the insufficient anchorage length of 1.8 m (72 in.) for the D = 57 mm (#18) bars which, based on ACI 318-89, require a basic development length of 3.0 m (117 in.) which is likely to be on the conservative side. In the other loading direction (negative moment in the joint), the column capacity is critical. Joint shear force levels derived from simple stress models, Fig. 4, show joint shear stress levels of $0.37\sqrt{f_c}$ MPa ($4.3\sqrt{f_c}$ psi) and $0.5\sqrt{f_c}$ MPa ($6.0\sqrt{f_c}$ psi), under positive and negative moment loading, respectively, which are both above an assumed level of $0.33\sqrt{f_c}$ MPa ($4.0\sqrt{f_c}$ psi), where diagonal tension cracking in the joint can be expected. Since the shear capacity of the 5 gauge wire spirals does not add significant joint shear capacity, the formation of any flexural hinge mechanism in adjacent members was inhibited.. This explains the encountered diagonal joint crack patterns during the Loma Prieta earthquake, see Fig. 1c,d,e.

In addition to the diagonal crack patterns, large areas of cover concrete spalling along the outer cap corner as well as a ruptured D = 57 mm (#18) reinforcement bar which was bent on a 45 cm (1'--6") radius were observed, see Fig. 1d,e.

The first phenomenon of cover concrete spalling can be explained with the fully reversed cyclic loading. Under negative moment, flexural cracks open on the cap surface as shown in Fig. 3 and under subsequent positive moment loading, the entire compression force has to be transferred through the negative moment reinforcement until the cracks can close. These high compression forces in the negative moment reinforcement transferred to the concrete by bond, have a tendency to spall off the concrete cover between flexural cracks developed in the previous tensile excursions. The second phenomenon, the ruptured reinforcing bar, see Fig. 1d, points to a potentially critical problem which needs further investigation. Common ultimate strain levels in D = 57 mm (#18) $f_y = 414$ MPa (Grade 60) bars are in a range from 7 to 15%. Introducing a R = 45 cm (18 in.) radius bent into a D = 57 mm (#18 or $\phi = 2.25$ in.) bar causes strain levels of D/(2R) = 225/(2 × 18) = 6.25%, which is close to the ultimate strain range. The very low strain reserves and possible strain aging effects which raise the notch ductile temperature at which steel will fail in a brittle mode can cause sudden failure in these bent bars at very low additional strain levels.

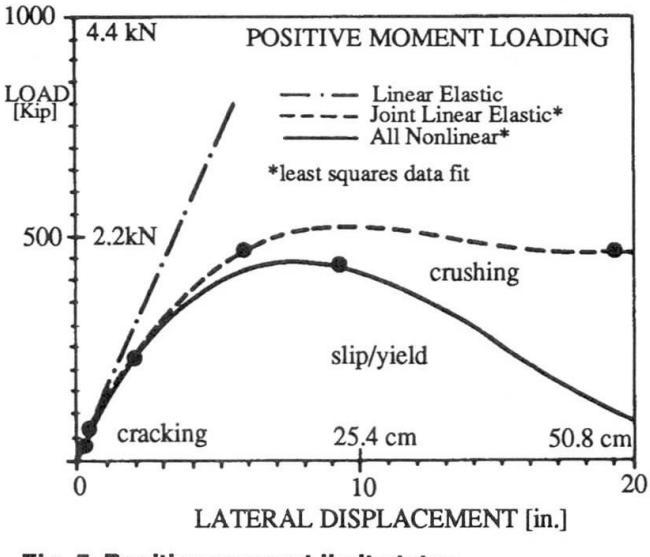
Fig. 5 Positive moment limit states

Since joints should be detailed based on capacity considerations such that the major inelastic action occurs in the cap or column, and since they should remain effectively elastic for small seismic disturbances (Paulay et al. [4]), the nonlinear finite element analysis was repeated with a linear elastic joint for a direct comparison of deformation limit states. As can be seen from Fig. 5, while joint deformations did not contribute significantly to the initial overall structural deformations, the failure mode in the positive moment direction shows improved ductile behavior when the failure mechanism is shifted from joint distress to flexural cap beam hinging. It should be noted that the cap beam capacity still may be artificially low due to the reduced yield strength in the bottom D = 57 mm (#18) reinforcing bars based on a reduced development length according to ACi 318-89. Negative moment loading behavior is also improved by forcing the yield mechanism clearly into the column (not shown). Since the bent joint failure is the critical link in the overall behavior, repair/retrofit of these joints is a logical next step.

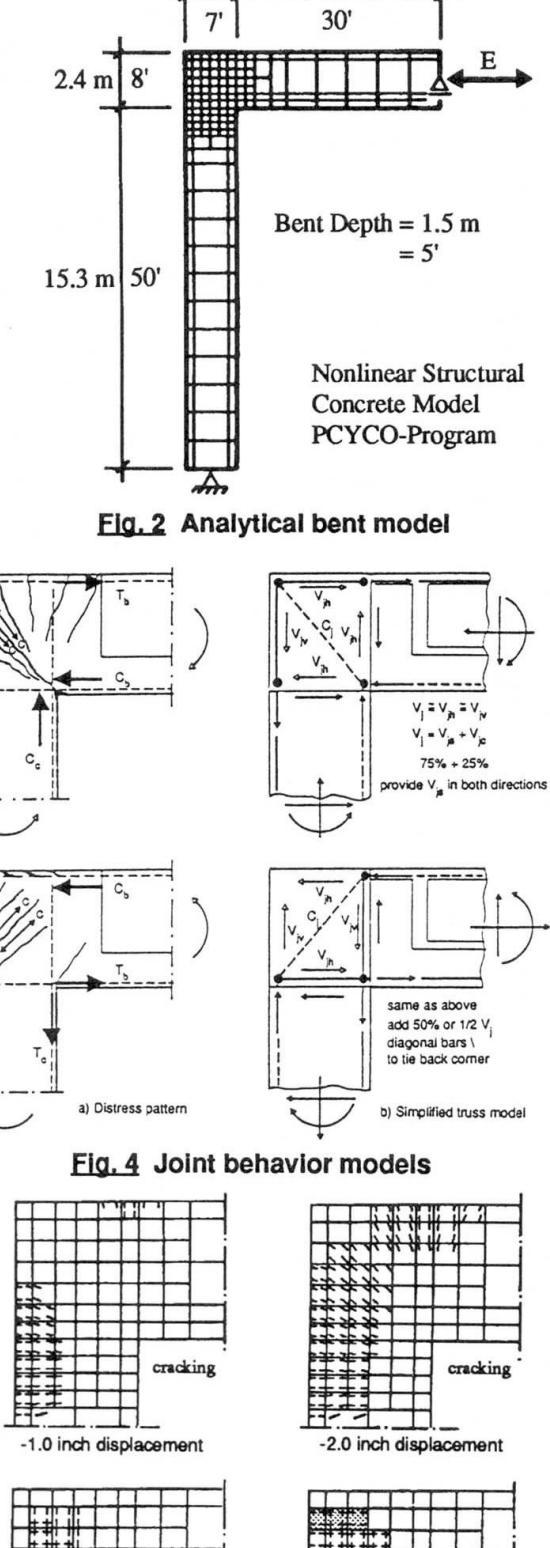
Fig. 6 Negative moment distress patterns

In addition to the simple stress models of the knee bent joint, detailed nonlinear finite element simulations, see Fig. 2, based on extended compression field principles were performed to determine analytically failure modes and joint deformation contributions to the overall bent deformations. Reinforcement development of straight bars was modeled by assuming a reduced yield level in the anchor zone decreasing linearly from the full yield at the ACI 318-89 basic development location to zero at the bar end. Subsequently derived yield patterns in bar anchorage regions therefore are indicative of bond failure or slip. Superimposed to the dead load case, the half bent, Fig. 2, was subjected to lateral force, and force-deformation envelopes with major event indicators, depicted for positive moment loading in Fig. 5, were obtained. Associated crack, slip/yield and first crushing patterns, see Fig. 5, indicate the failure mechanisms in the joint region. The heavy yield in the joint center, both horizontally and vertically, indicates the deficiency of both vertical and horizontal joint shear reinforcement, particularly under negative moment on the joint. Also, the crushing of the concrete in the outer joint region under the bent negative moment reinforcement under loading to the left or negative moment indicates the high compressive stress state and associated transverse prying forces in this region and the need for sufficient transverse confinement reinforcement, as outlined by Schlaich et al. [2], for strut and tie models for negative moment knee joints.
