| Zeitschrift: | IABSE reports = Rapports AIPC = IVBH Berichte |
|---|--|
| Artikel: | Reconstruction of the Benten Viaduct after the 1995 earthquake |

Reconstruction of the Benten Viaduct after the 1995 Earthquake

Mitsuhiro HAYASHIDA Eng. Hanshin Expressway Public Corp. Osaka, Japan Hidenao HAYASHI Advisory Officer Hanshin Expressway Public Corp. Osaka, Japan Shiro KAWAKITA Chief Eng. Hanshin Expressway Public Corp. Osaka, Japan

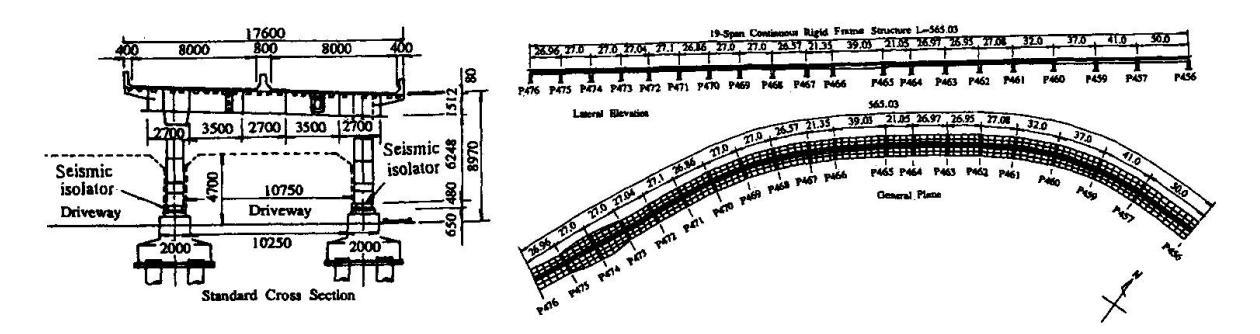
Fig. 2 General View of Benten Viaduct

The Hanshin/Awaji Earthquake occurred on January 17, 1995, caused tremendous damage on the Hanshin Expressway Kobe Route, especially at Benten section (referred in Figure 1). The reconstructed bridge, "Benten Viaduct", was determined to be the 19-span continuous rigid frame with steel deck along with the installation of seismic isolator. The general view of structure is shown in Figure 2.

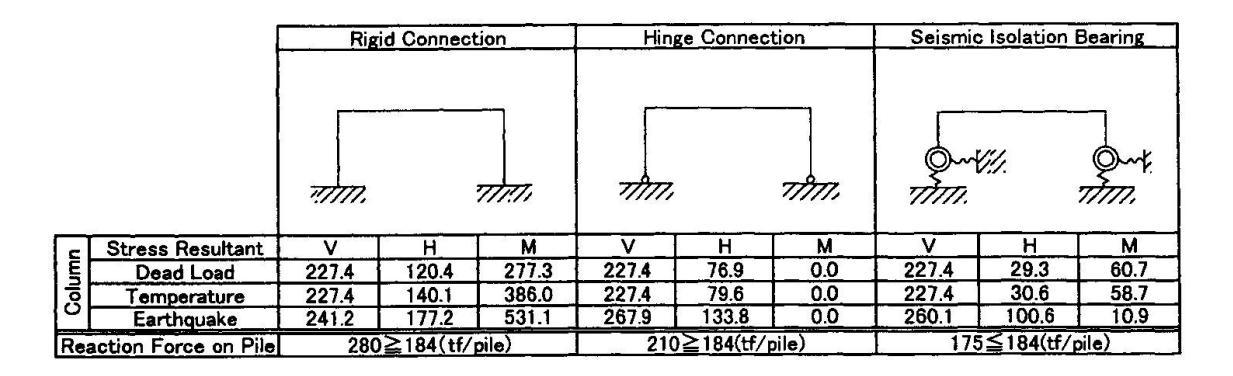
Table 1 Comparison of Structure

According to the strategy above, it was decided to adopt a continuous rigid frame. It was supposed that the additional piling reinforcement was needed for rigid connection or for hinge connection and finally it was concluded to adopt the structure of installing seismic isolation bearing on the foundation (referred in Table 1). Since the Benten Viaduct is warped to the seaside and the overhang length of cross beams differs slightly, analysis was made on the entire structural model of the two types shown on Figure 3.

Both east and west end of Benten Viaduct, 2 spans continuous steel box girder bridges were arranged as a absorber bridge. It was to prevent the adjacent simple girder bridges from a remarkable difference of vibration characteristics.

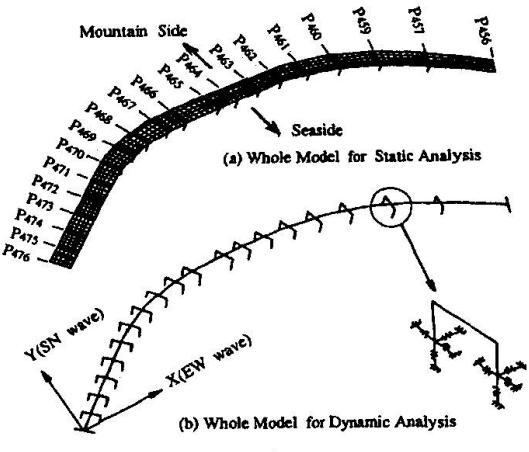
Fig. 3 Entire Models for Analysis

In static analysis model (a) in the Figure 3 was used. The superstructure consisted of main girders, beams, and piers which was supported by the two way horizontal spring as well as perpendicular and rotational ones. The characteristic of isolator is expressed in natural period (T) and the ratio of yield point load (Qd/Wu)[2]. In order to give an appreciate initial coefficient of bearing reaction for the static analysis model, the period and the ratio of yield point load were decided by applying a representative bridge pier that would satisfy the following three design objects.

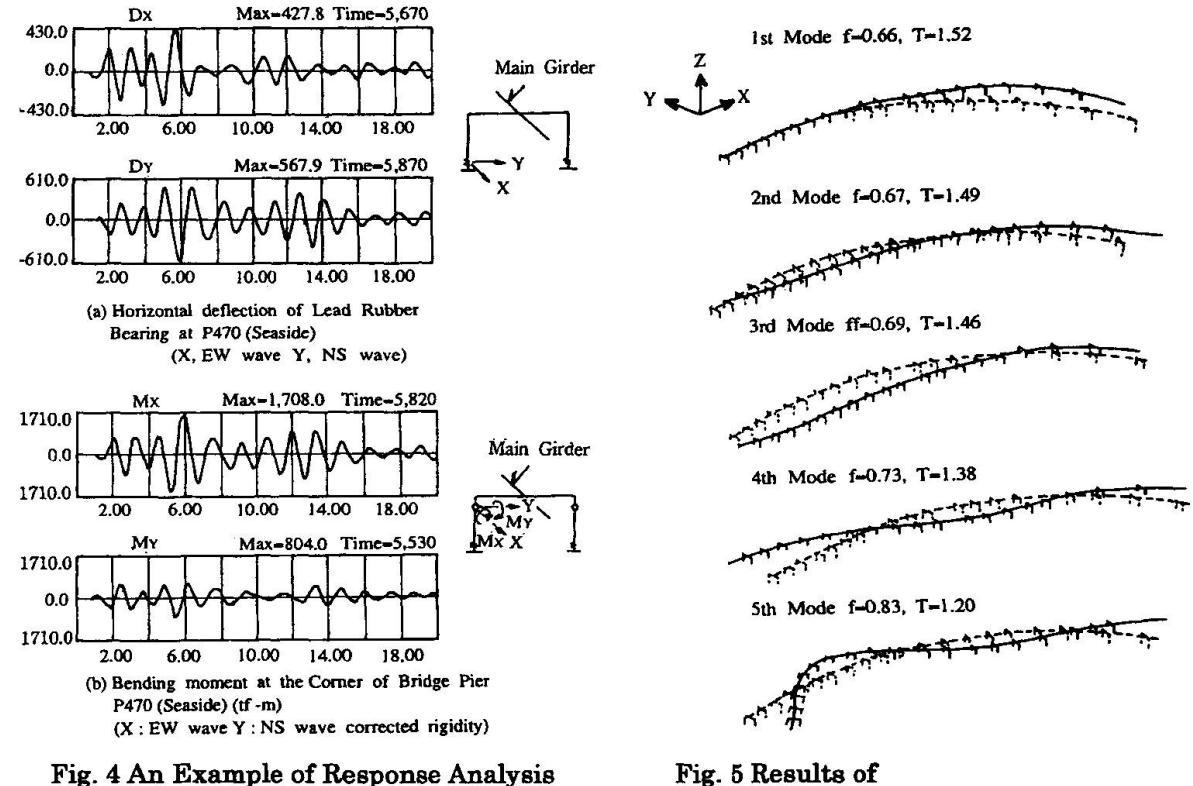
On Time History

The time histories were exemplified in the Figure 4 for the response in the horizontal deflection of the seismic isolator and the bending moment at the beam joint at P470. Maximum deflections were 428mm in the longitudinal direction of bridge and 568mm in the transverse direction, which were observed after 6 seconds from the beginning of earthquake.

The results of natural vibration analysis on the entire model is shown on Figure 5 and all up to 5th modes shows inherent mode of horizontal direction. From the result of natural vibration analysis applied on a plane model, the mode for horizontal move at the bearing position is so remarkable that the similar tendency may be seen in a three dimensional model.

Natural Vibration Analysis

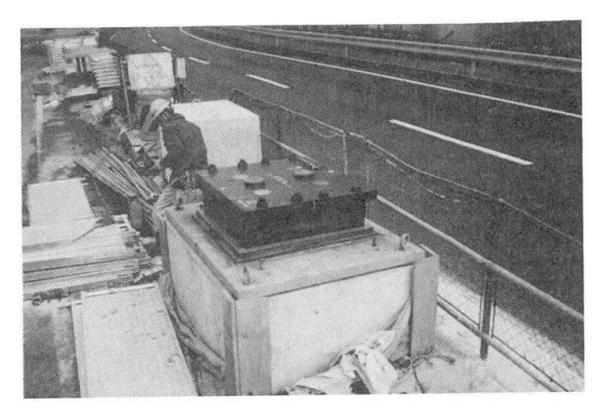
Photo. 1 Seismic Isolation Bearing

Seismic isolation bearing was designed referring to the "Manual of Isolation Design for Highway Bridge." There are two types of seismic isolator, LRB (Lead Rubber Bearing) and HDR (High Dumping Rubber). LRB is a laminated-rubber bearing concluding lead plugs inside to give bi-linear deformation characteristic, while HDR is made of laminated super elastic gum.

Benten Viaduct has so much dimension of statically indeterminate that LRB was supposed to be more effective than HDR, because it is softer on various temperature range and harder under strong earthquake force. Each LRB bearings was designed in the same height nevertheless the difference of their design load in order to make the deformation characteristics regular. The appearance of seismic isolation bearing is shown in Photograph 1.

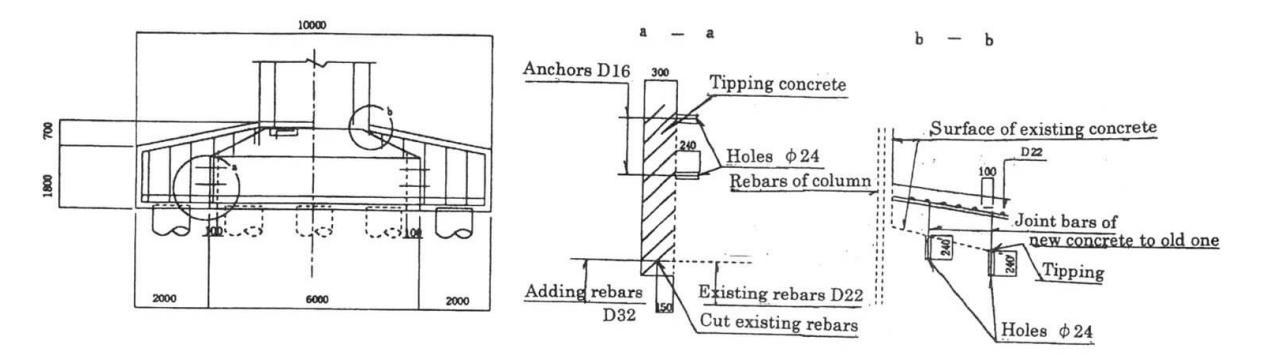
Fig 6 Reinforcement of Pile and Footing

Before the reconstruction project, bearing capacity (qd) of existing pile foundation was researched by means of corn penetrating test. Bearing capacity of 300 to 600 tf/m^2 was confirmed in most part, however, there still found some foundations which had only 150 tf/m² of qd. Therefore, these foundations had to be reinforced with adding piles, and the number of them were fourteen, which was 30% of the foundations among Benten section.

Also, the reinforced bars were jointed to the existing ones by means of enclosed arc welding. Details of reinforcement of footing are shown in figure 6.

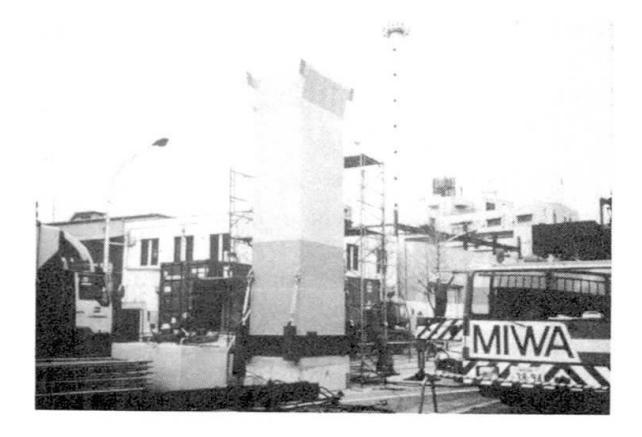
Photo. 2 Stabilizer System

The steel piers were unstable on the soft seismic isolation bearings until they formed a three-dimension rigid frame. In the field work, a stabilizer system were invented as shown in photograph 2. This system was introduced to stabilize the columns before the erection of girder and deck, and it could save the accuracy of piers and bearings also. The stabilizer was designed to have a temporary horizontal bearing capacity against 0.15G.

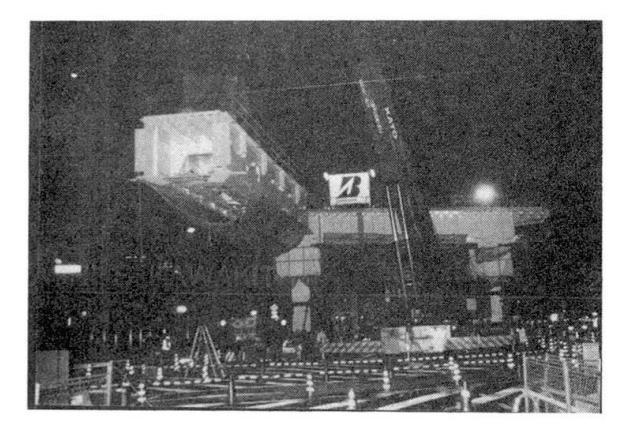
Photo. 3 Erection of Girder and Deck

The length of Benten Viaduct is as much as 686m, which causes ± 28 mm's expansions at both ends from the difference of temperature of ± 10 degrees centigrade. To keep an adequate accuracy of erection, columns and cross beams were built up first. After that, plate girders with steel deck were erected measuring and correcting the errors at each pier points. The accuracy of erection was finally found to be less than 5 mm at the isolators point.
