BII3: Special erection methods

Zeitschrift: **IABSE congress report = Rapport du congrès AIPC = IVBH
Kongressbericht**

Band (Jahr): **4 (1952)**

Typical methods of erecting four bridges across main rivers in the Netherlands

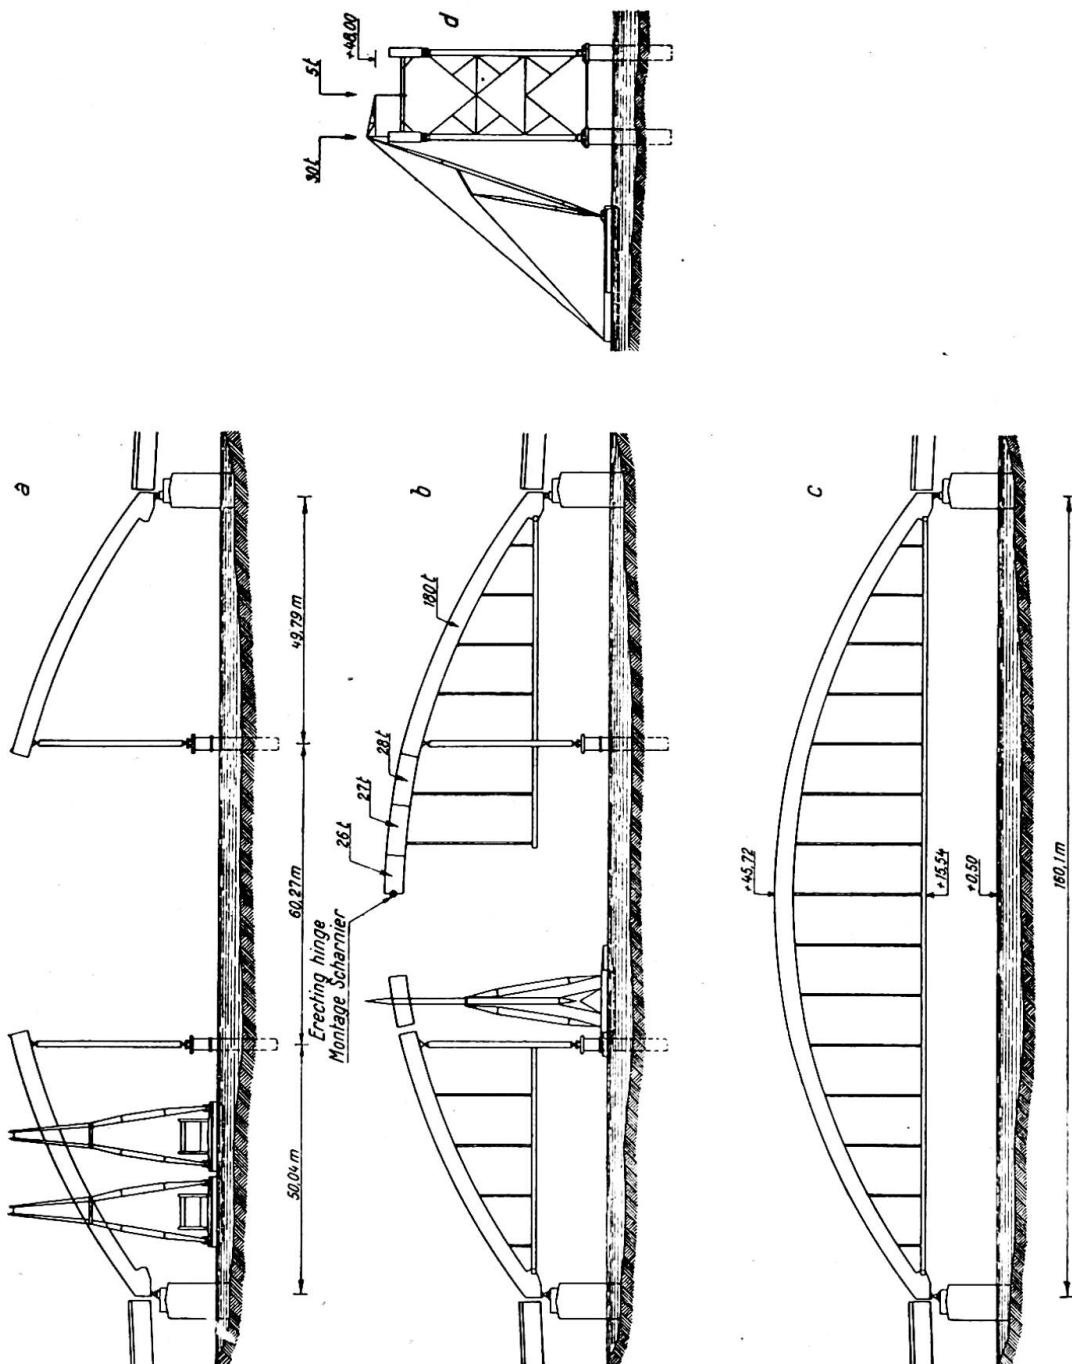
Fig. 1. Bridge over the River Lek near Vianen

The erection method is shown in fig. 1(b). Two auxiliary piers of steel sheet piling were driven in the river 60 m. apart. On these piers heavy reinforced-concrete blocks were made. The 30-m. high steel pillars were constructed of the floor-girders of the bridge.

At first four arch units, each with a weight of 180 tons, were placed with the above-mentioned floating cranes. The higher parts of the arch were built from both sides. For this assembly a floating crane had to be supplied with shear legs constructed of truss-jibs used on another work (fig. 1(d) and fig. 2).

The river crossing at Vianen was first completed in 1936 as shown in fig. 1(c). To allow international and other traffic to pass during erection a passage of 60 m. was kept in the trestlework. To assemble the arch, with a span of 160 m., 28 m. above the flooring a movable tower-swing-crane with the underside of the arm 3 m. above the top of the arch was used.

No girders or spans were available for building a trestlework with a suitable passage for navigation. The available time and the demands of navigation made it necessary to erect the main span in big units with floating cranes. These cranes, the Condor and the Heracles, shown in fig. 1(a), can lift 200 and 250 tons each.

In the top of the arch a temporary hinge was constructed, an opening of 300 mm. being left for this hinge; afterwards one of the bridge parts had to be rolled in to bring the two parts together. After completing the concrete flooring the two parts of each arch were joined by gusset plates thus putting the hinge out of action. Thus the main span is a three-hinged arch for the dead weight only. Special calculations were made to give the bowstring the right camber.

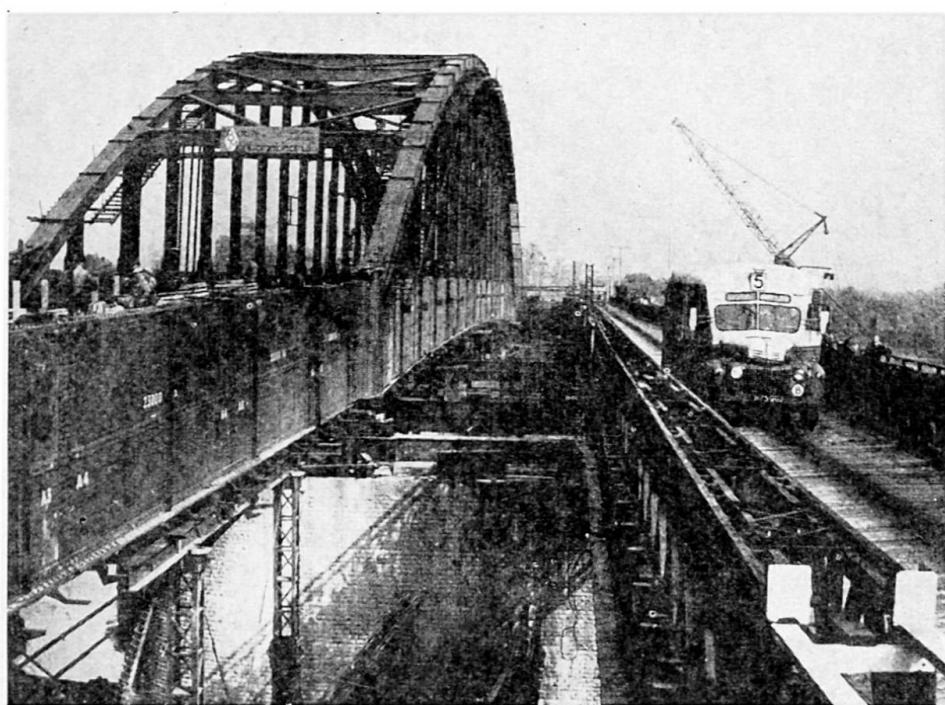
Fig. 4. Arnhem Bridge

The second reconstruction had some interesting features, as on the piers of the bridge two double-triple Bailey-bridges were laid. To reduce the span of the Bailey-bridges two auxiliary piers were placed in the river (figs. 4 and 5 (a)).

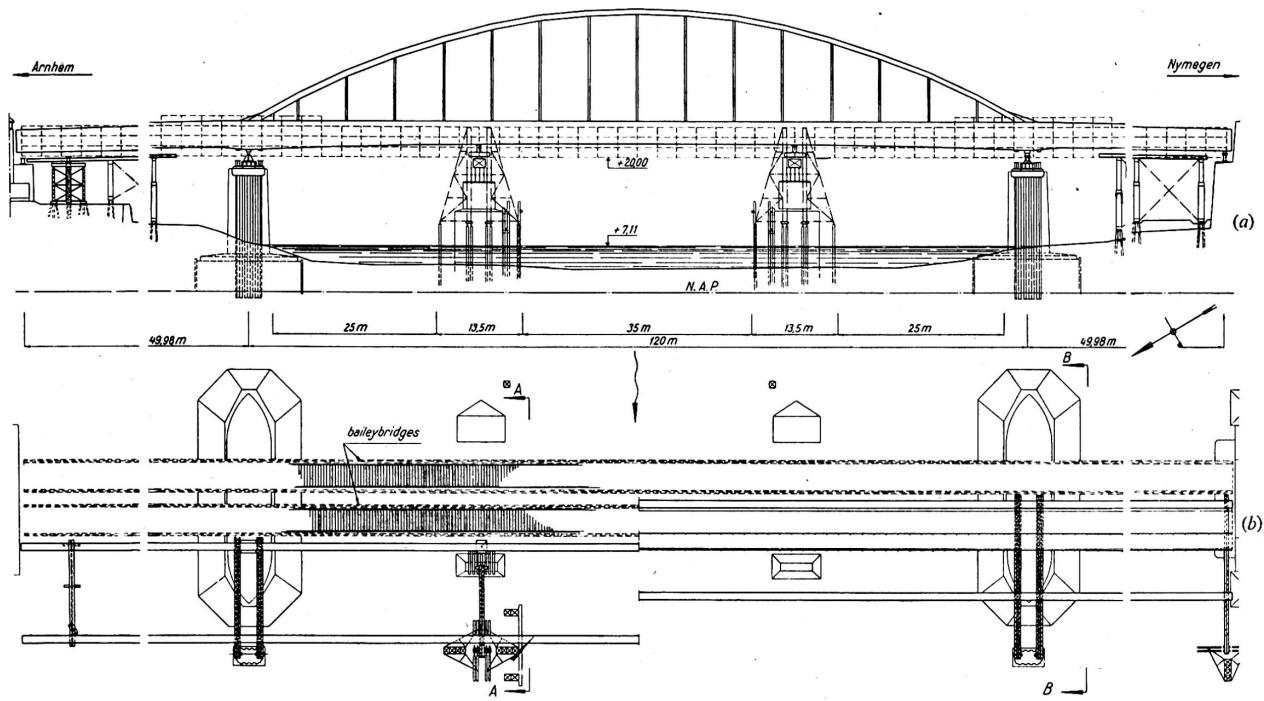
Fig. 5. Bridge over the River Rhine at Arnhem

As the maximum weight was limited by the piling, the concrete slab could only be completed for one traffic lane (fig. 5(b) and (d)). The footway at the side of the

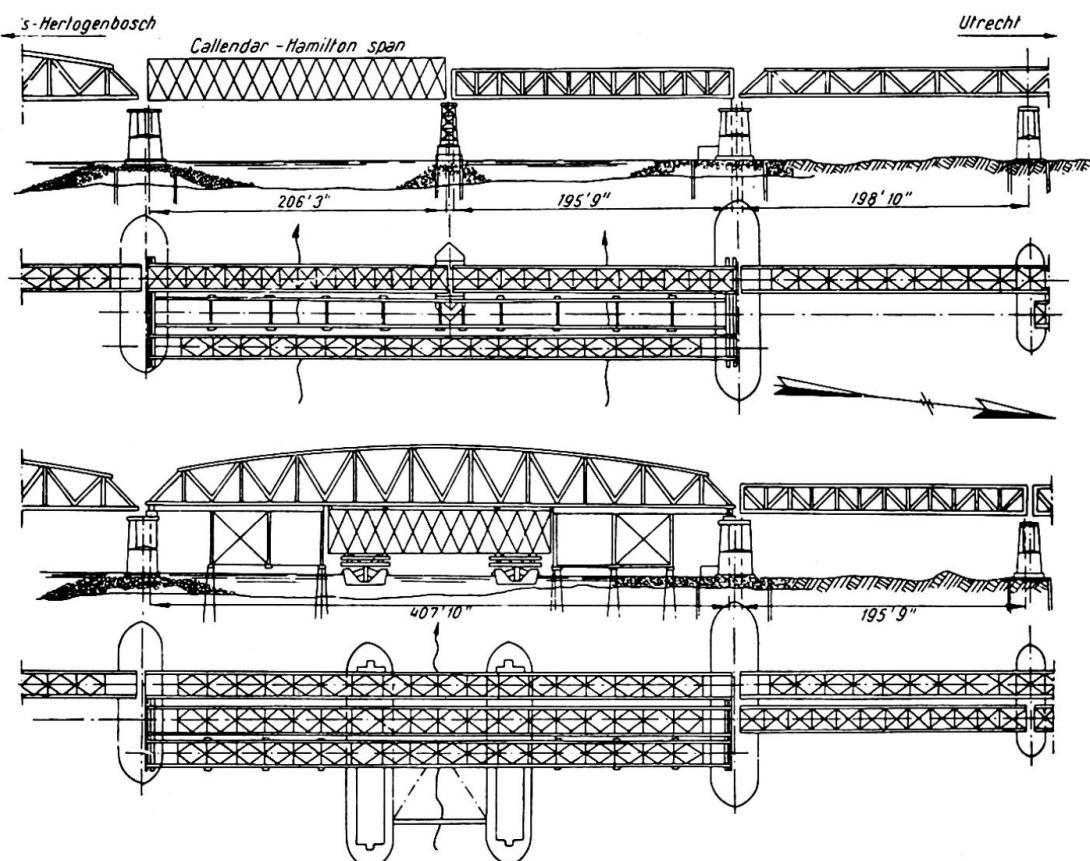
In order to complete the repair of the whole bridge, four big spans had to be built, one to replace the two small temporary spans in the western row of spans and three for the eastern row, in which the land between river and dike was bridged by one new span on three supports, five old spans that could be repaired, and the span that had been temporary used in the western row of bridges. Two of the big spans were erected in 1950 and two in 1951. To avoid interference with the navigation—the upstream river traffic uses the middle channel and the downstream traffic the southern one—all the spans were assembled over the northern channel (fig. 8).

Fig. 8. Railway bridge over the River Waal near Zaltbommel

The first span was assembled on a falsework under the future eastern track by means of a floating crane. After completion it was rolled sideways clear of the eastern row of spans; this was executed in the night of Saturday/Sunday 29/30 July 1950. On that Sunday the Callendar-Hamilton span was put on four coupled barges by two floating cranes, and the small span was first rolled eastward and

then northward into its original position in the eastern row of spans. To enable this, roller paths were constructed on the northern part of the falsework as well as on the land. On the roller-frames, moving on the last-mentioned paths, trestle supports were erected on which the span—for obvious reasons—was supported at its last-but-one bottom-chord connection points. Then, the same day, the big span was rolled westward into the western row of spans.

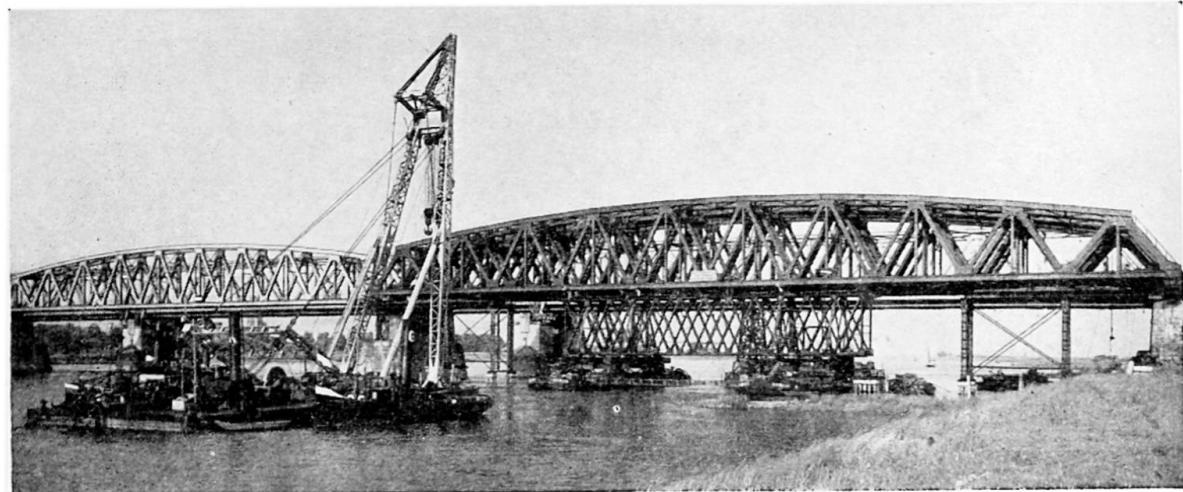
Fig. 9. Zaltbommel Bridge

In the early spring of 1951 new falsework was constructed eastward of the eastern row of spans (fig. 9). The central part of this falsework consisted of the shortened and

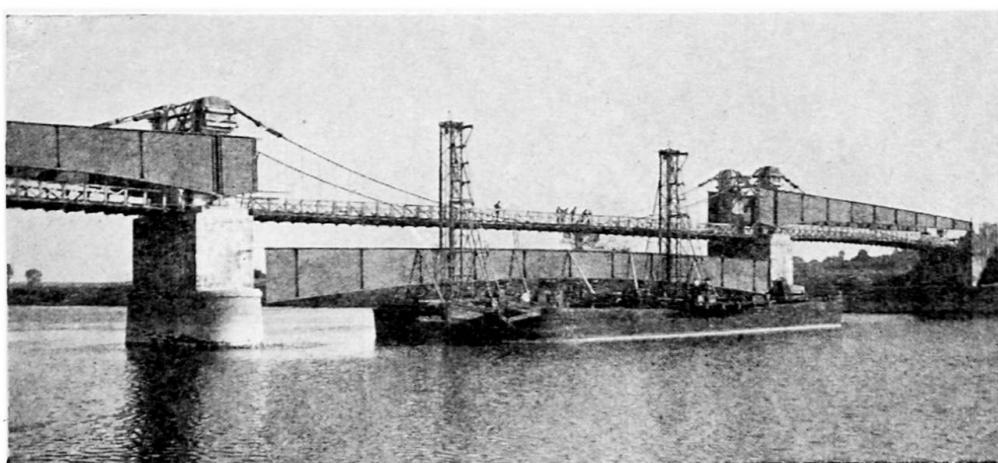
Fig. 1. Pont route de Bragny—montage des poutres sur chalands (1936)

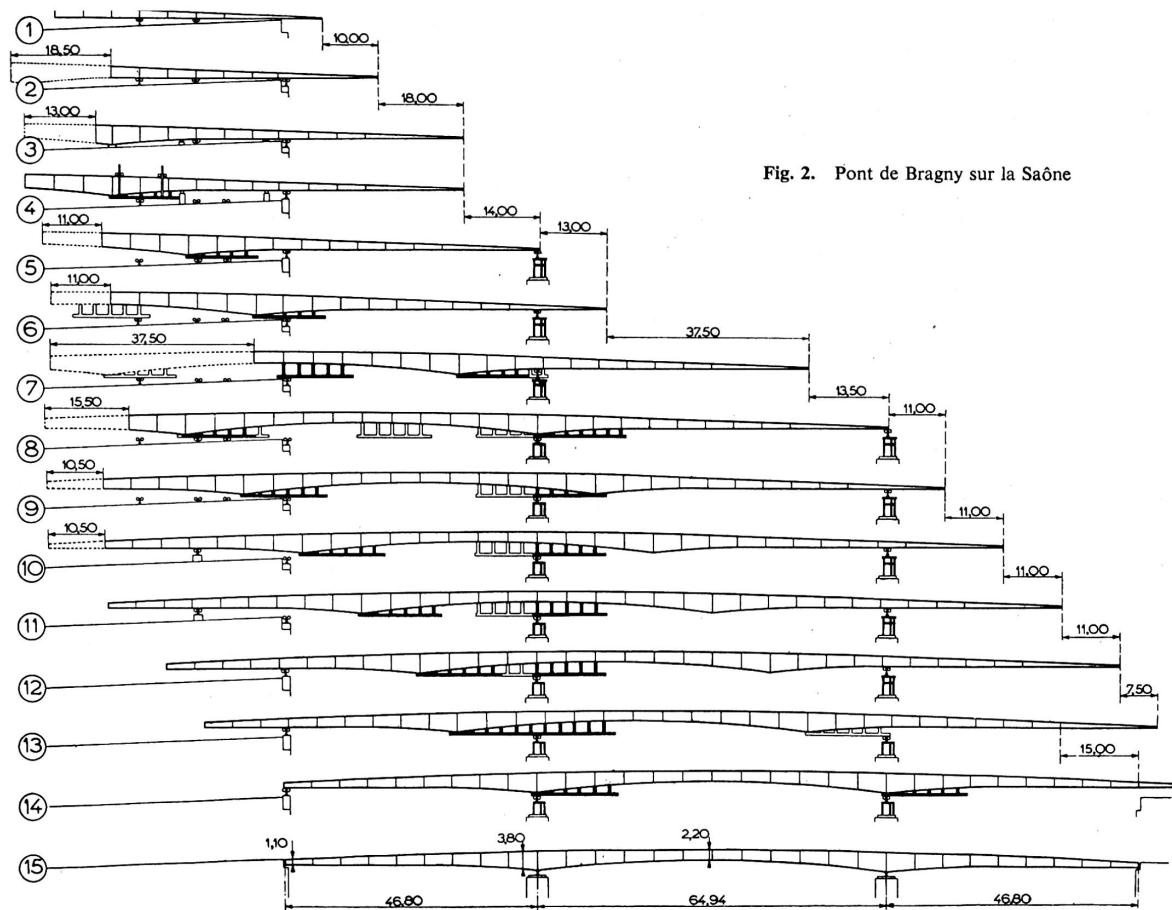
Fig. 2. Pont de Bragny sur la Saône

Quinze opérations successives de lancement s'échelonnèrent sur trois mois (fig. 2):

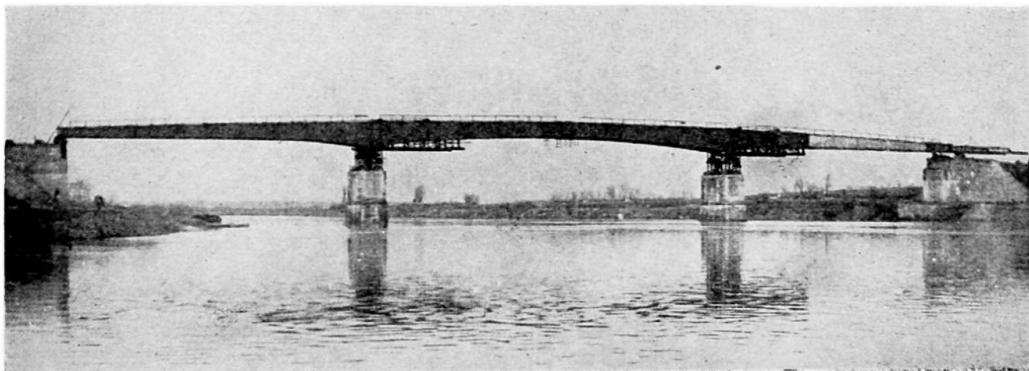
Fig. 3. Pont route de Bragny—Mise en place par lançage en 1950 sur berceaux (fin du lançage)

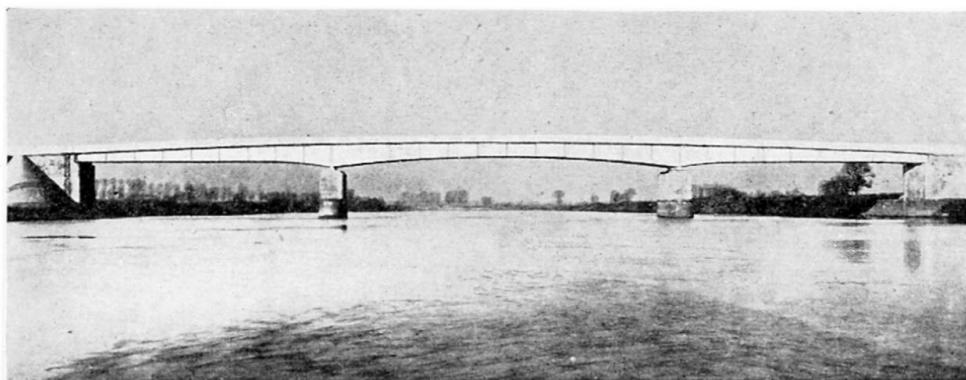
Fig. 4. Pont route de Bragny en acier 54—Vue d'ensemble

- 11ème opération*—Déplacement des 1er et 2ème berceaux et lançage sur 11 m.
12ème opération—Déplacement des 1er et 2ème berceaux et lançage sur 7 m. 50.
13ème opération—Déplacement du 1er berceau, abaissement de 1 m. 50 des galets sur 2èmes piles et lançage sur 15 m. (fig. 3).
14ème opération—Démontage de l'avant-bec et descente sur appuis.
15ème opération—Mise en place des appareils d'appui et réglage du pont (fig. 4).

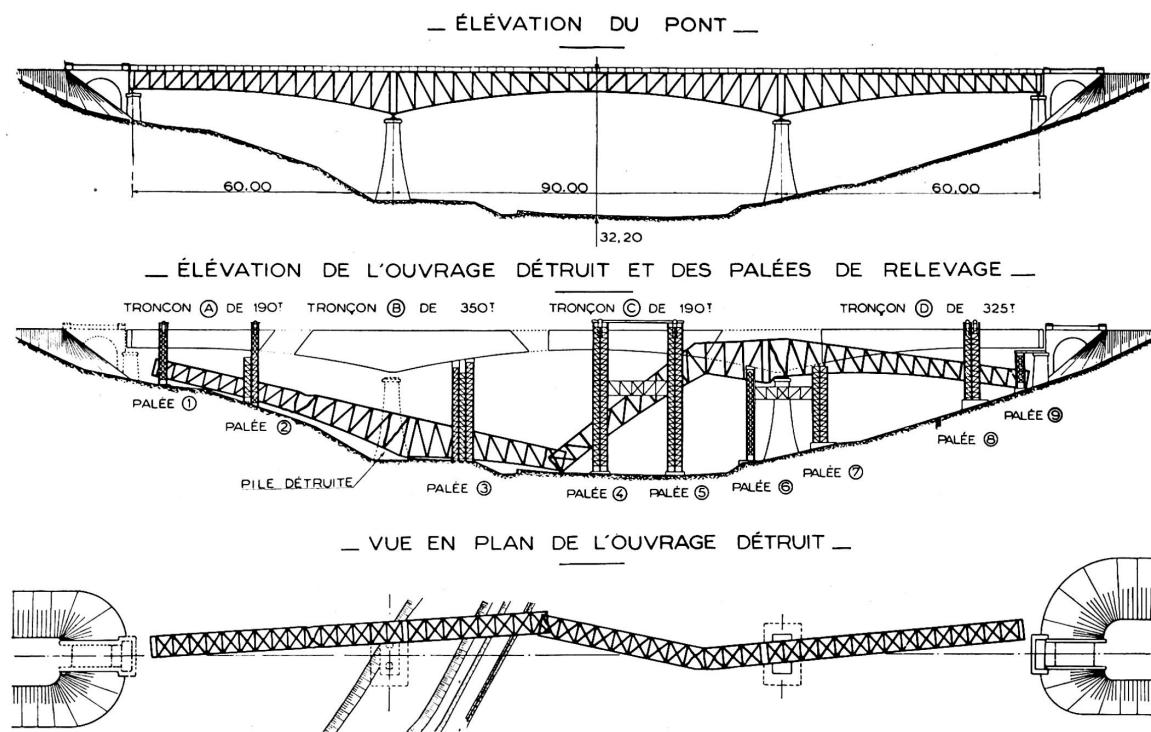
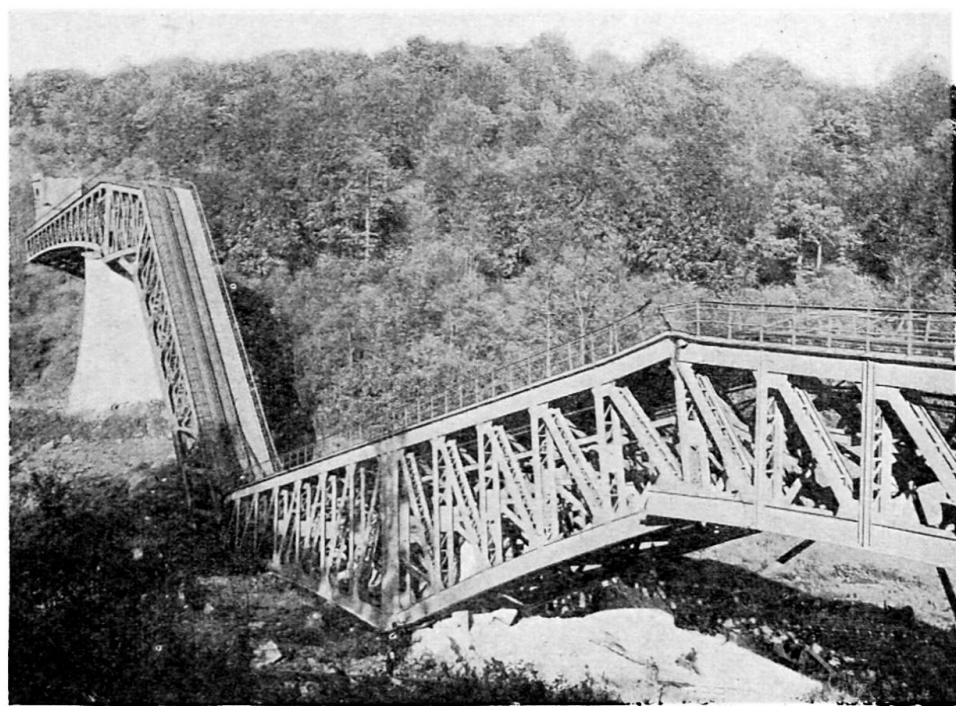
totalement, les autres sur le tablier, qui fut sectionné en trois points, suivant schéma ci-joint (figs. 5 et 6).

Fig. 6. Viaduc de Serrouville. Destruction—détail de la 1ère cassure côté Conflans

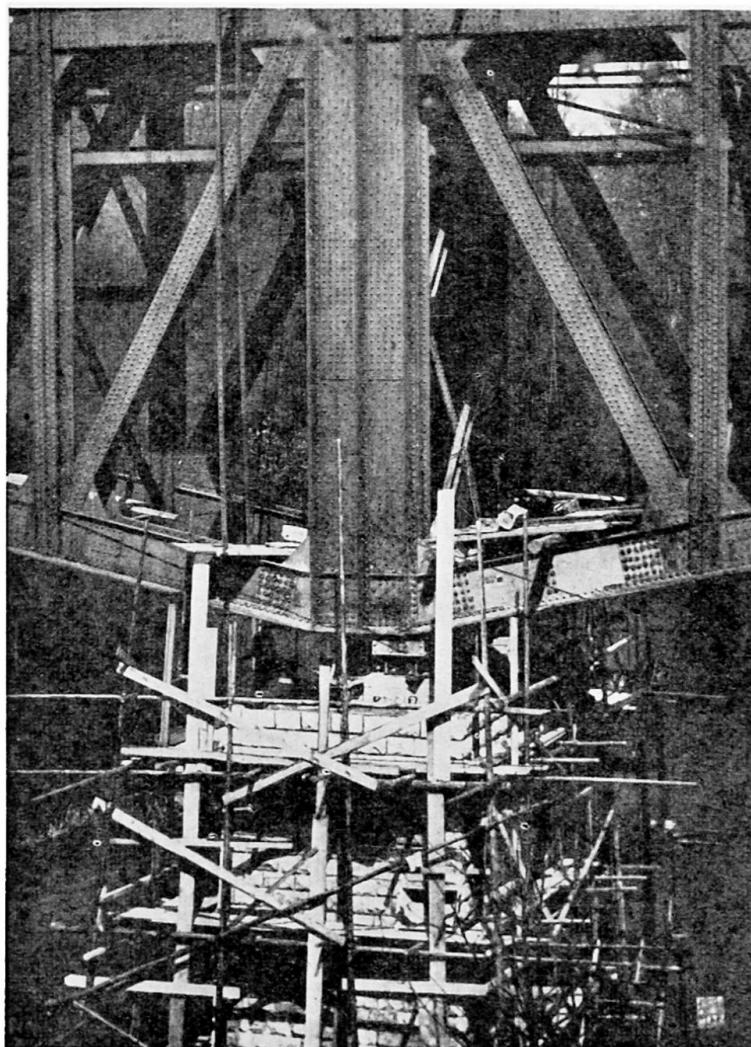
Les opérations se sont déroulées comme suit pour le relevage par vérins (un de 300 t. sur pile, le 2^{ème} de 100 t. sur palée anglaise), en utilisant des blocs de béton de 1 m. × 1 m. × 0,5 m. de hauteur coulés à l'avance (fig. 7).

Fig. 7. Viaduc de Serrouville—Reconstruction de la pile sans le tronçon B en cours de relevage

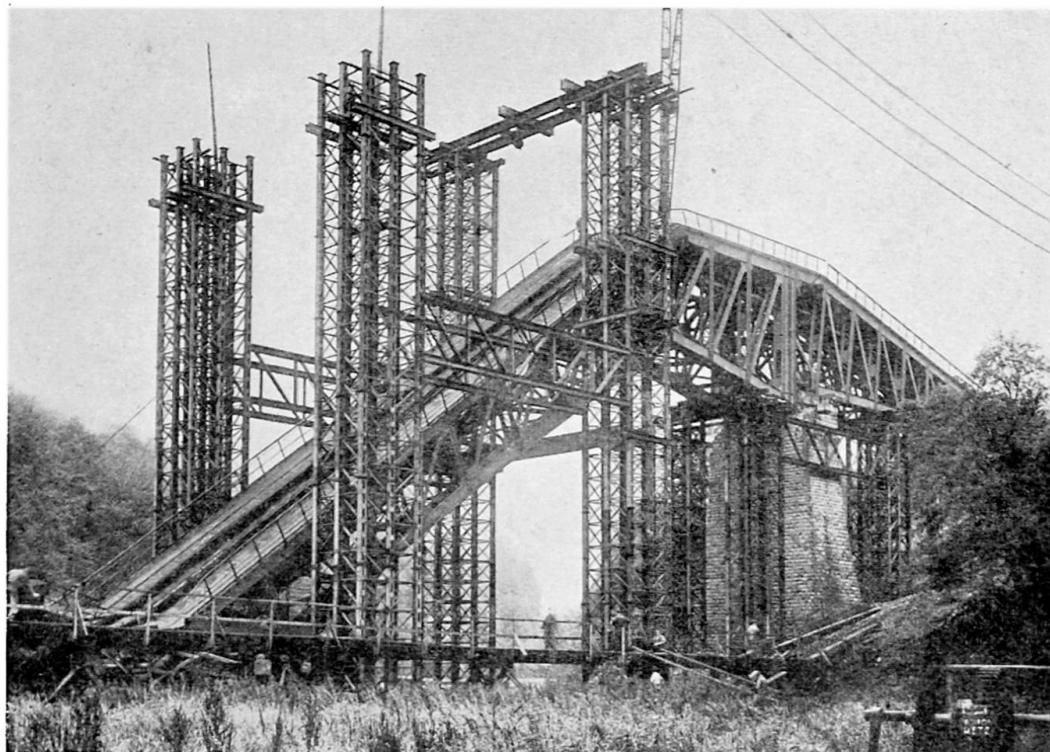
Ce tronçon était incliné à 45° et sa liaison à la partie haute avec le tronçon suivant était précaire. Aussi ne pouvait-il pas être question de le relever en soulevant seulement l'extrémité fichée en terre (fig. 8).

Fig. 8. Viaduc de Serrouville—Palées de relevage

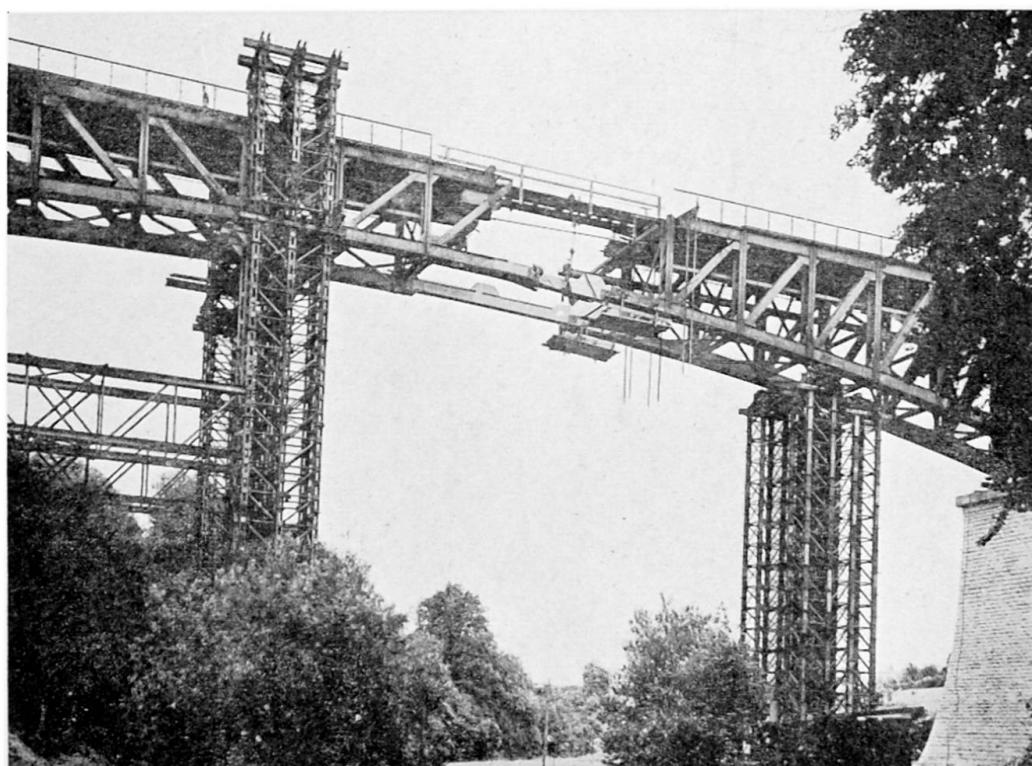
Il ne restait plus alors qu'à rétablir la continuité du pont en remontant, au droit des trois brèches, des éléments neufs ou réutilisés après réparation (fig. 9).

Fig. 9. Viaduc de Serrouville—Montage des éléments nouveaux au droit des brèches

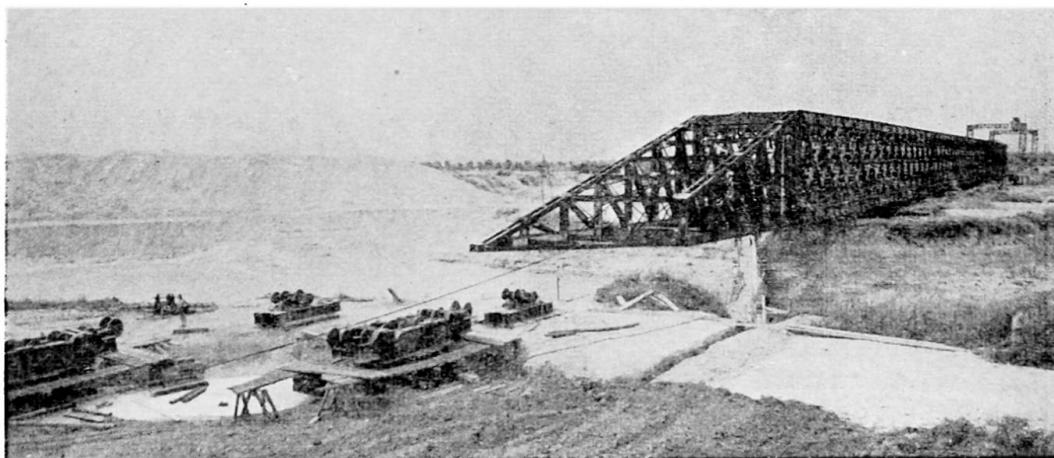
Fig. 10. Pont rail de Bollène—Ouvrage en cours de lancement

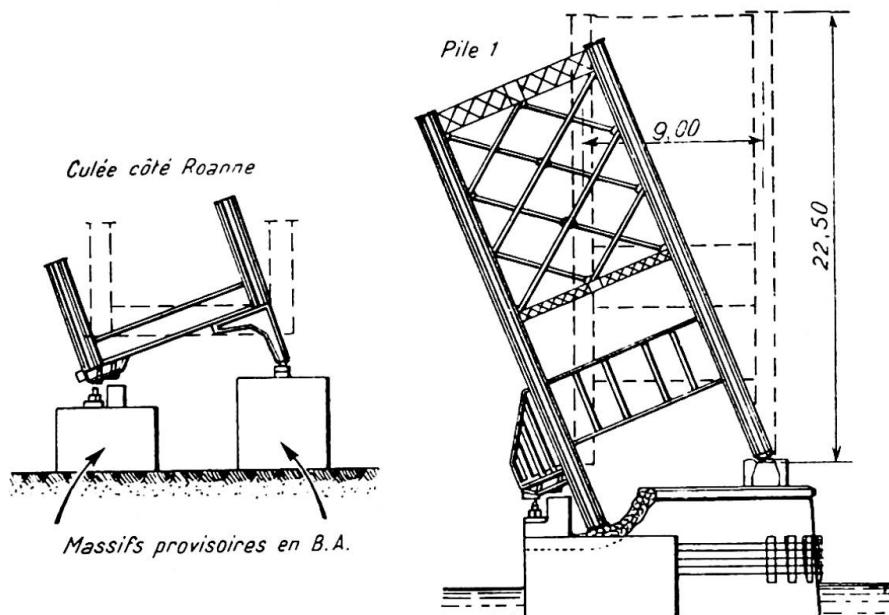
Fig. 12. Viaduc de la Mulatière sur la Saône—Relevage du tronçon côté Roanne

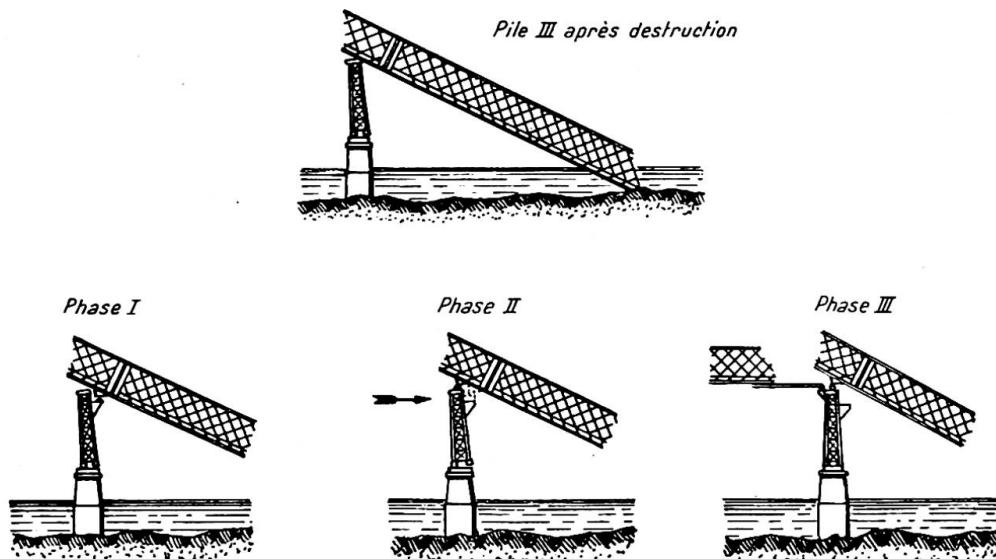
Fig. 13. Pont de Cubzac sur la Dordogne—Redressement de la pile III

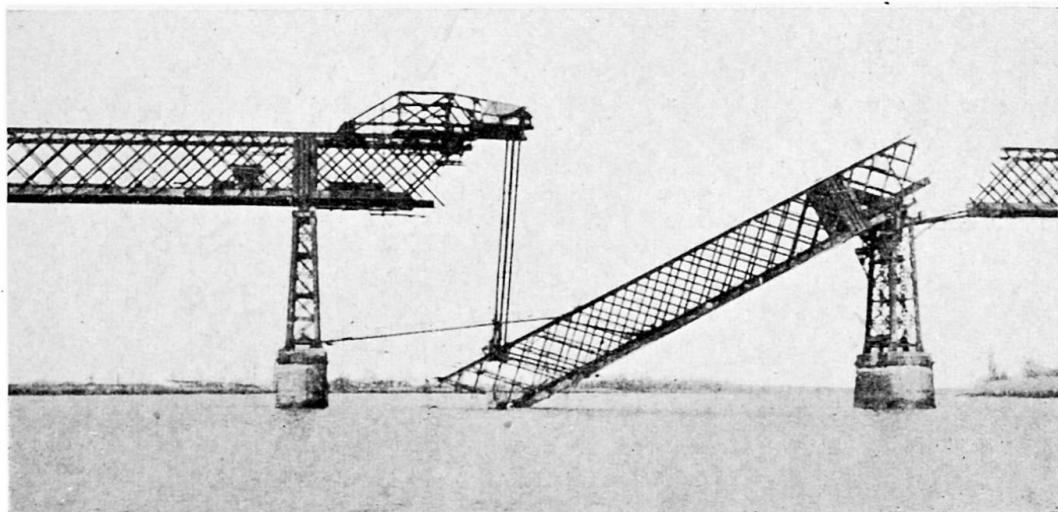
Fig. 14. Pont de Cubzac—Levage du tronçon

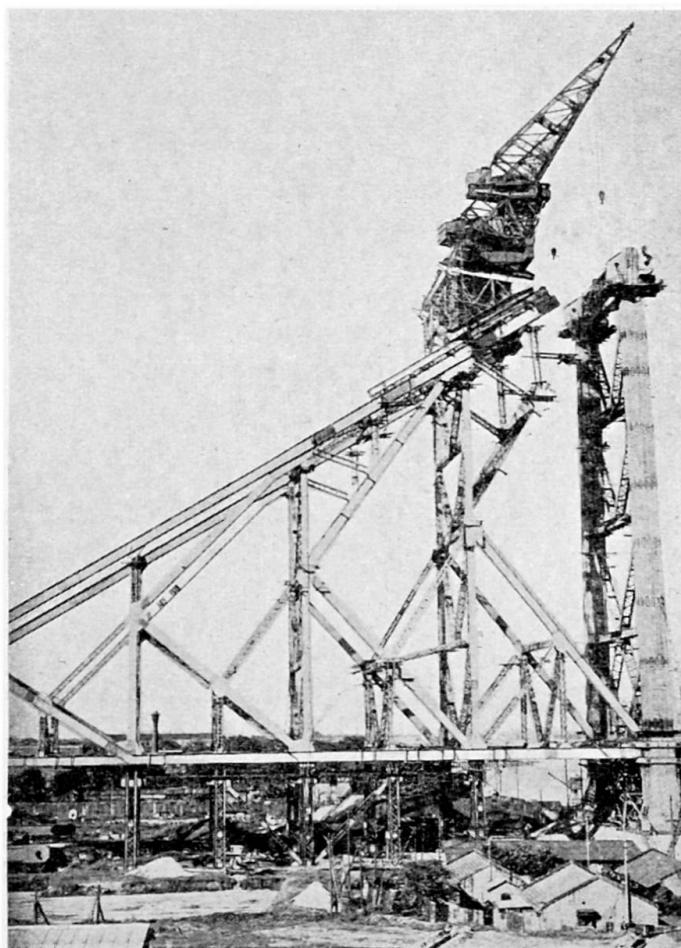
Falsework is most suitable for erection of trusses over a dry river-bed or in shallow water where staging can easily be provided. It may also be used for the erection of the anchor arm of a cantilever bridge as in the Quebec and New Howrah Bridges

Fig. 1. New Howrah Bridge, Calcutta. Erection of anchor arm on falsework. Note fleeting tracks for creeper crane and temporary members supporting top chord

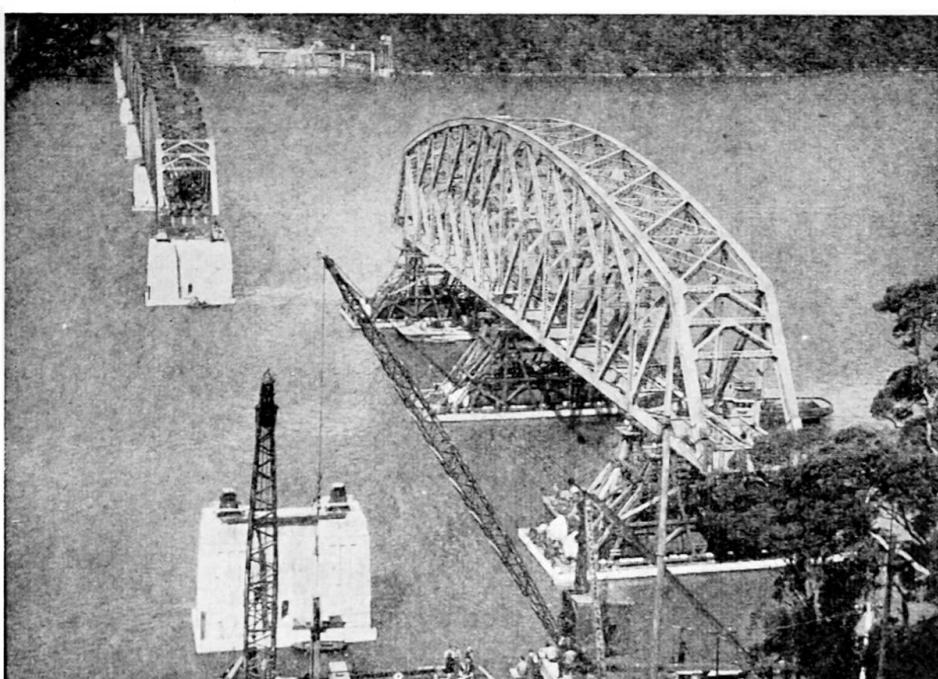
Floating out may be adopted for the erection of spans of 150 ft. or more, over a river that is too deep or otherwise unsuitable for staging, and where there are facilities for assembling the spans on pontoons, moored close to the shore, e.g. the Willingdon Bridge in Calcutta and the bridges over the Hawkesbury River, N.S.W. (fig. 2). It

Fig. 2. New Hawkesbury River Railway Bridge. Floating in 445-ft. span

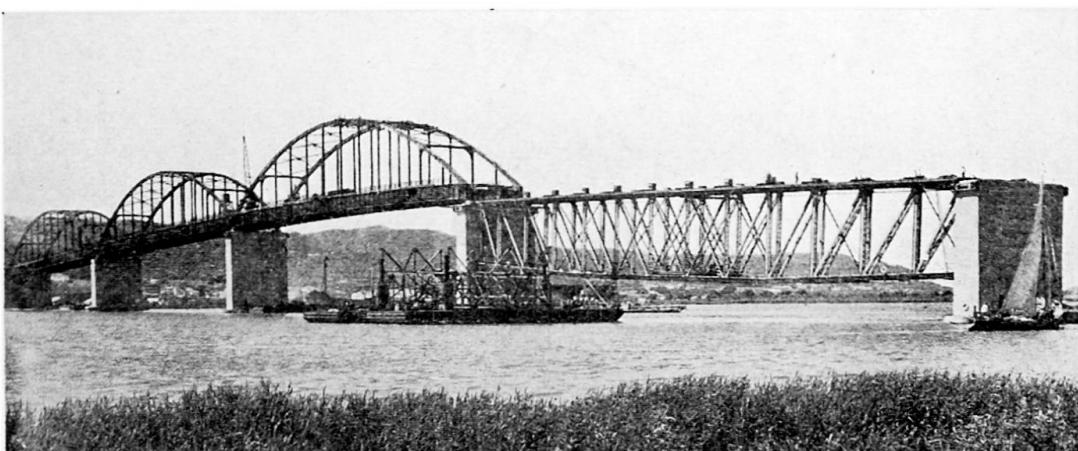
Erection on service girders (fig. 3), e.g. Vila Franca Bridge, is similar in its effects to erection on staging and facilitates prestressing.

Fig. 3. Vila Franca Bridge over the Tagus near Lisbon. Service girders floated into position ready for erection of fourth span

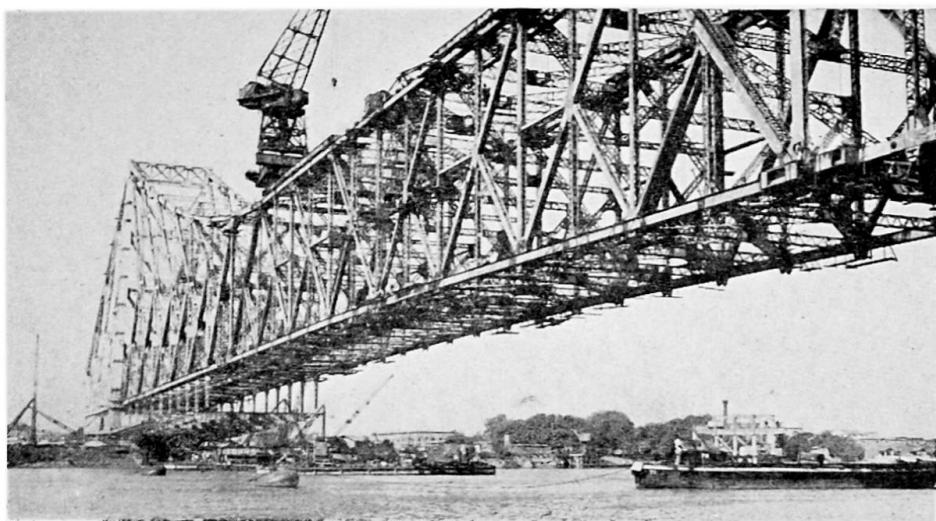
Fig. 4. New Howrah Bridge, Calcutta. Junction of suspended span after erection as two cantilevers

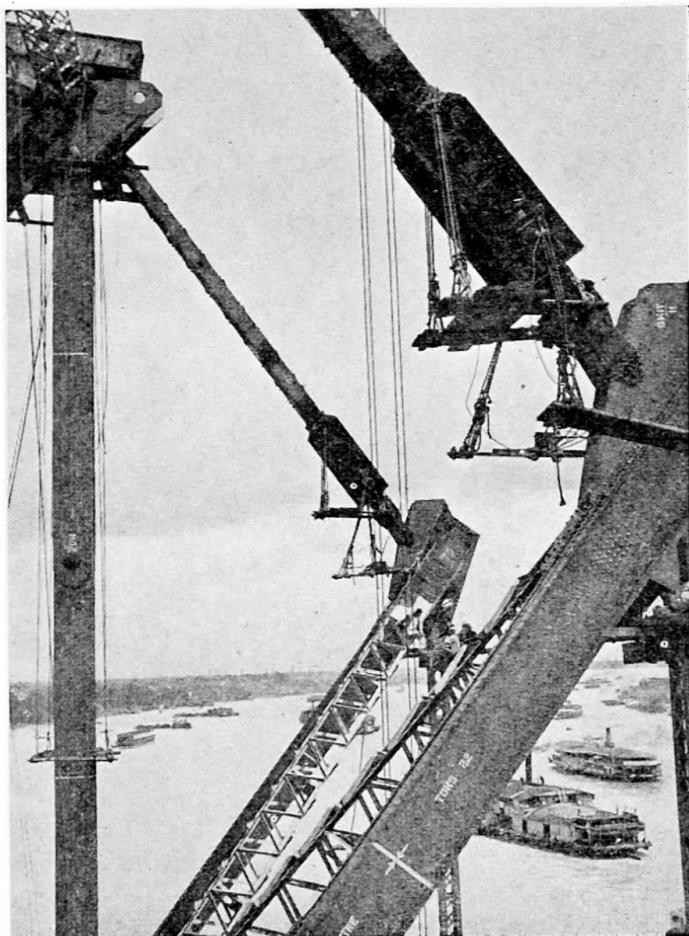
Fig. 5. New Howrah Bridge, Calcutta. Temporary adjustable members with 200-ton jacks being used for prestressing of cantilever arm

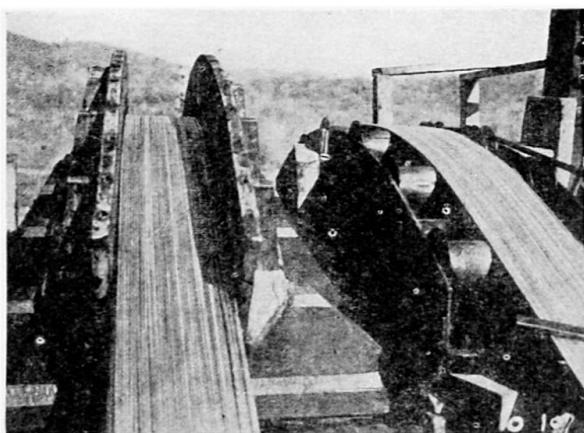
An interesting innovation in the Otto Beit Bridge was to use parallel wire cables but to pull each strand across in the form of a flat ribbon made up of a number of wires side by side. Strands were socketed at the ends for connection to the anchorages and retained their individuality to some extent at the tower saddles, which were specially shaped to accommodate the layers of wires; but throughout the remainder of their length they were squeezed together and bound (fig. 6).

Fig. 6. Otto Beit Bridge, Rhodesia. Erection of cable strands in the form of ribbons of parallel wires. Note tower saddle on left with new strand about to be placed

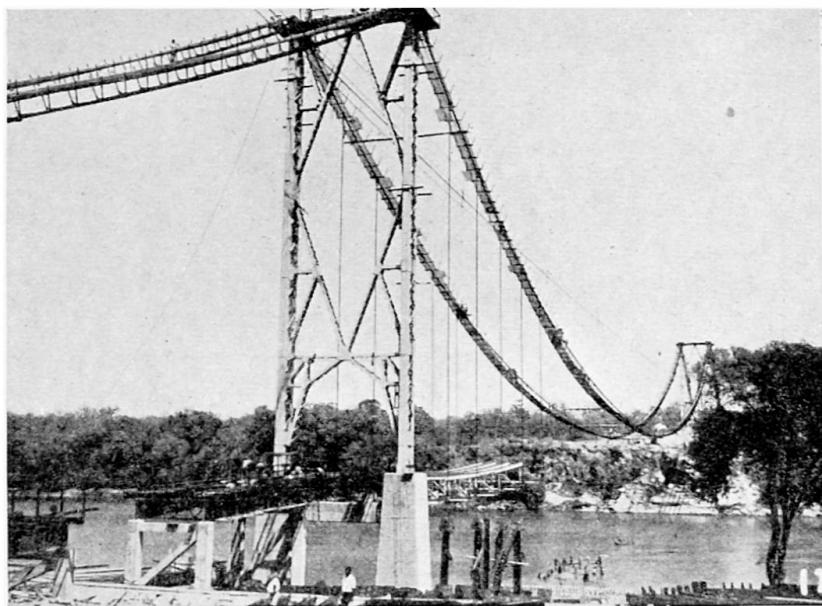
stringers right along the span before erection, thereby avoiding severe distortion of the cables (fig. 7).

Fig. 7. Otto Beit Bridge, Rhodesia. Erection of deck cross girders.
Note opening in tower bracing for Blondin on Bridge centre line

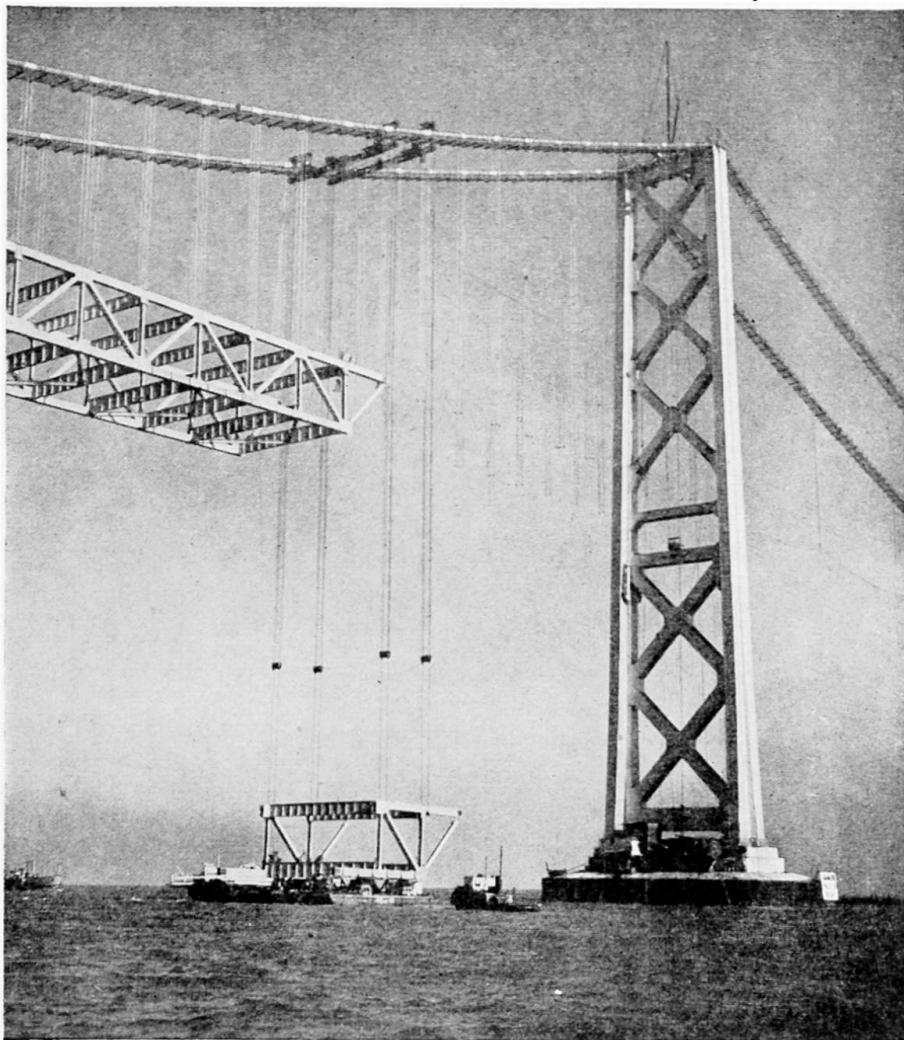
Fig. 8. San-Francisco-Oakland Bay Bridge. Erection of heavy units of deck steelwork

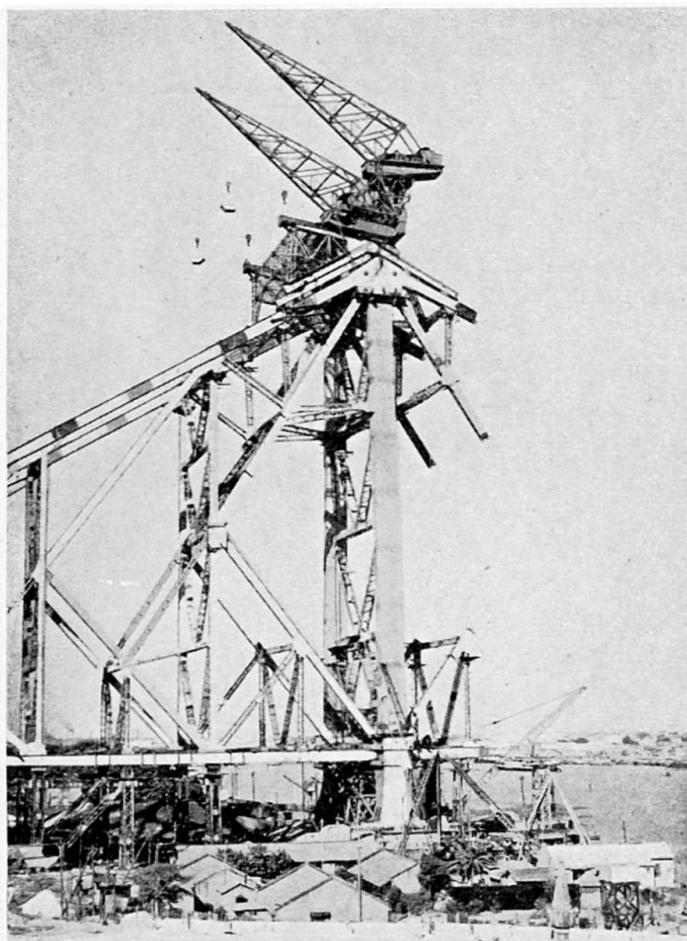
Fig. 9. New Howrah Bridge, Calcutta. Creeper crane moving off temporary cradle on which it had been hoisted up anchor arm on to fleeting tracks on cantilever arm

crane over the top chord is that upper chord members of a cantilever bridge are seldom heavy enough to support its weight in bending. On the Howrah Bridge special fleeting tracks had to be bolted on to stools on the top chord and temporary members had to be inserted in the bracing to support the chord under the weight of the crane (fig. 9). Moreover, if the cantilever bridge is of conventional outline, special means have to be provided to haul the crane over the peak at the end post. The tendency in America today is to use comparatively light guyed-derricks, as on the San-Francisco-Oakland Bay Cantilever Bridge, in preference to heavy creeper cranes.

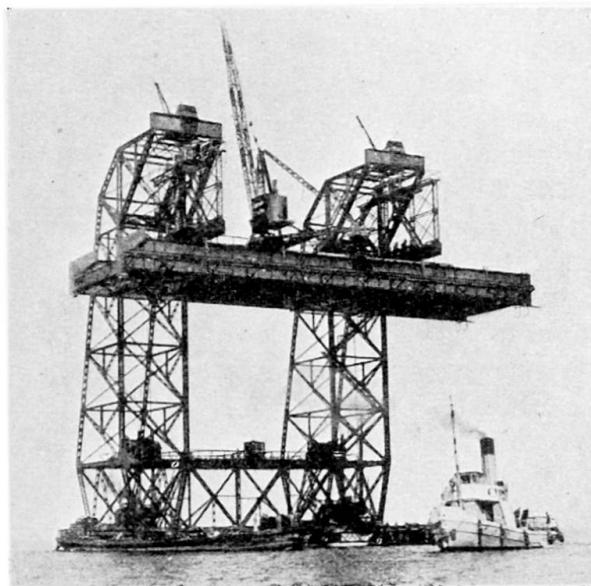
Erection by means of floating cranes generally has no effect on the design of the superstructure. In the Storstrom Bridge complete plate-girder side-spans weighing up to 500 tons each were hoisted up bodily by means of a huge floating crane and placed on their bearings on the piers at a height of 90 ft. above water level (fig. 10).

Fig. 10. Storstrom Bridge. Floating crane lifting 500-ton side span complete with erection crane on it

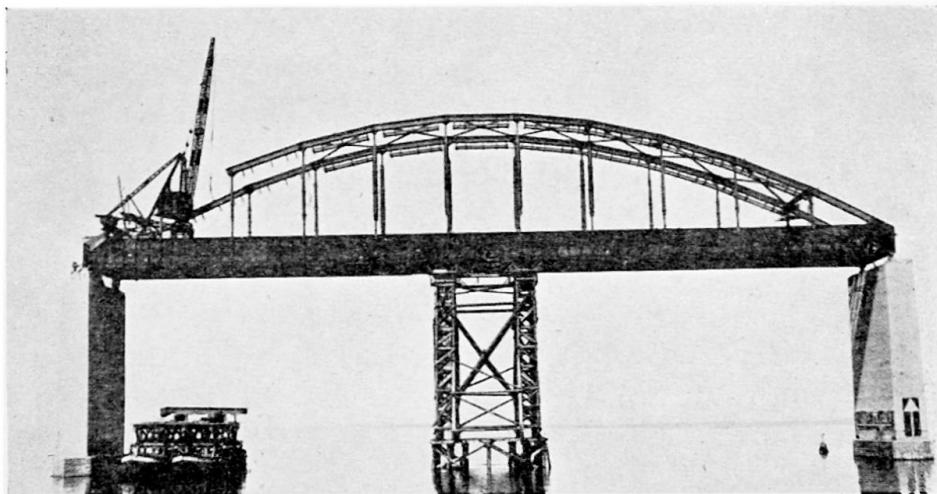
The main spans on this bridge consisted of tied arches with plate girders 12 ft. deep in the deck. The plate girders were erected in halves by the floating crane and joined on a temporary trestle at the centre (fig. 11). The arch rib was then erected overhead

Fig. 11. Storstrom Bridge. Plate girders of navigation span assembled in two halves by floating crane and connected on temporary trestle. Arch rib and hangers erected by travelling crane
