**Zeitschrift:** IABSE congress report = Rapport du congrès AIPC = IVBH  
Kongressbericht

**Artikel:** The behaviour of a symmetrical pitched roof portal loaded to collapse

**Autor:** Baker, J.F. / Eickhoff, K.G.

**The Behaviour of a symmetrical pitched roof portal  
loaded to collapse**

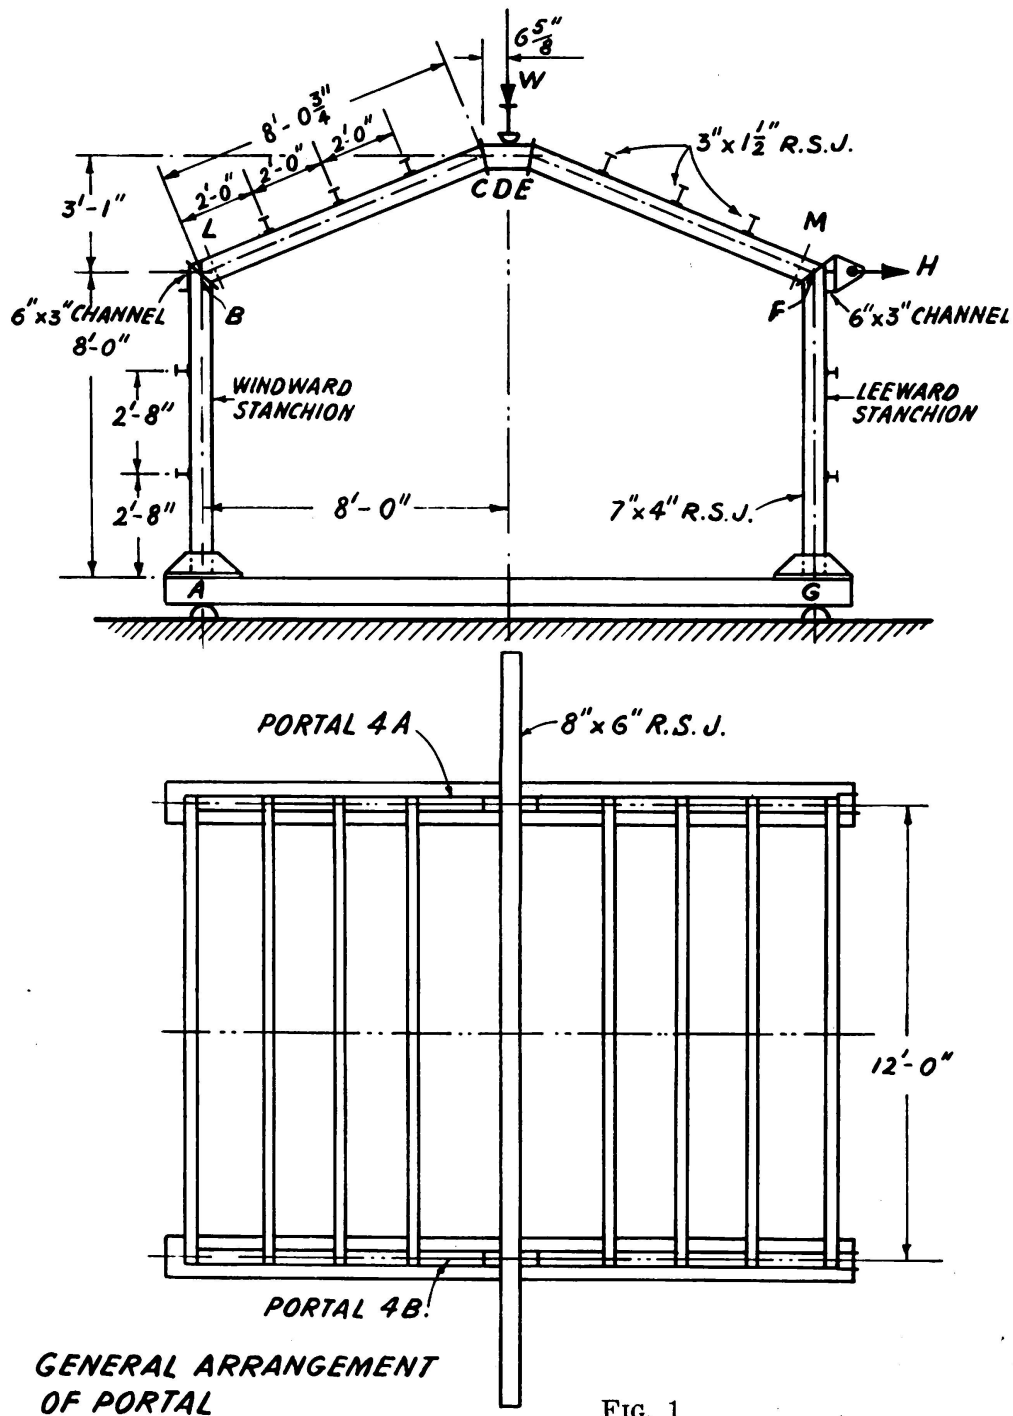
FIG. 1

The frame consisted of two similar symmetrical pitched roof portals, constructed throughout of 7"  $\times$  4"  $\times$  16 lb. per foot Rolled Steel Joist, having a span of 16 feet, a stanchion height of 8 feet and a roof slope of  $22\frac{1}{2}^\circ$ . The two portals were erected 12 feet apart, and braced by two eaves beams of 6"  $\times$  3" channel, and purlins and sheeting rails of 3"  $\times$  1 $\frac{1}{2}$ " R. S. J. (Figs. 1 and 2). The feet of the stanchions were rigidly attached to two heavy girders, also at 12 foot centres, which were in turn bolted down to a reinforced concrete raft. The raft to girder connections were such that the raft did not apply any restraining moment to the girder and thus, since the girder was stout enough to remain elastic when subjected to the full plastic moment of the stanchions, the rotations of the stanchion feet under any applied moments could be calculated from the elastic properties of the girder.

The portal was designed on the assumption that, at collapse, plastic hinges would form at the four points B, D, F and G (Fig. 1). However, owing to local increases in the depth of the section at B and F, due to the construction of the joints, plastic hinges did not form at these points, but at L and M where the section had returned to normal.

- They assume (1) that the plastic hinges are at B, D, F and G (Fig. 1)
- (2) that the plastic hinges are at L, D, M and G.
- (3) that, with hinges as in (2), the portal has deformed according to the deflections calculated above.

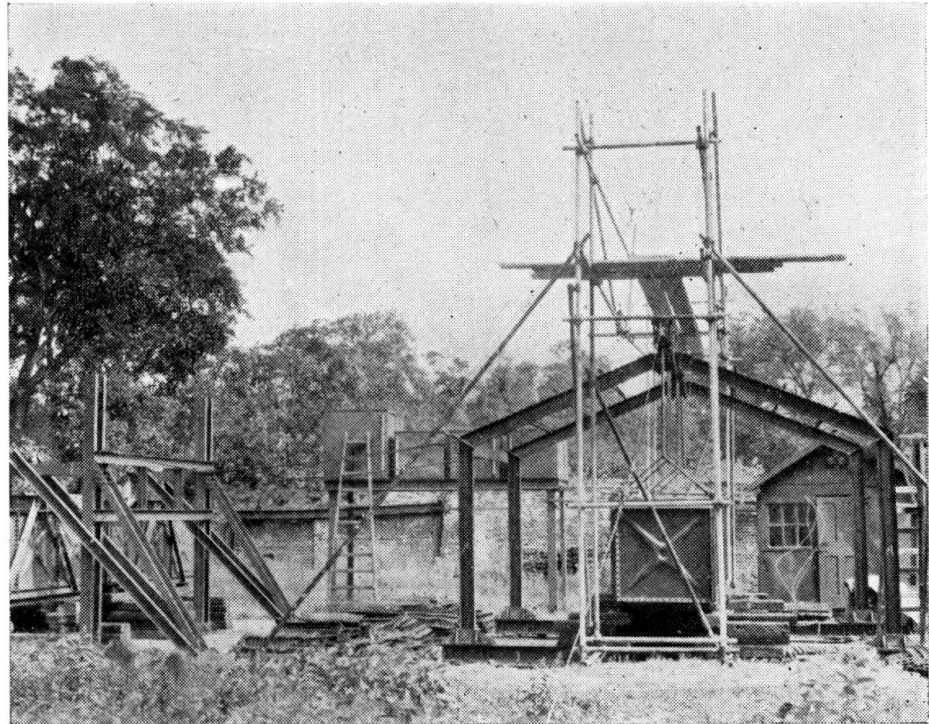
Horizontal load was applied by a second pair of tanks, each of which was suspended from a pair of steel cables passing over a large pulley held in a fixed frame (Fig. 2). The cables were attached to each portal through a heavy lug welded to the top of the stanchion (Fig. 3).

FIG. 2. Side view of frame before loading

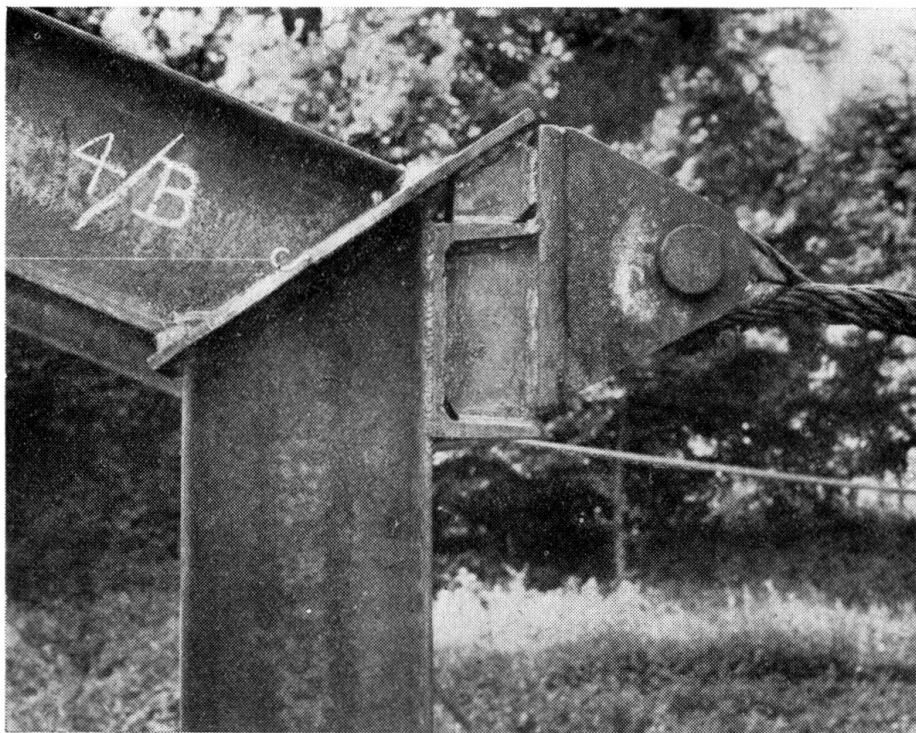
The joints of the portals were made by cutting off the lengths of R. S. J. to the required angle, and then profile welding them to  $\frac{3}{8}$ " thick division plates (Fig. 3). These division plates were flame cut. The profile welds were of  $\frac{1}{2}$ " leg round the flanges, and  $\frac{1}{4}$ " leg round the web. This form of joint has been used extensively throughout the whole series of portal tests, and has proved entirely satisfactory.

FIG. 3. Joint F, showing side load attachment

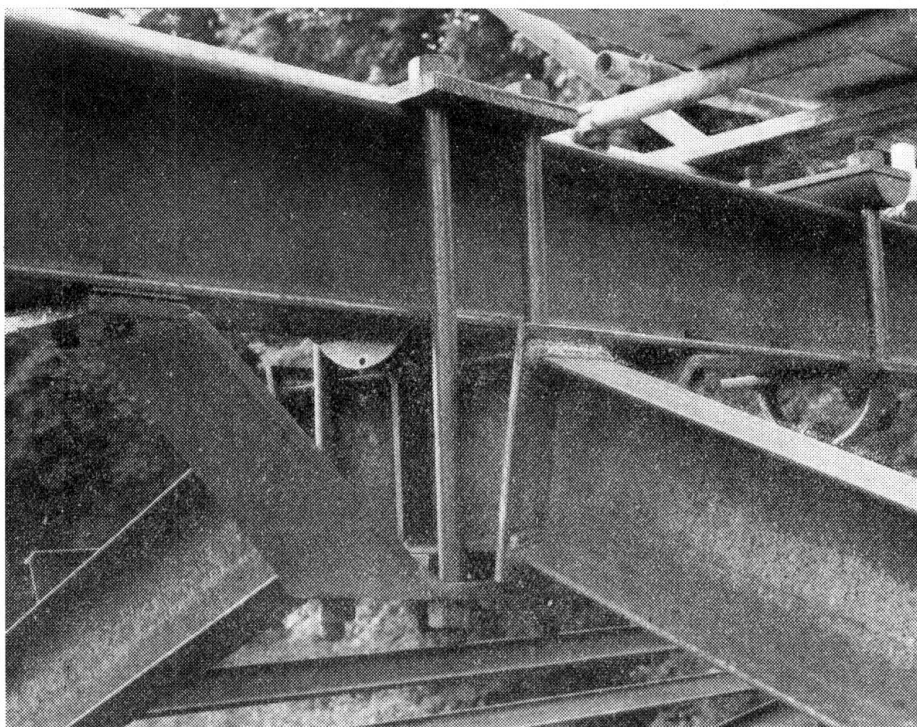
Vertical load was applied to the portals by a pair of steel tanks which were suspended from an 8"  $\times$  6" R. S. J., the ends of this joist being attached to the apex of each portal (Figs. 1 and 4). As will be seen from the photograph (Fig. 4) the load was applied through a length of half round material on the underside of the 8"  $\times$  6" R. S. J., and each frame was stiffened at this point by two pieces of  $\frac{3}{8}$ " plate welded to the web and flanges of the 7"  $\times$  4" R. S. J.

FIG. 4. Vertical  
load attach-  
ment

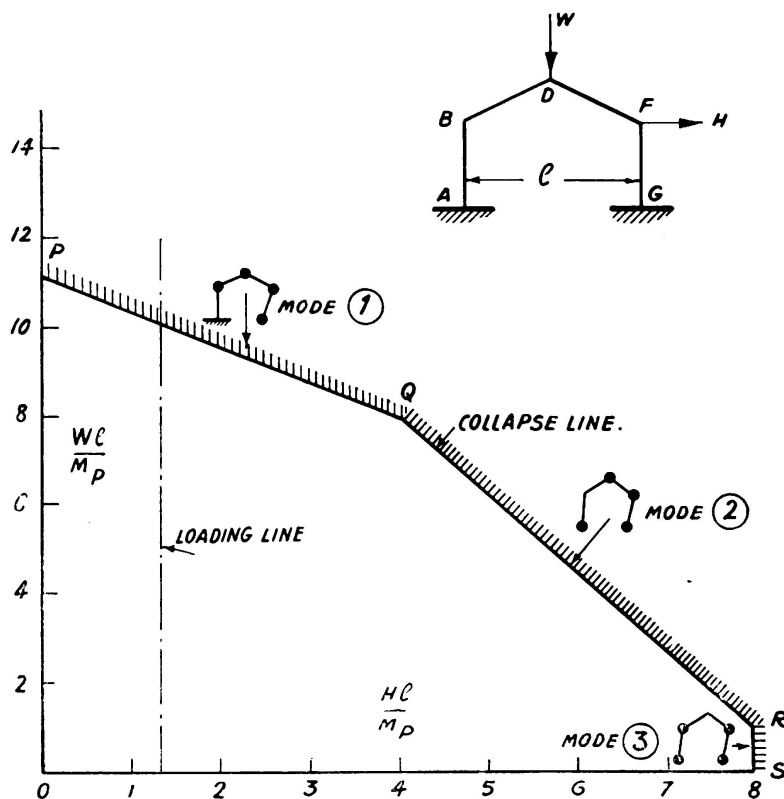
FIG. 5

sequence of loading can be represented by a curve on this diagram, and when such a loading curve reaches the line P Q R S the portal will collapse in the mode corresponding to the particular portion of the line P Q R S which has been reached.

The portal was loaded in such a way that collapse according to the mode [1] would be expected. This mode corresponds to the line P Q

in Fig. 5, and has plastic hinges at the points B, D, F and G, the bottom of the windward stanchion remaining elastic. The total horizontal load, H, was applied before any of the vertical load, this being purely a matter of convenience in testing. The final choice of  $H=1.70$  tons for the total horizontal load, corresponding to the vertical line shown in Fig. 5, was quite arbitrary.

#### THEORETICAL COLLAPSE LOADS

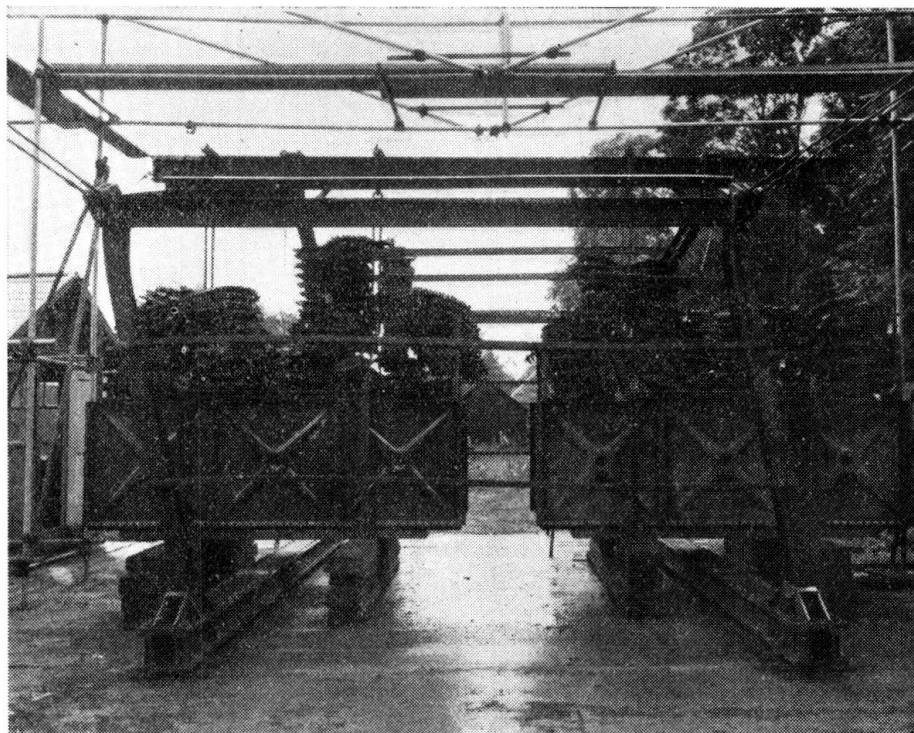
Final collapse of the frame occurred at a vertical load of 14.20 tons per portal. The frame supported this load for about twenty minutes, the vertical and longitudinal deflections creeping all the time, and then collapsed laterally (Fig. 6). Viewed from the leeward end, (Fig. 6) the tops of the leeward stanchions moved over to the left, while the main loading beam deflected to the right, and the vertical loading tanks

FIG. 6. End view of frame after collapse

The frame finally collapsed laterally, and the precise form of collapse was of course influenced by the amount of lateral bracing between the

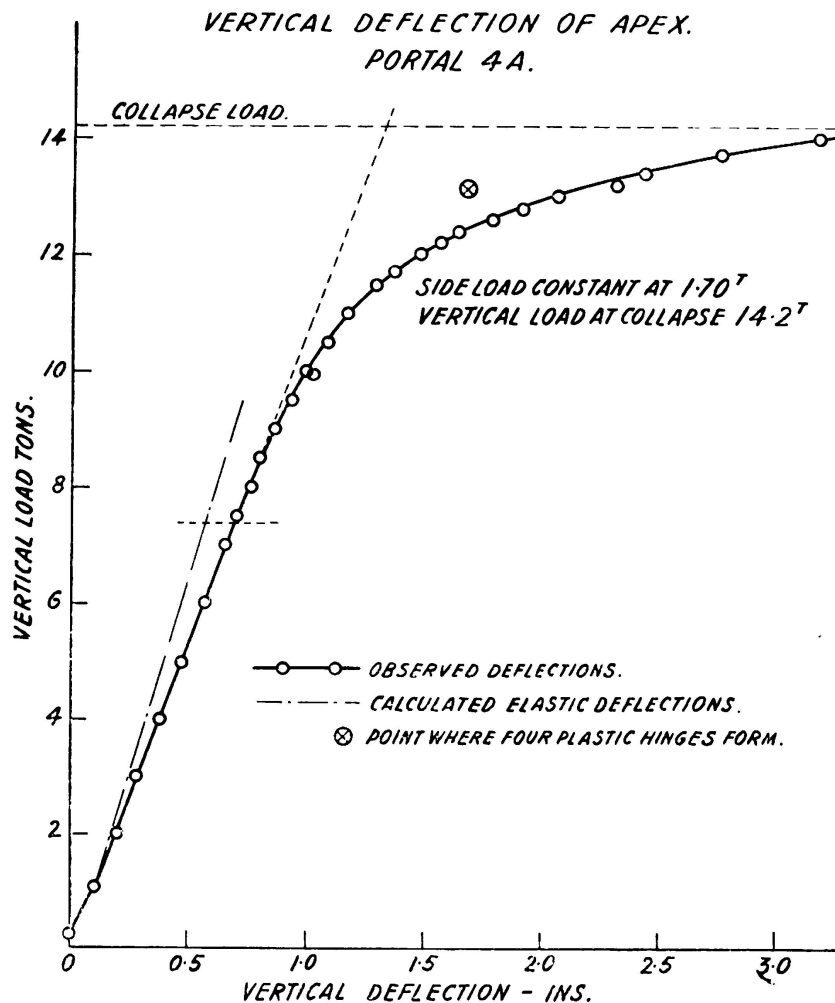
FIG. 7

The vertical deflection of the apex of portal 4 A is shown in Fig. 7, and the horizontal deflections of the tops of the stanchions in Fig. 8. The first signs of yield were observed as follows:—

The moments and deflections of the portal in the elastic range were calculated theoretically by slope-deflection methods, and the corresponding elastic load deflection lines are shown in Figs. 7 and 8. It will be seen

It will be seen from Figs. 7 and 8 that the load-deflection curves for the portal 4 A depart from the elastic line at a vertical load of about 8 tons. This premature departure from elastic behaviour is due both to residual stresses in the members forming the portal and to the lack of complete rigidity in the connections. It is a measure of the extent to which an elastic analysis differs from reality when applied to a «rigidly jointed» structure.

The points corresponding to these loads and deflections are shown in Figs. 7 and 8. Considering the somewhat sweeping assumptions made

It will be seen from Figs. 7 and 8 that under these working loads the frame would be elastic, with approximate deflections of 0.68 inches vertical at the apex and 0.51 inches horizontal at the top of the leeward stanchion.
