Tests of a 1/10-Scale Concrete Model to Aid Design of a Large Prestressed Bridge

W.G. CORLEY

EIVIND HOGNESTAD

Manager, Structural Development Section, and Director
Engineering Development Department, respectively
Portland Cement Association
Skokie, Illinois, USA

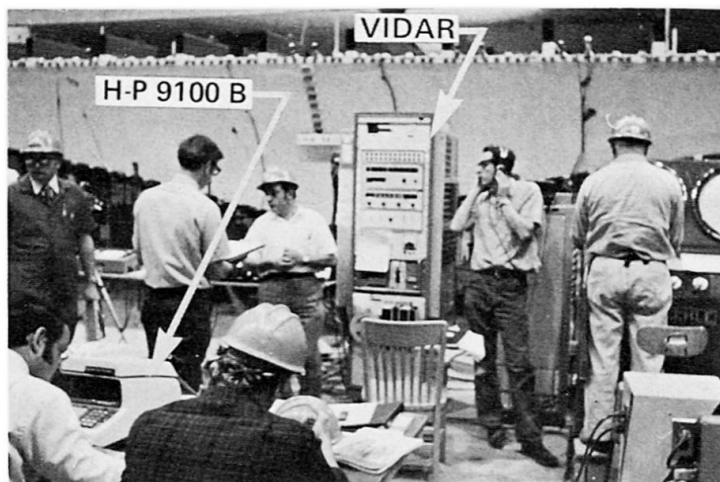
At each load increment, all data were recorded. Loads, reactions, strains and deflections were recorded on printed and punched tape using a high speed VIDAR digital data acquisition system shown in Fig. 6. The punched tape can be

As soon as a complete set of data was recorded on the VIDAR, selected readings were fed into a Hewlett-Packard 9100B (H-P 9100B) desk computer located in the test control center as shown in Fig. 6. This computer was programmed to give measured values of reactions, key stresses and deflections. As the test progressed, the measured values were compared with previously calculated values. This immediate access to important reduced data permitted the test to proceed rapidly while still maintaining complete control.

FIG. 6. Test control center

used to feed the data directly into an IBM 1130 Computer. Recording of 400 channels of information with this equipment required about 40 seconds.

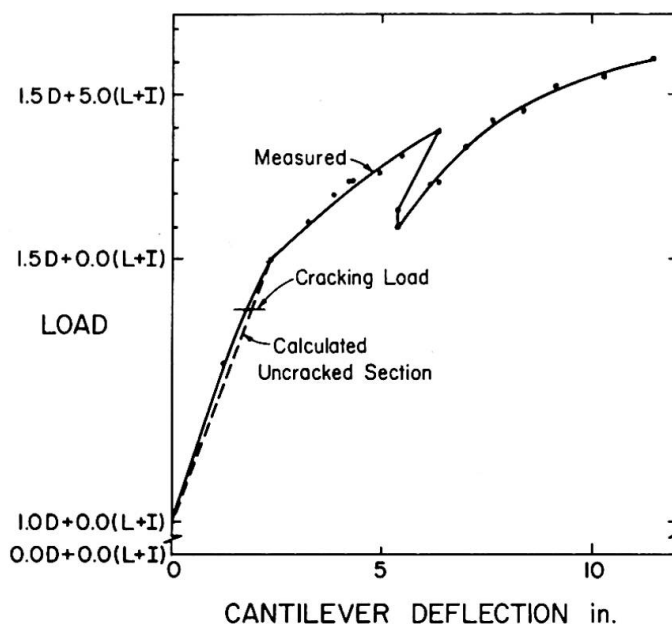
Figure 8 shows calculated and measured load versus deflection relationships for mid span (end of cantilever). Calculated deflections were based on an uncracked section and measured material properties. As can be seen, the observed deflections were in satisfactory agreement with those calculated.

FIG. 8. Cantilever load vs. deflection - test to destruction
