# **The Rebuilding of Wandsworth Bridge**

HAROLD FIRTH, O.B.E., M.I.C.E., Deputy Chief Engineer and

FRANCIS MATTHEW FULLER, B.Sc. (Eng.), M.I.C.E., M.I. Struct. E., Divisional Engineer  
for Bridges and General Works of the London County Council

### *Short description of new bridge*

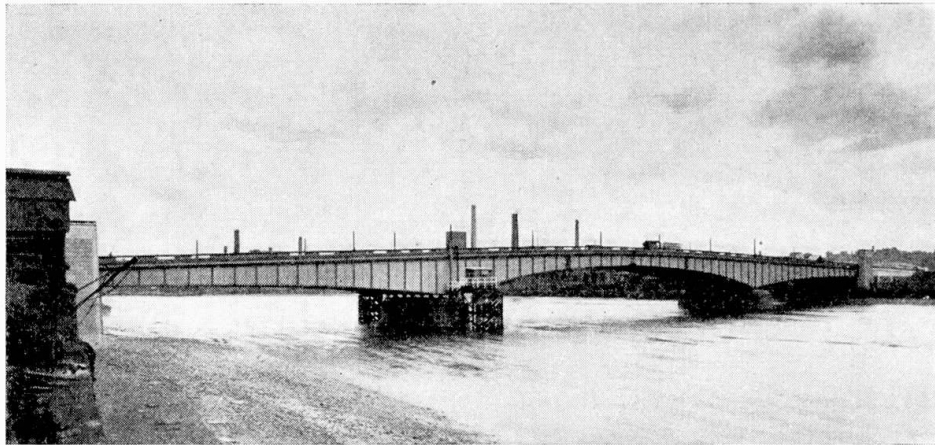
Photograph A. Wandsworth Bridge  
Upstream elevation from eastern end of Carnwath Laundry Wharf

The new bridge is illustrated in Figs. 1 to 4 and on photographs A – D. It is a steel bridge of the deck cantilever type, 646 ft. long between faces of abutments, and comprising three main spans. It is 60 ft. wide with a carriageway 40 ft. wide and two footways each 10 ft. in width. The two shore openings formed by the anchor arms of the cantilevers have each a clear span of 164'6" at Trinity High Water level, the span from centre of abutment bearing to centre of pier being 178'6". The centre opening has a clear span of 284 ft. at Trinity High Water level and comprises a suspended span of 120 ft. and two cantilever arms of 90 ft. each, making the total span 300 ft. centre to centre of piers. There are 7 longitudinal main girders, spaced at 10 ft. cross centres, the five girders under the carriageway of the anchor and cantilever arms are of lattice construction but the two outer girders and all the suspended span girders are plated. All main members of the lattice girders are of high tensile steel which has also been used for the plate girders, except at the shore ends of the anchor arms, where it was more economical to use mild steel. The headway at the centre is 21 ft. above T.H.W. The abutments and piers are of mass concrete faced with granite and are founded on the London blue clay. The new approach viaduct at the south end of the bridge comprises 5 reinforced concrete slab spans on mass concrete piers and at the north end there is a single approach span. The immediate approaches of the bridge between Townmead Road, Fulham, and York Road, Wandsworth, have been regraded and widened to 60 ft.

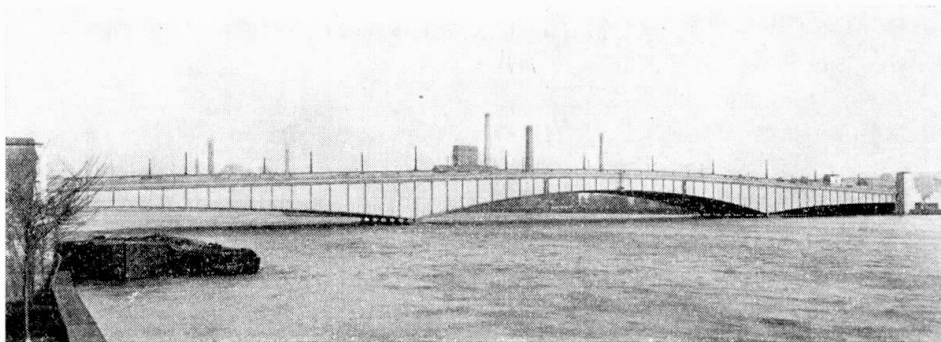
Photograph B  
Wandsworth Bridge. Upstream elevation looking south east

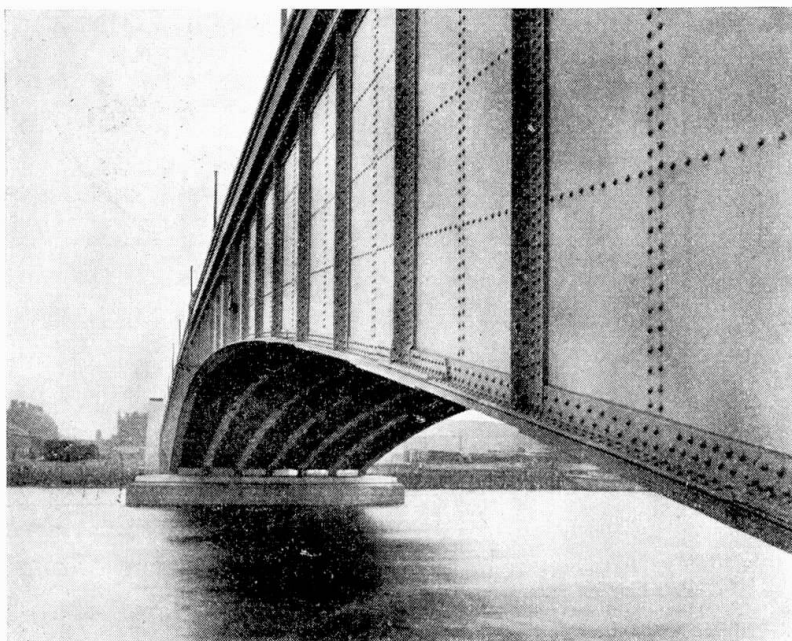
Photograph C. Wandsworth Bridge. Centre span showing  
upstream parapet girder and north river pier

No attempt has been made to disguise the fact that there is a suspended span, as the bearings are clearly visible. Purists may criticise the curved soffit of the suspended span, but in addition to the improved appearance it was more economical to curve the soffit than to lift the whole bridge in order to provide the requisite headway for river traffic.

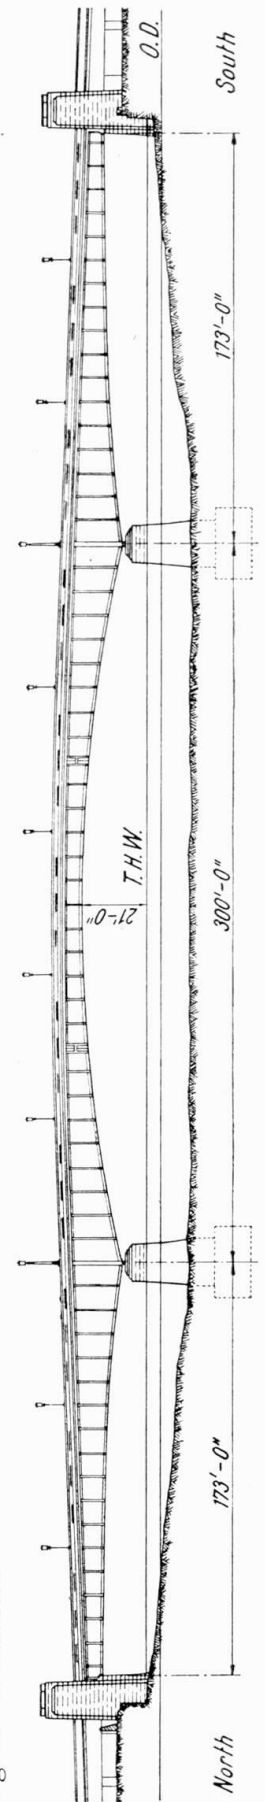
Fig. 1. Elevation

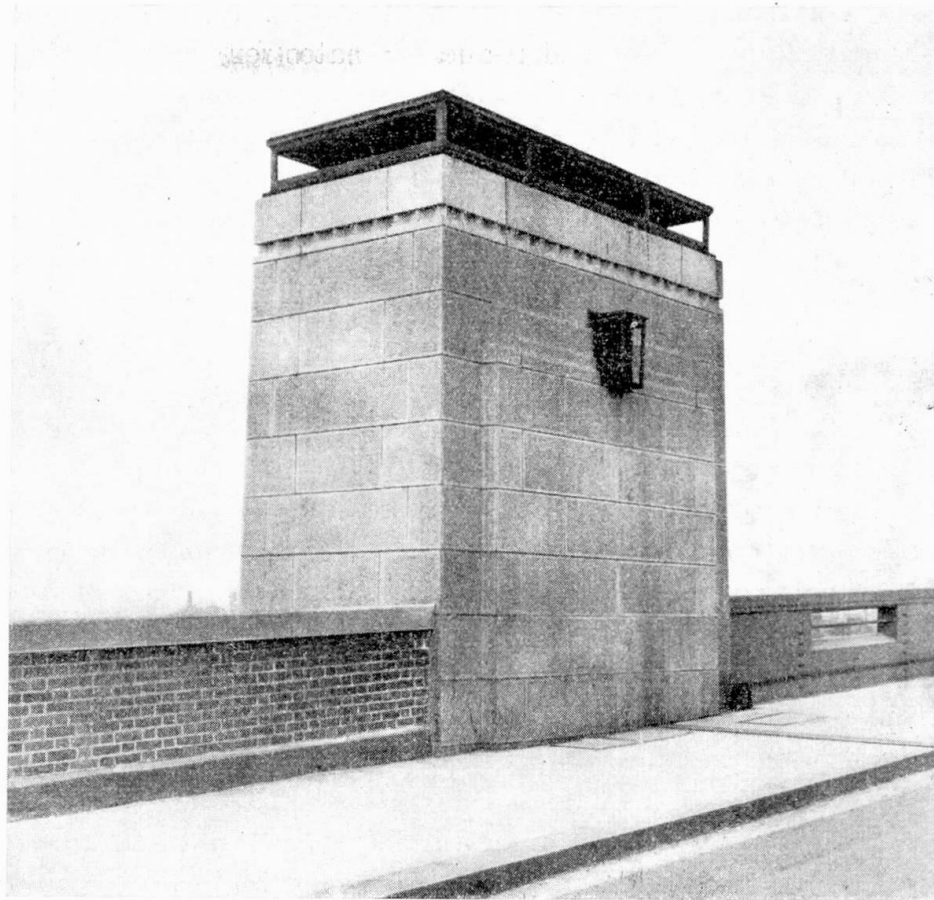
Photograph D. Wandsworth Bridge. South west pylon

Except for the granite pylons at each end of the bridge there are no special architectural features and the appearance of the bridge depends more on its outline than on ornamentation.

width as the bottom chord of the roadway girders. The granite facing to the piers, abutments and the outer face of the pylons was specified to be "rock face finished with projections punched off to a maximum of 1 inch from pitched line". This rough finish to the granite has a pleasing effect.

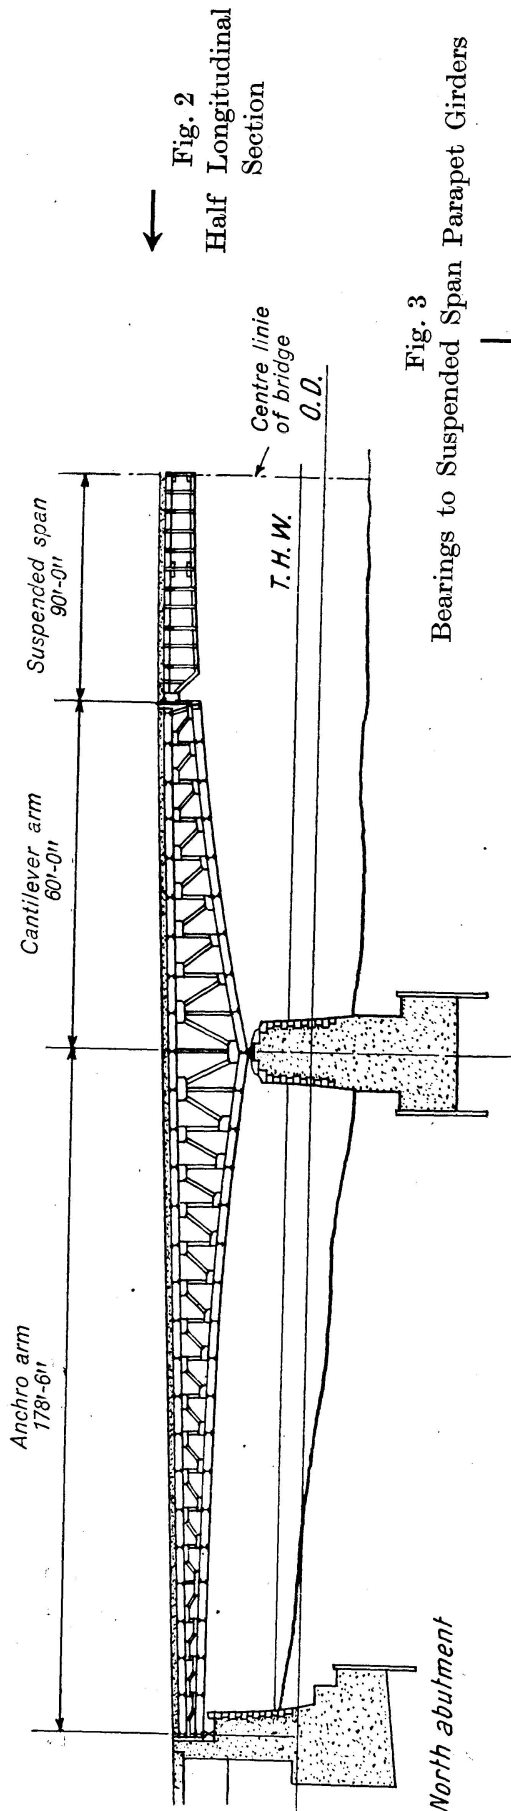
Fig. 3  
Bearings to Suspended Span Parapet Girders

The main girders are carried on fixed bearings at the piers and on expansion bearings at the abutments. The suspended span rests on fixed pin bearings at the south end and on expansion bearings at the north end. Details of the bearings are shown in figure 3.

The cast steel bearings are fixed to the piers by anchor bolts and channels.

In order to provide for a possible upward reaction at the abutments the expansion bearings are also held down by bolts and channels. Under normal loading there is no upward reaction but a small upward reaction is possible under certain improbable conditions of loading.

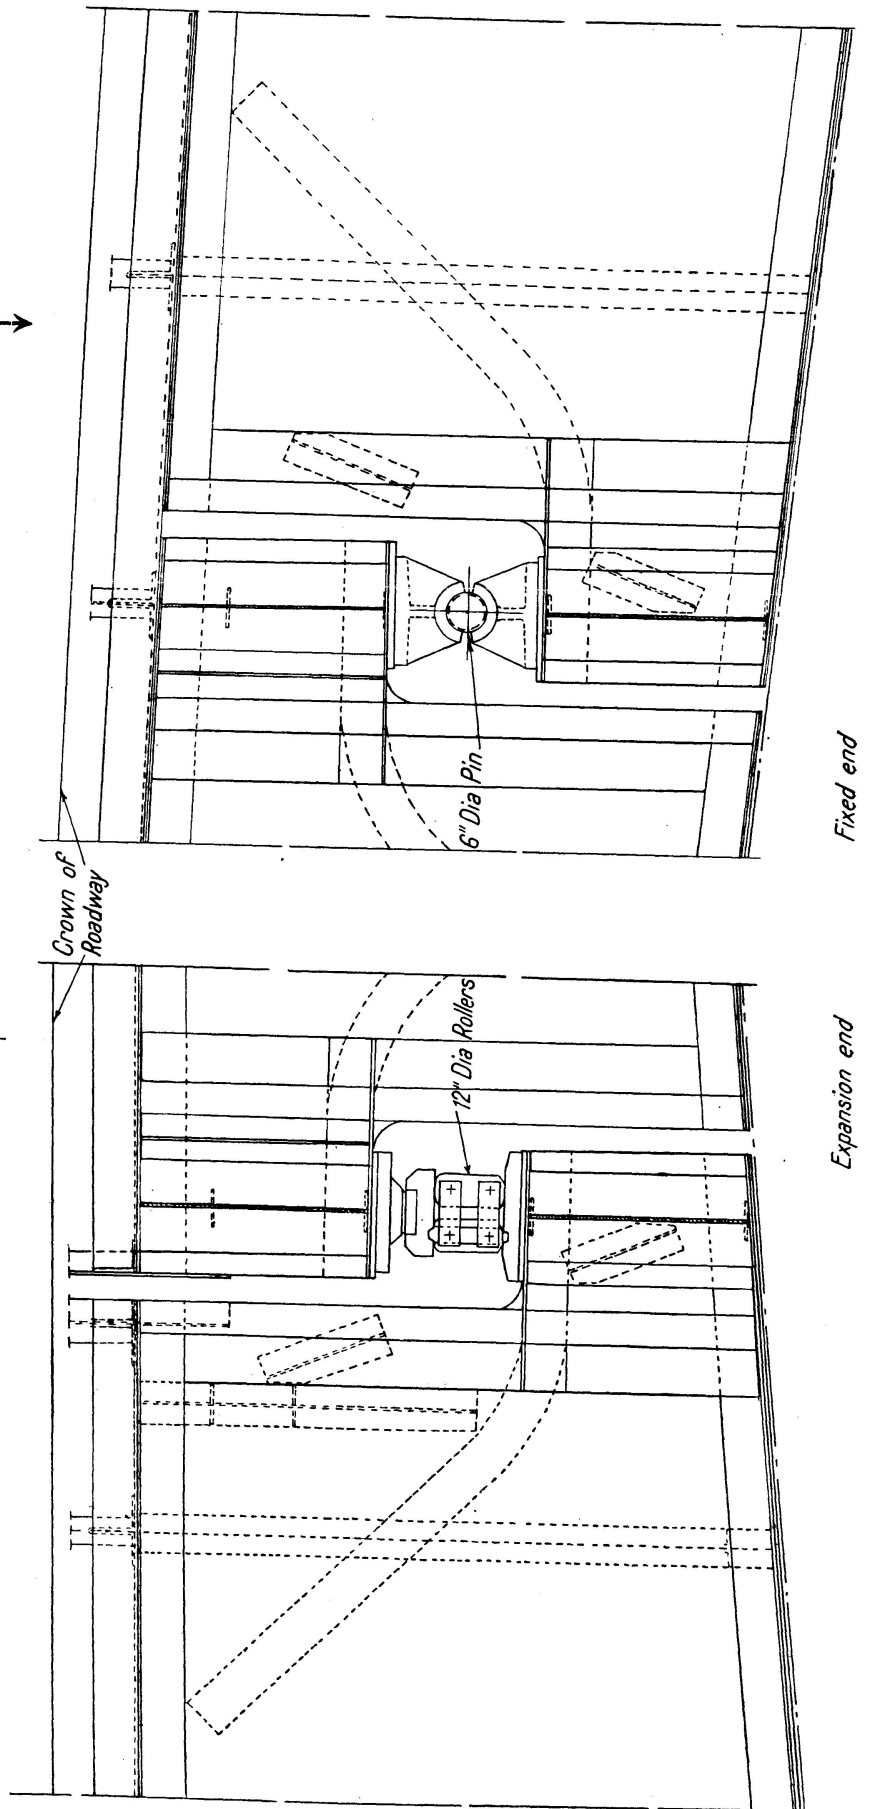
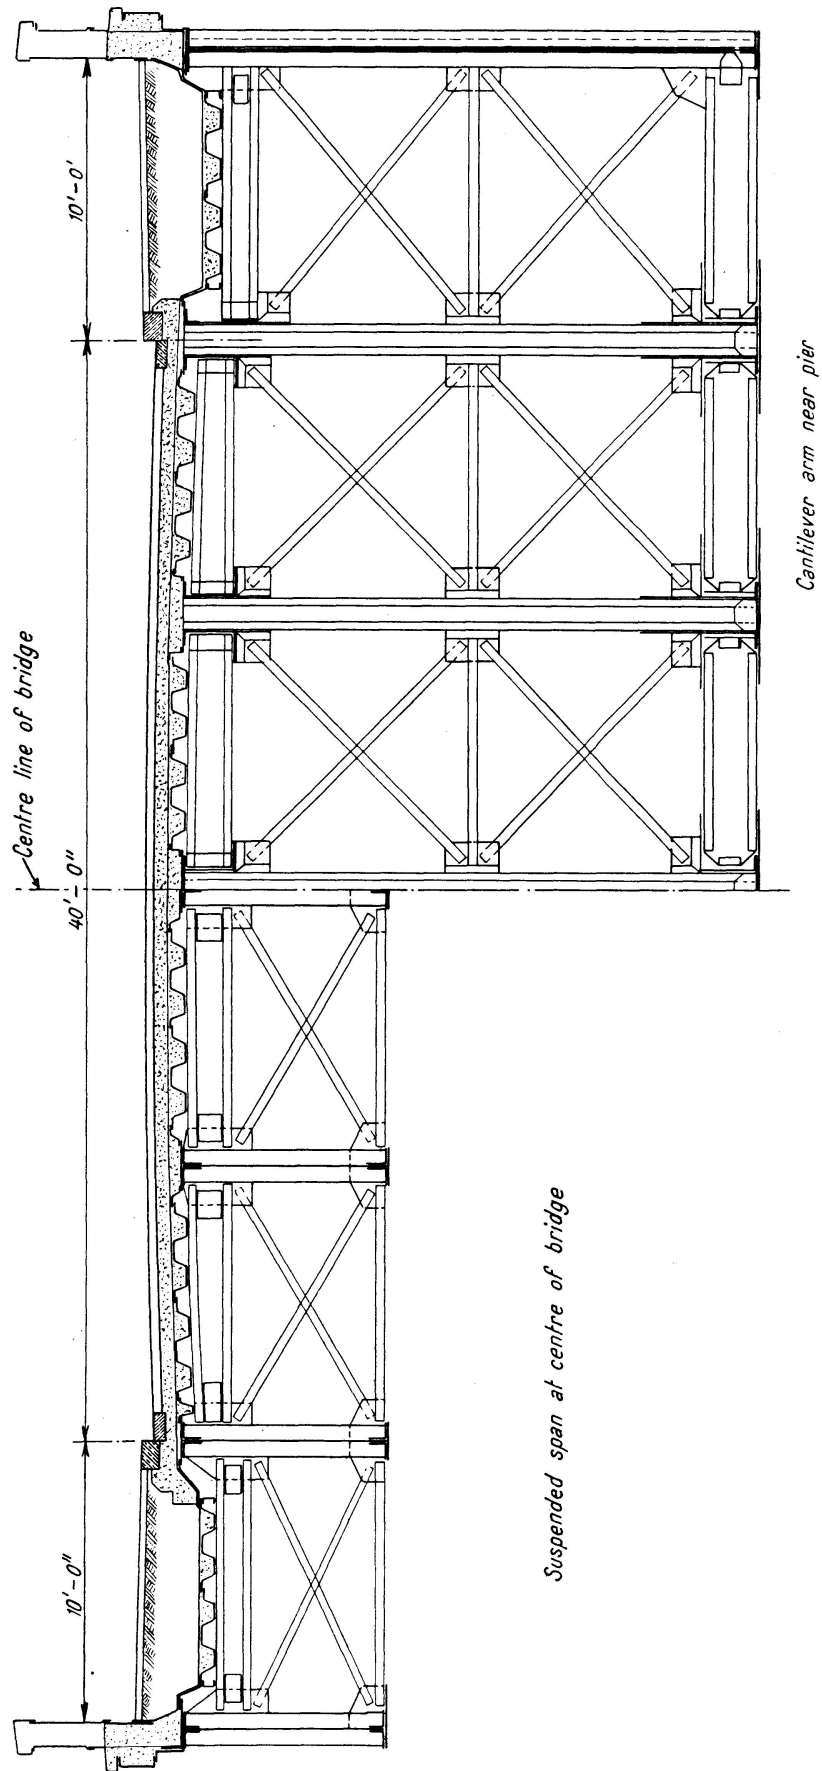
Fig. 4. Half Cross Sections

The deck of the bridge is carried on 7 longitudinal main girders spaced at 10 feet centres. The five inner girders of the anchor and cantilever arms are N. type lattice girders but all the girders of the suspended span and the outer girders of the anchor and cantilever arms have solid web plates. The steel troughing which forms the deck of the bridge is  $\frac{1}{2}$ " thick under the carriageway and  $\frac{3}{8}$ " thick under the footways. It is carried on cross girders spaced at 10 ft. centres spanning between the top booms of the main girders. There is cross bracing between the main girders at each cross girder and lateral bracing is provided in the plane of the bottom flanges of the main girders. Typical details are shown in figures 2 and 4.

A cornice built up of steel plates and sections and filled with 6 to 1 concrete runs the length of the bridge and rests on the top of the outer girders.
