Behaviour of brick masonry buildings during earthquakes

BEHAVIOUR OF BRICK MASONRY BUILDINGS DURING EARTHQUAKES

Nejat BAYÜLKE

Chief of Structural Division
Earthquake Research Institute
Ministry of Reconstruction and Resettlement
Ankara-TURKEY

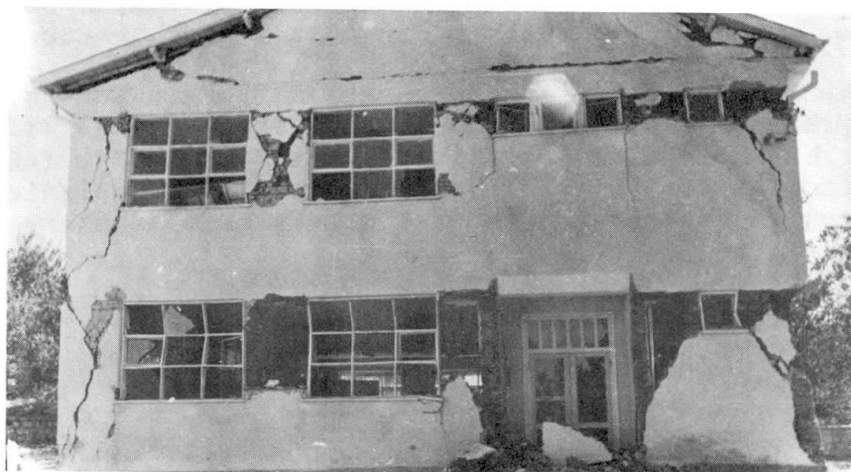
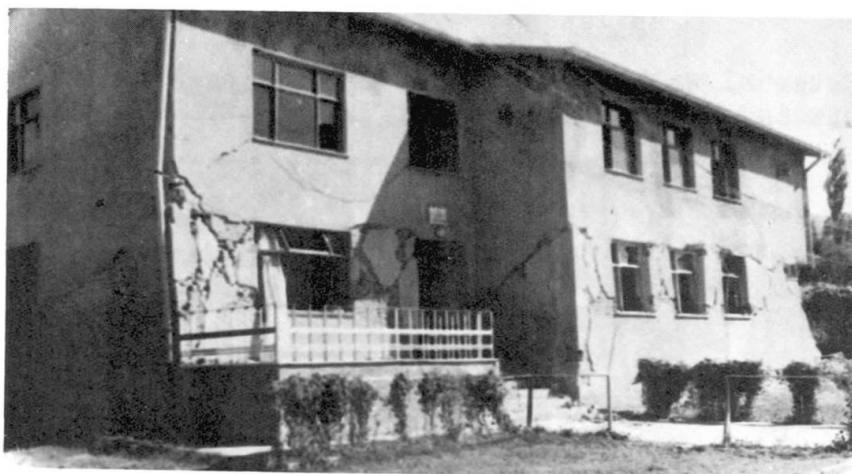
Figure-5 Typical Failure of Brick Masonry

Figure-6 Typical Failure of Brick Masonry

Figure-7 Typical Failure of Brick Masonry

This initial diagonal cracking of the wall, if the earthquake continues at a high intensity, will result in the decrease of vertical load carrying capacity of the wall and vertical cracks due to vertical loads will begin to appear in addition to the existing cracks due to diagonal tensile stresses in the wall. This process will eventually lead to the complete collapse of the wall. Figures-5,6,7 show this kind of heavily damaged brick masonry walls
