Zeitschrift: Swiss express : the Swiss Railways Society journal
Herausgeber: Swiss Railways Society
Band: 4 (1994-1996)
Heft: 5

Inching Along Through the Lötschberg Tunnel

By George M. Hoekstra

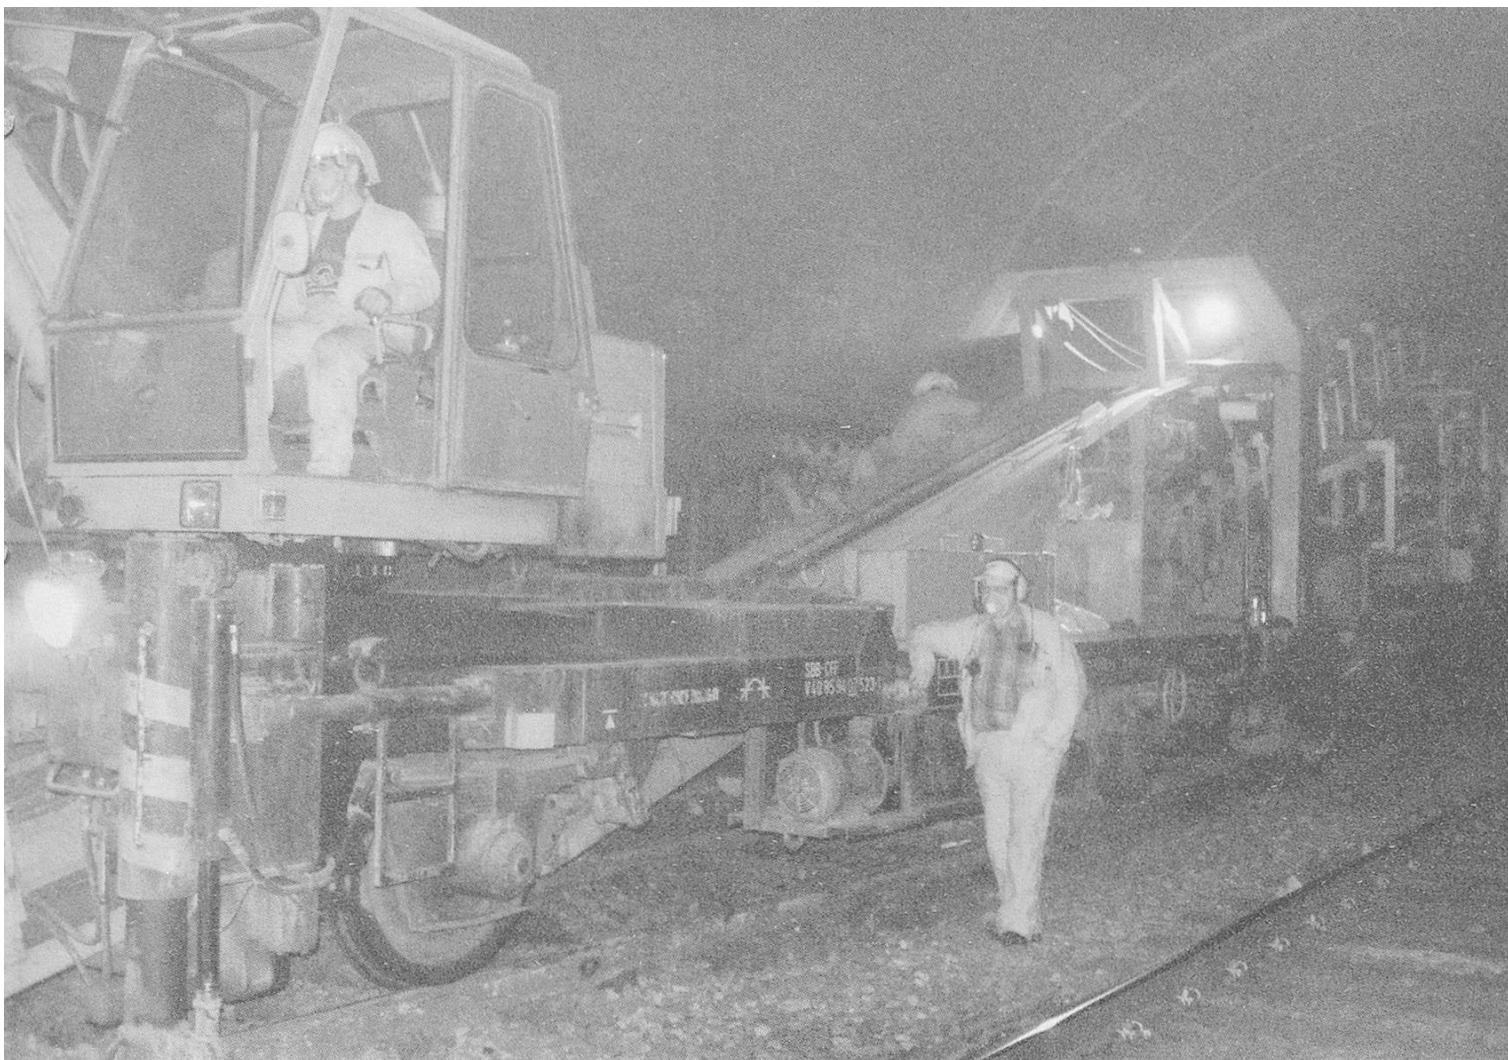
Lowering the track base with hydraulic hammer drill. Note how close the running tracks are to the work site.

The right-hand track is worked on initially. The track is cut into sections 18 m long, lifted and removed from the tunnel. Useable sleepers are stored. Then the old ballast is removed and the rock floor of the tunnel is lowered. All this spoil is loaded by a conveyor belt into waiting hopper wagons. The work is extremely dusty, so apart from the operators wearing special *Airstream* masks and other personnel wearing face dust masks, the BLS has installed a special vacuum cleaner wagon, capable of filtering 120,000 cubic metres of air each eight hour shift. No less that 12 kilogrammes of very
