LOGBOOK—THE ICE SHELL

Oliver Burch, Anthony Haag,
Damian Ineichen, Fabian Kuonen

Today, on the 25th January 2019, we, a team of four ice shell builders, have finally arrived in the mountains—to be precise: in Obertschappina, Canton of Grisons, Switzerland. In the preceding months, we had been calculating, testing and experimenting with different materials and methods of form-finding in specific environmental conditions. All that effort directed towards one goal: to master the art of building ice shells.

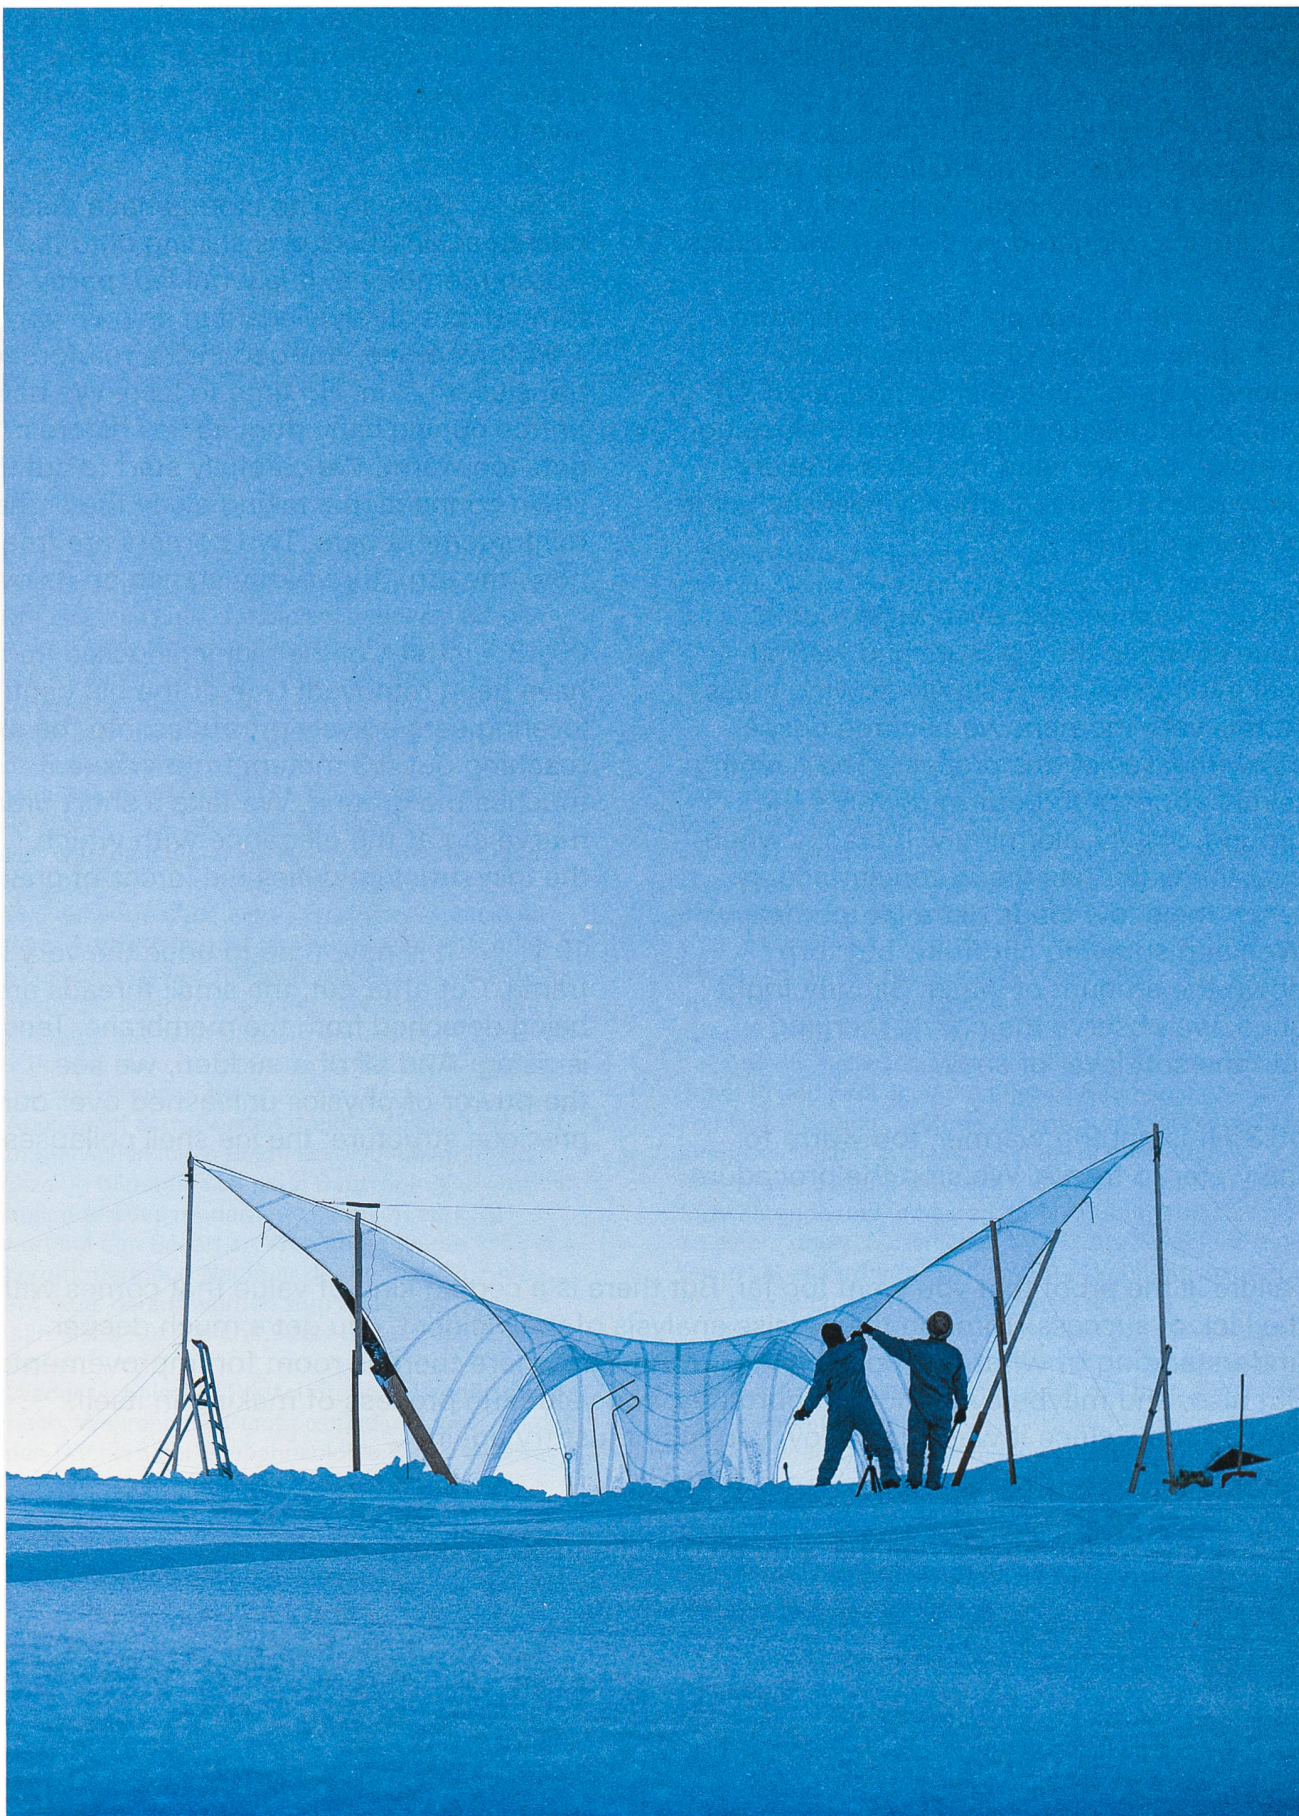
A The Ice Shell on January 25th, 2019, at 17:09h

After these months of preparation, the on-site assembly of the falsework is now complete: a rigid frame out of bent reinforcement bars, attached to a glass-fiber textile, three-dimensionally seamed up, creating a doubly curved surface of 56.6 square meters. In plan: an equilateral triangle with a side length of 10 meters. In elevation: a combination of trimmed curves, with two cantilevering tips of 4.3 meters, reaching a maximum height of nearly 3.5 meters. The conditions are good: Clear blue sky, cold weather, and some hot tea boiling on the fire in the mountain hut nearby.

17:13 The last rays of the setting sun refract in the glass fiber threads, emphasizing the seams of the cutting pattern. No clouds, so every bit of warmth that the dry air can carry is clearing away into the sky. The temperature drops constantly, it is now -8° Celsius. We are thrilled—and ready to start the freezing procedure.
