Albania Dam Safety Monitoring

Abstract

This article deals with the implementation of geotechnical and geodetic monitoring systems for five hydropower dams in Albania. The dams were equipped with different automatic and manual sensor systems to improve the safety of the dams by monitoring the behaviour of the structures and their surroundings. The topography and accessibility in this wild and beautiful country presented a very special challenge.

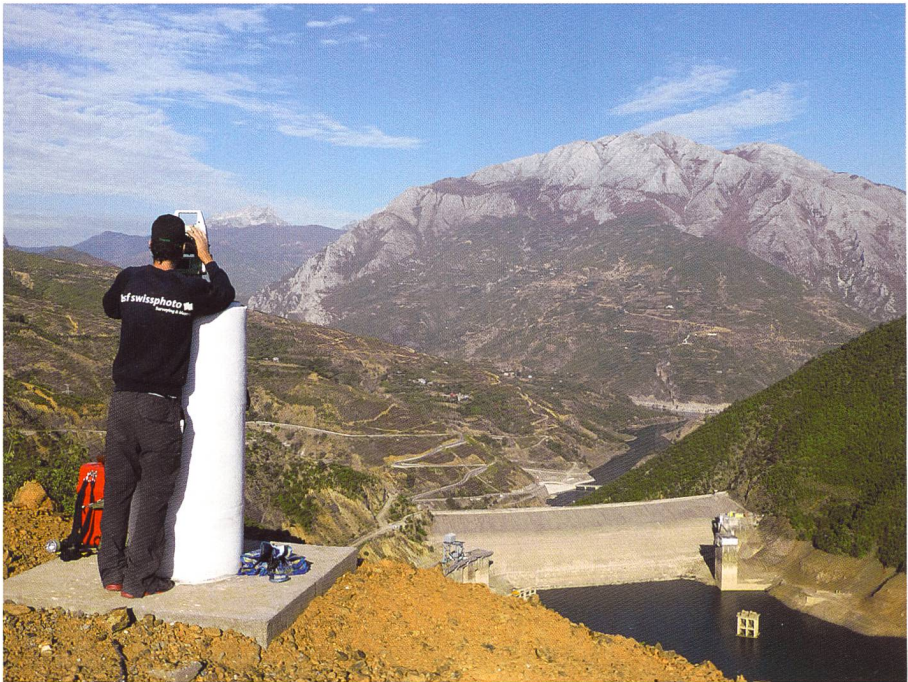
Figure 1. Geodetic Monitoring at Fierza HPP.

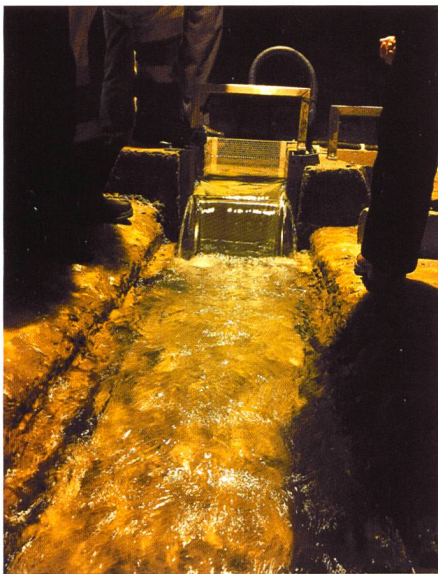
Figure 2. Automated rectangular weir measuring seepage flow inside Komani dam.

To monitor the structural integrity of the dams a three-pronged approach is used. Seepage through the dam body is monitored using automated piezometers behind the grout curtain and by collecting and measuring seepage run-off via automated V-notch weirs (see figure 2). Standpipe piezometers are used on the downstream dam face and the abutments to monitor water levels. And lastly, an automated seismic network records vibrations in a background mode and seismic events.

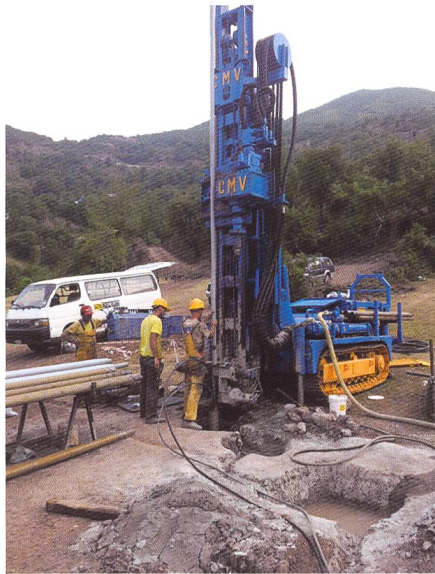
Figure 3. Drilling works for inclinometers with sub-contractors Altea Geostudio2000 at Porava.

Other measurement points include inclinometers installed in landslide areas near the dams (Fierza HPP and Komani HPP). An example is shown in figure 3 regarding the Porava landslide area near HPP Fierza. Furthermore, jointmeters and pendulums are used inside Ulza dam to monitor its deformations depending on the reservoir level.

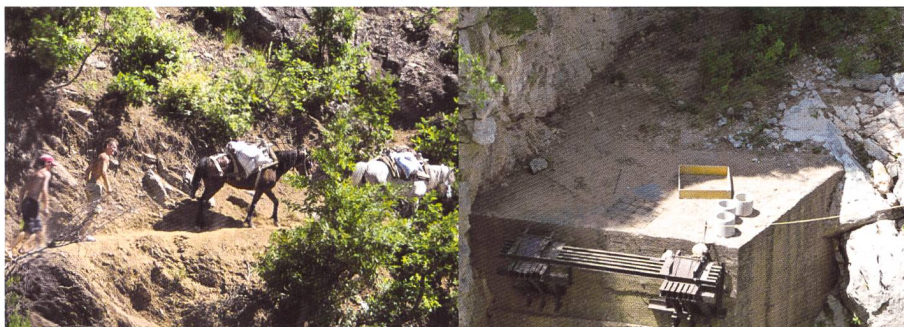
Figure 6. Transport of construction material, Mules, improvised cable cars.

The civil work for the reference points was carried out in the summer months May to September 2012 and proved to be difficult due to the topography and accessibility. Most of the locations are in steep and rocky terrain and cannot be reached by car. The construction material such as cement, gravel, water, etc. had to be transported by mules or by pretty adventurous self-made cable cars. There

we were happy to have the support of a local subcontractor who had the experience and creativity to make it happen. All the excavations were done manually (see figure 6).

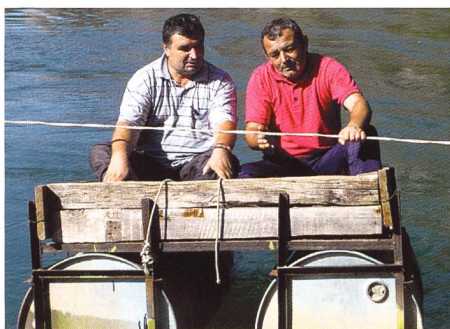
Figure 8. Improvised ferry service downstream of Shkopet HPP, Installation of object points at Ulza HPP.

The measurements were taken by a team consisting of specialists from BSF Swissphoto and KESH. Meanwhile on the job training was given. The measurements were completed within two days at each dam. Due to the difficult access and long distances between the points we were happy to have additional personnel of the hydropower plants at our disposal (see figure 8).
